Address of site 104 Cabarita Road, Avalon

Report Title: Geotechnical Report 104 Cabarita Road, Avalon

GEOTECHNICAL INVESTIGATION: **New Jetty at 104 Cabarita Road, Avalon**

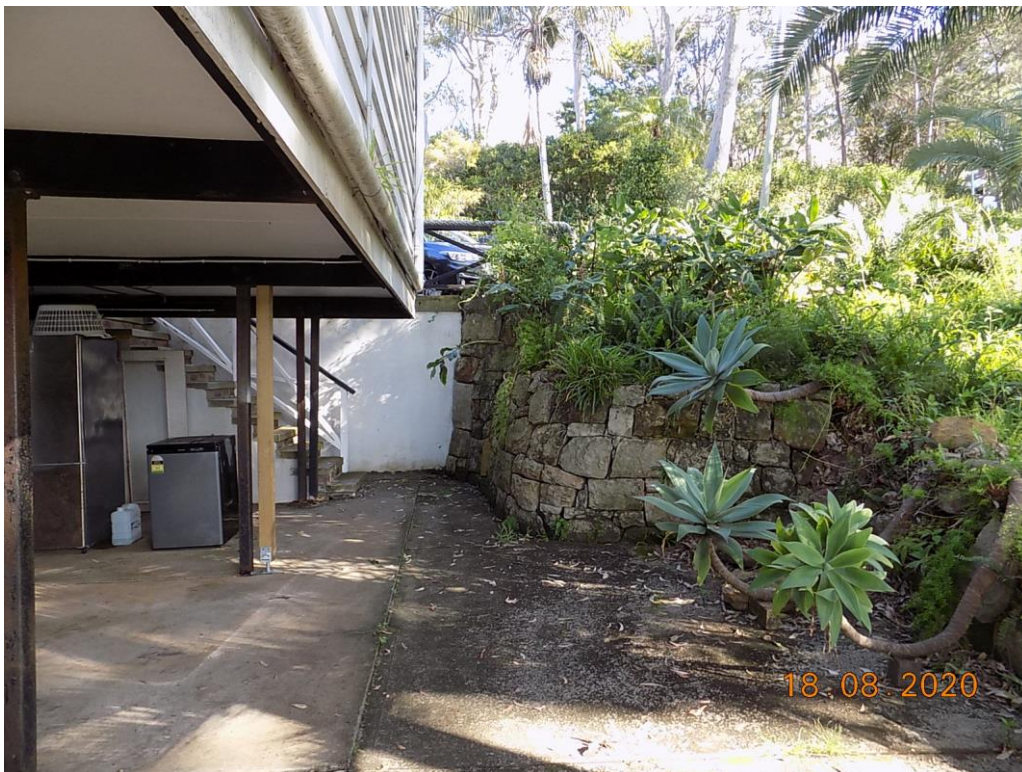
Photo 3

- 2.3** The property is accessed by a concrete Right of Carriageway (ROW) off Cabarita Road (Photo 1). A concrete driveway diverts off the ROW and runs to a carport under the house and to a parking area on the uphill side of the house (Photos 2 & 3). The fill for the parking area is supported by a stable rendered masonry retaining wall reaching ~2.0m high (Photo 4). The old part two-storey house is supported on steel posts (Photo 5). Some of the supporting posts have rusted and tilted but have been remediated with additional supports (Photo 6). The area surrounding the house is lawn and garden-covered. These gardens slope steeply to the waterfront below the house (Photo 7). Three buildings have been constructed at the W end of the waterfront (Photo 8). An excavation has been made in the slope to create a level platform for the upper level of the larger building. The cut is supported by a stable sandstone block retaining wall ~1.1m (Photo 9). The larger building is a two-storey

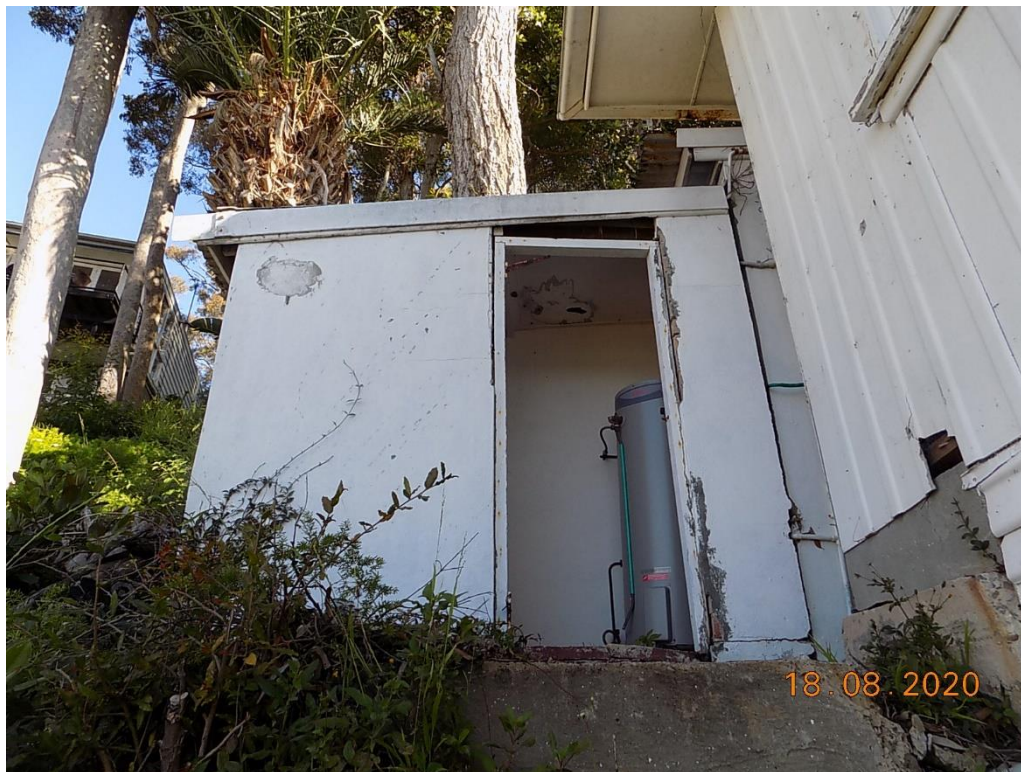
Photo 10

boathouse supported on sandstone block foundations. The sandstone block foundation walls have weathered to a point where deterioration is occurring rapidly and this process is undercutting the walls above (Photo 10). One portion of a small brick building upslope and to the E of this building displays significant settlement downslope (Photo 11). We recommend these buildings be assessed by a structural engineer to determine the details of the required remedial works. Until this inspection is carried out, we recommend no one spend time in these structures. Another stable sandstone block boathouse has been constructed at the E end of the waterfront (Photo 12). Between the boathouses is a near-level lawn (Photo 13). The cut for the lawn and E boathouse is supported by a stable ~1.8m high sandstone block retaining wall (Photo 14). The fill for the lawn is supported by a ~1.6m high sandstone block seawall (Photo 15). The seawall was observed to be supported directly onto Low to Medium Strength Shale at the waterfront. Some of the sandstone block components of the seawall were also observed to be weathered (Photo 16). We recommend the more weathered components be replaced.
