Development Application for _____	Name of Applicant _____
Address of site 2a Allen Avenue, Bilgola Beach, NSW

REPORT ON GEOTECHNICAL SITE INVESTIGATION

The site is located within the H1 (highest category) landslip hazard zone as identified within Northern Beaches (Pittwater) Councils Geotechnical Risk Management Map (Map Sheet GTH_016). The site is also designated as Acid Sulfate Soils hazard Class 5 (Map-Sheet ASS_016).

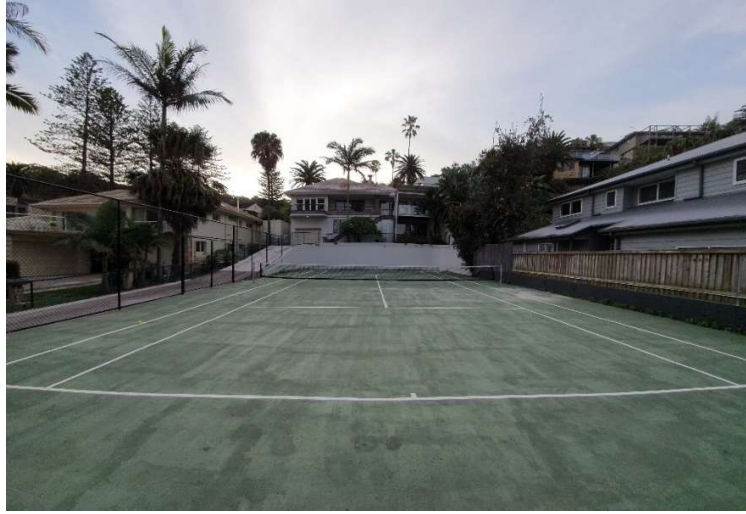
Photograph-2: Front view of the site. View looking west.

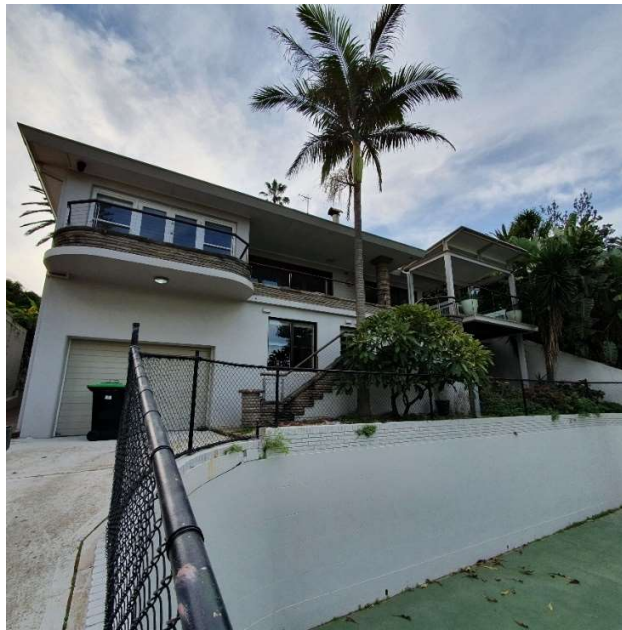
Photograph-3: Site-dwelling frontage. View looking north-west.

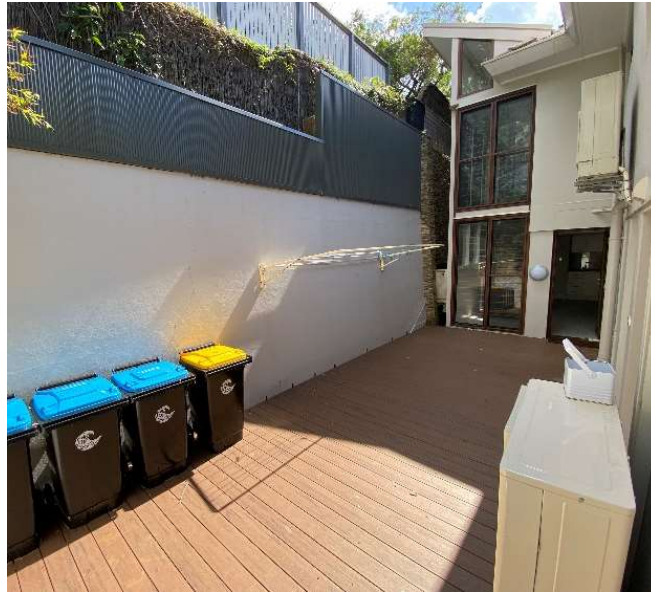
Photograph-4: Rear deck of the site. View looking north-west.

The site-dwelling is detached from the western boundary (approximately $\leq 1.0\text{m}$ to $\leq 4.0\text{m}$). Along the western boundary is an approximately 4.0m to 5.0m high retaining wall. The southern portion of the wall is rendered (Photograph-4), whilst the northern portion is stone veneer clad. Observations from the top of the wall identified what appears to be a concrete column/pier which is located on top of the wall (Photograph-8 and 9) (approx. $\leq 1.0\text{m}$ high and approximately 2.5m spaced along the western boundary). To the rear of the retaining wall (within south-east corner of No8 The Serpentine) a stormwater drainage pit which may be part of the water easement located along the south boundary of the site and a large tree (approximately $\leq 10\text{m}$ high) are located 1.0m from the retaining wall. The retaining wall contained a semi-vertical crack (up to $\leq 1\text{mm}$ wide and 3.0m long, Photograph-10), however it appeared stable with no signs of rotation, humidity, or underlying geotechnical issues and appeared in good condition.

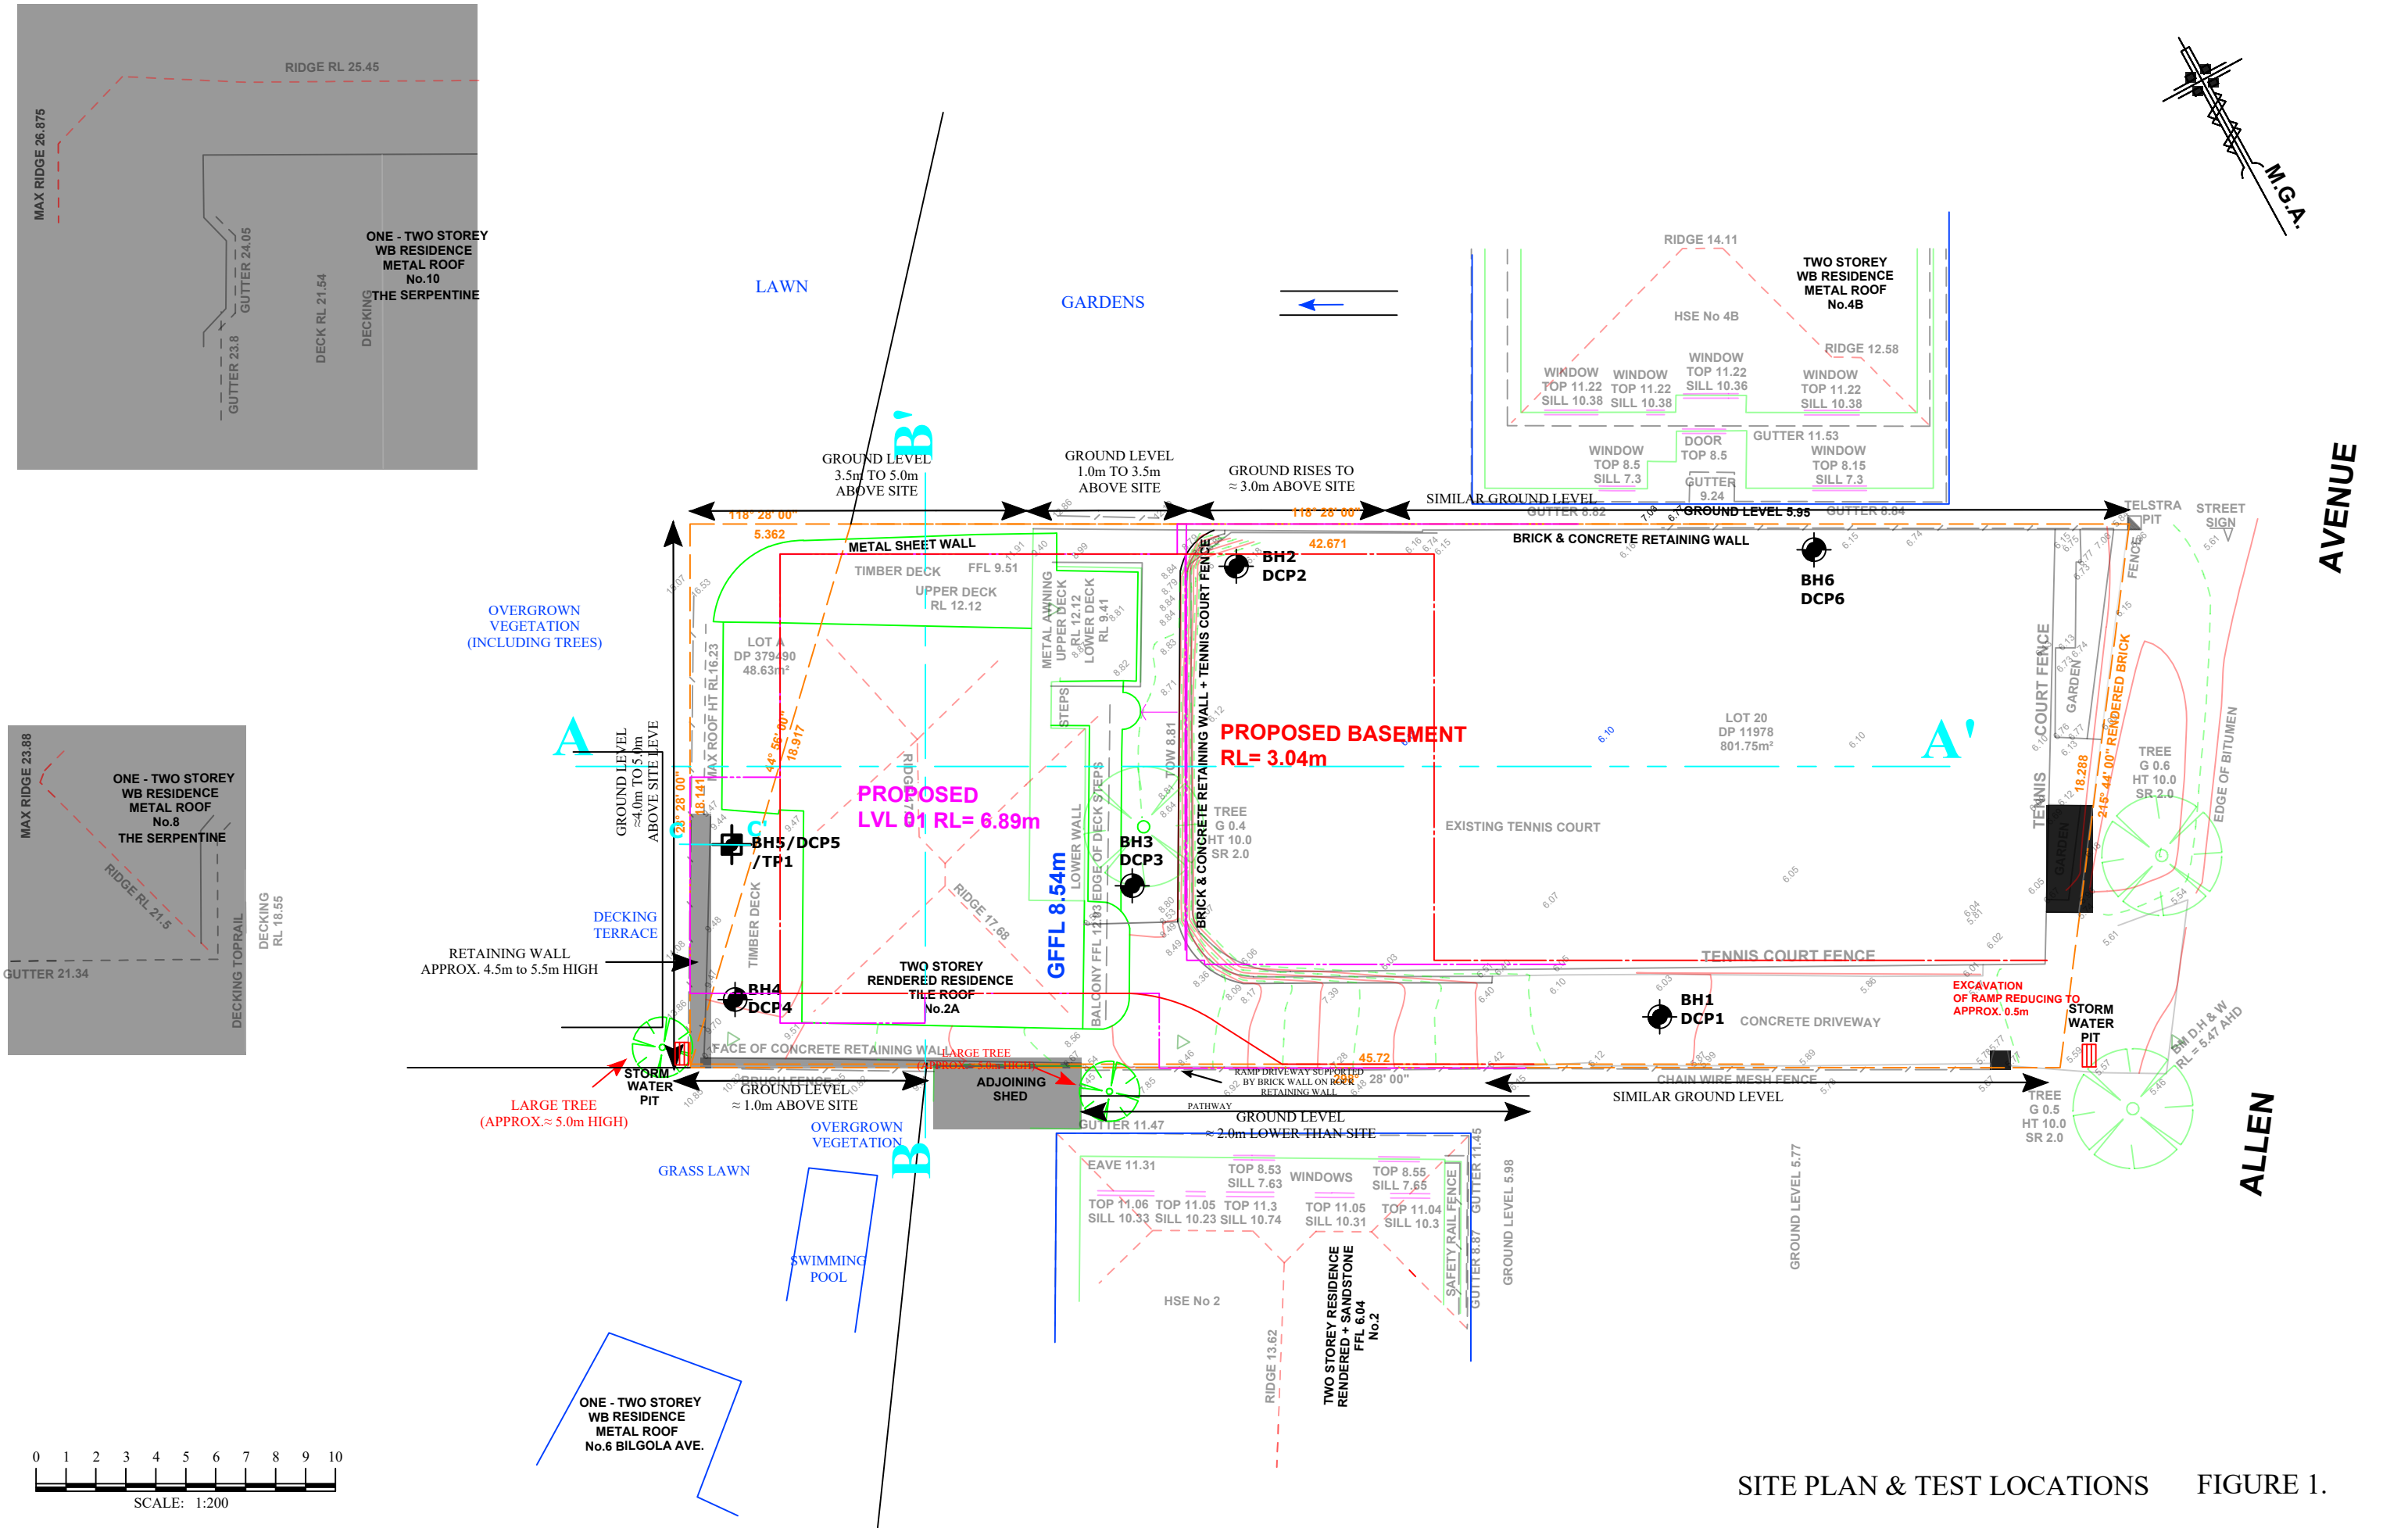
SITE PLAN & TEST LOCATIONS FIGURE 1.

TP1 (Photograph-12) was excavated below the existing retaining wall along the western boundary at the location as specified in Figure 1. TP1 was excavated to approximately 0.30m depth below the deck level and identified that the base of the retaining wall comprised of brick. TP1 is described in Figure 5.
