**GEOTECHNICAL INVESTIGATION  
PROPOSED POOL HOUSE, SWIMMING POOL AND ART STUDIO  
90 CABBAGE TREE ROAD, BAYVIEW, NEW SOUTH WALES  
MS YASMINA ELSHAFEI AND MR FORD ENNALS**

**MMGEO2025YEFE\_AB Revision A  
MARCH 2025**

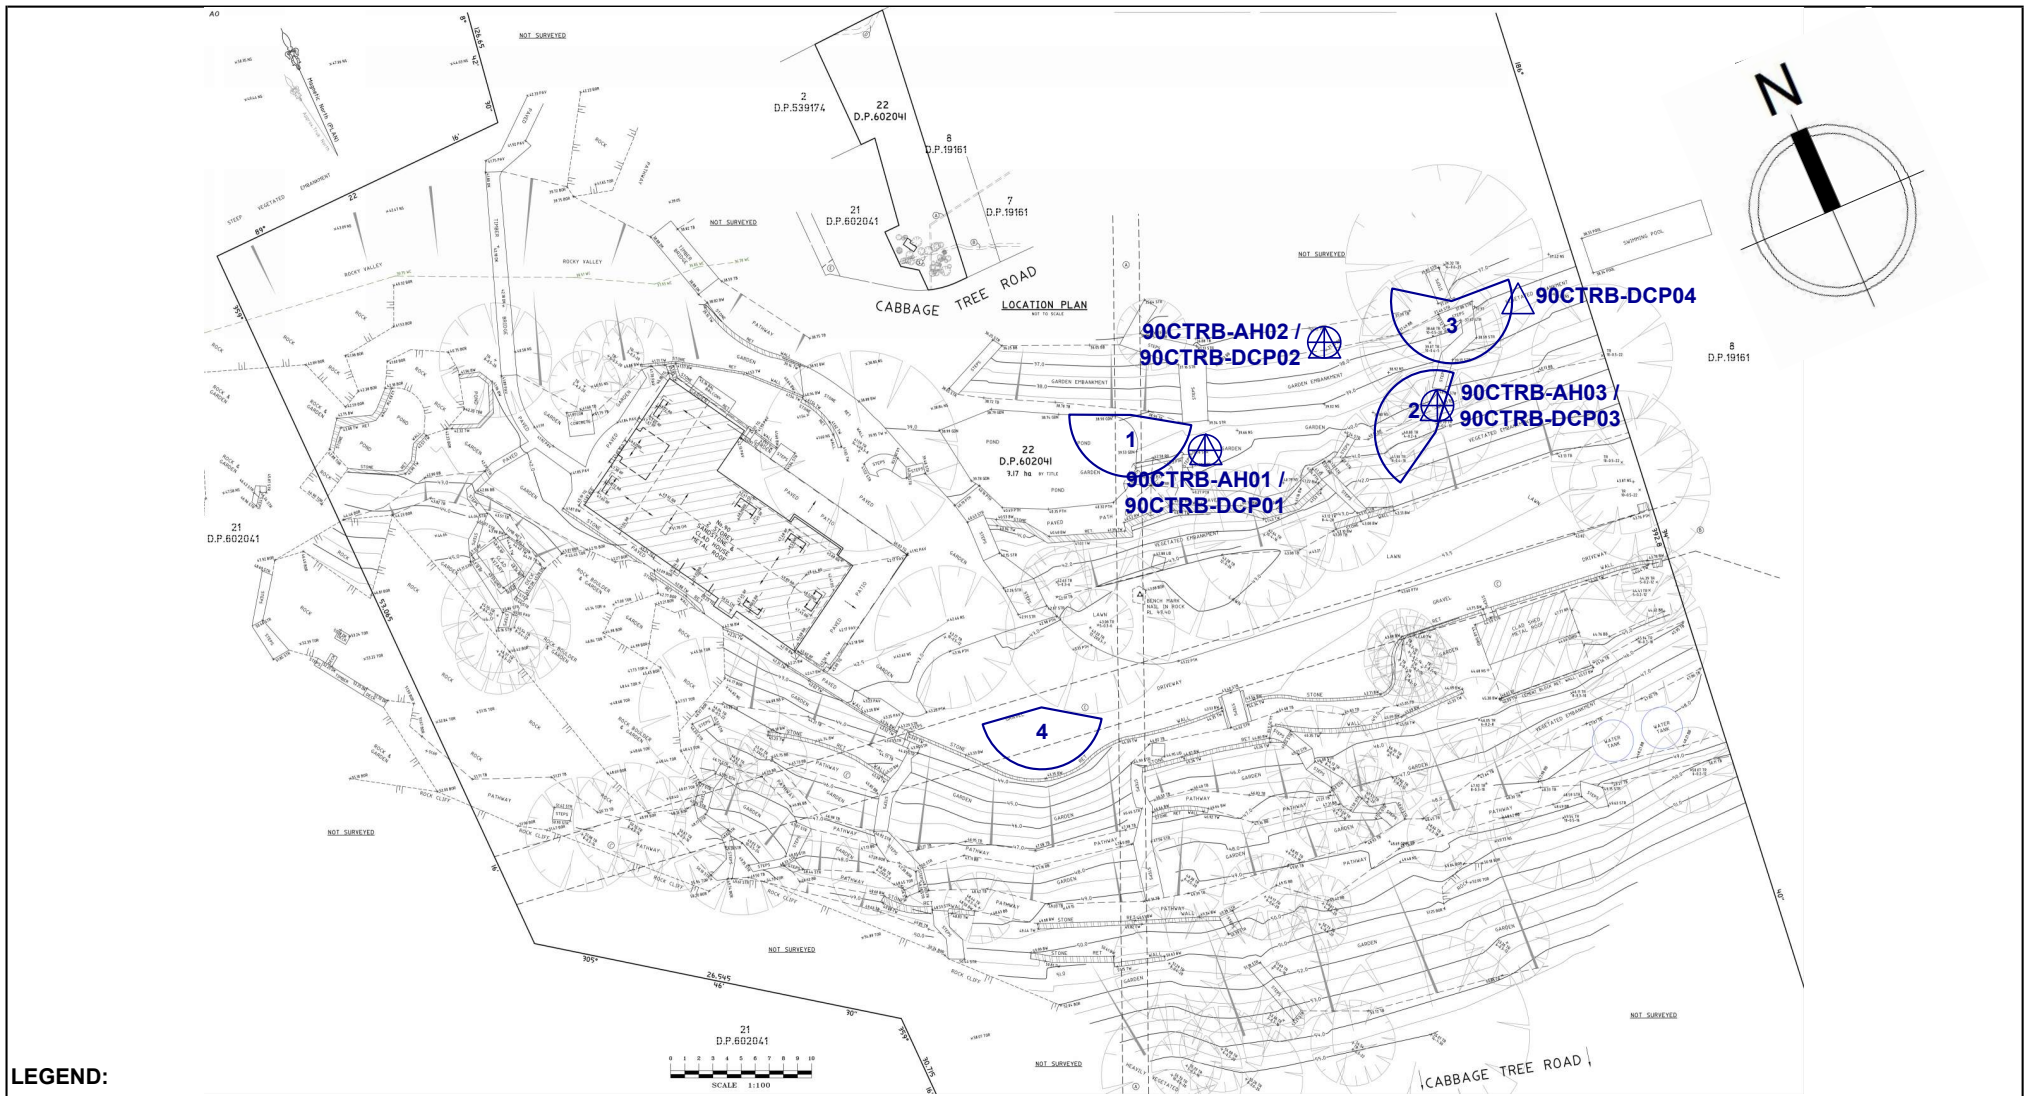
| original size | A4 | | project no: | MMGEO2025YEFE_AB | figure no: | 5 |

The photographs presented in Figure 5 illustrate the site conditions as of 12 March 2025.

The latest site observations we made on 12 March 2025 prompted alignment with the findings from the geotechnical investigation in respect to the ground conditions at the proposed locations of the pool house and the art studio and that there were no significant changes to the site conditions.

**PHOTOGRAPH 1 - APPROXIMATE LOCATION OF 90CTRB-AH01 AND 90CTRB-DCP01 (VIEW TO SOUTH)**

PHOTOGRAPH 6 - EXPOSED GROUND CONDITIONS AT THE LOCATION OF THE ART STUDIO (VIEW TO NORTHEAST)
