Construction Impact & Management Statement for soon to be Lodged Development Application

MARCH 2019

84 Hilma Street

COLLAROY PLATEAU, NSW

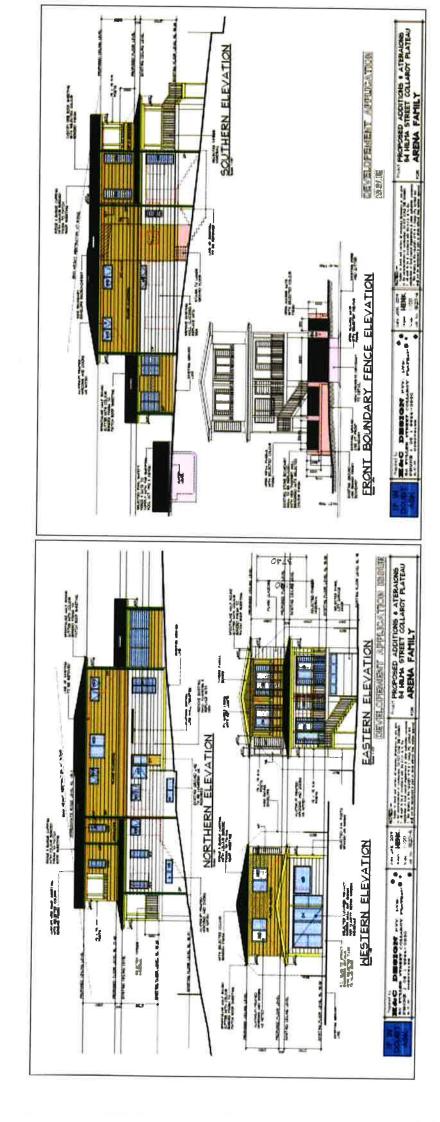
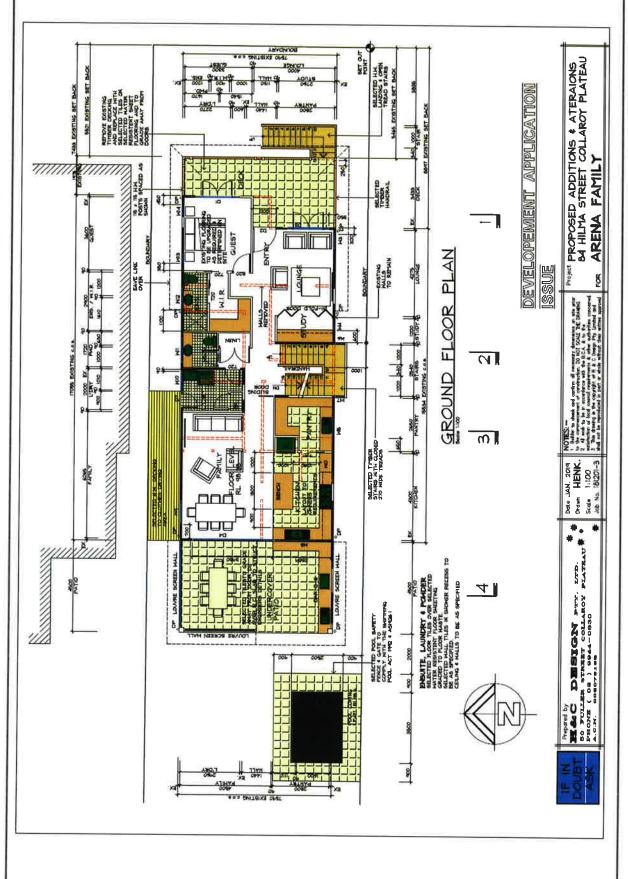
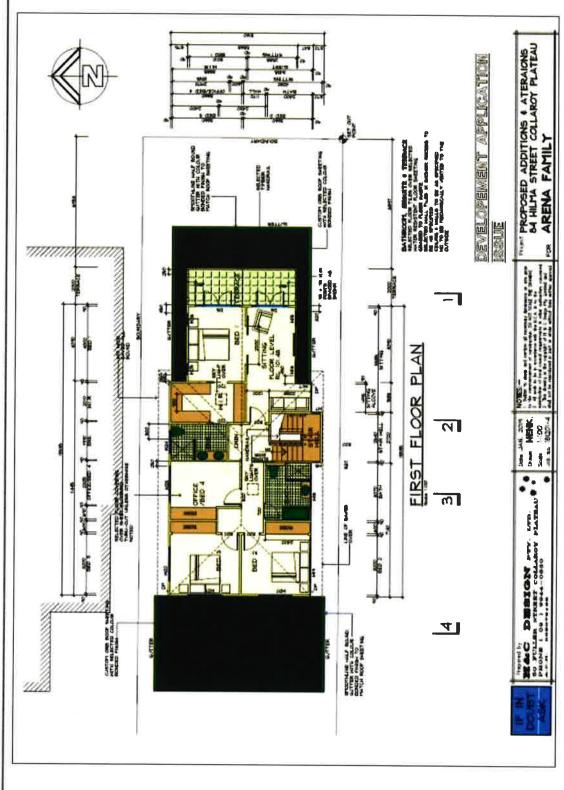
Figure 1: Page 8, 9 & 10: Illustrates proposed Alterations/Additions to the existing dwelling residence including new inground swimming pool & new landscape concept.
