REPORT ON GEOTECHNICAL SITE INVESTIGATION

# **NEW DEVELOPMENT**

# 321-331 CONDAMINE STREET, MANLY VALE

**Project No.: 2020-028**

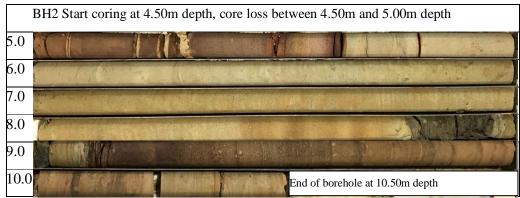
Core photograph - Borehole 2

Groundwater inflow was not encountered during the augered portion of BH1 drilling. Signs of water seepage inflow was encountered in BH2 at approximately 3.00m depth. Water was used as a flush medium during coring negating groundwater inflow observations.
