Report Title: Geotechnical Report 67 Marine Parade, Avalon

Report Date: 20/8/19

GEOTECHNICAL INVESTIGATION:

Alterations and Additions at 67 Marine Parade, Avalon

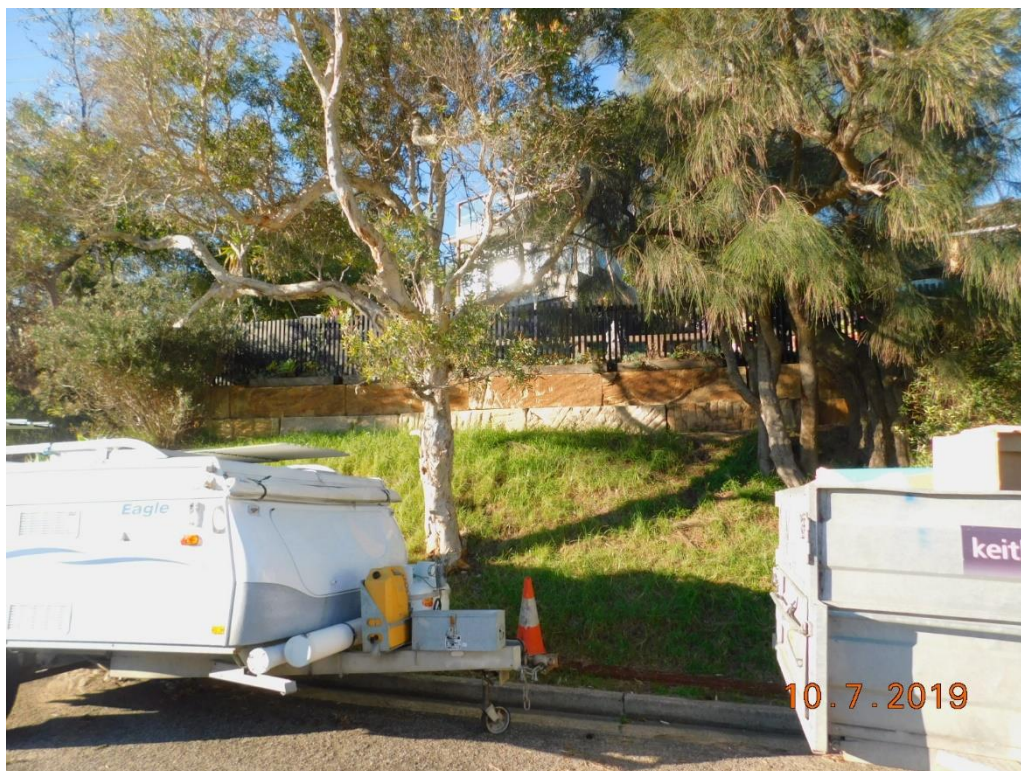
Photo 2

- 2.3** At the road frontage, a concrete driveway runs up the slope to a garage on the downhill side of the house (Photo 1). A dimensioned sandstone block wall up to 2.5m high runs E-W and retains a cut for the driveway (Photo 2). A shallow fill has been added for a lawn area above the cut and is supported by a ~0.6m dimensioned sandstone block wall on its downhill side (Photo 3). Both walls appear well-constructed. The single-storey brick and clad house is supported on brick walls and brick piers (Photo 4). No significant signs of movement were observed in its supporting brick walls or brick piers. A cut has been made into the slope on the uphill side of the

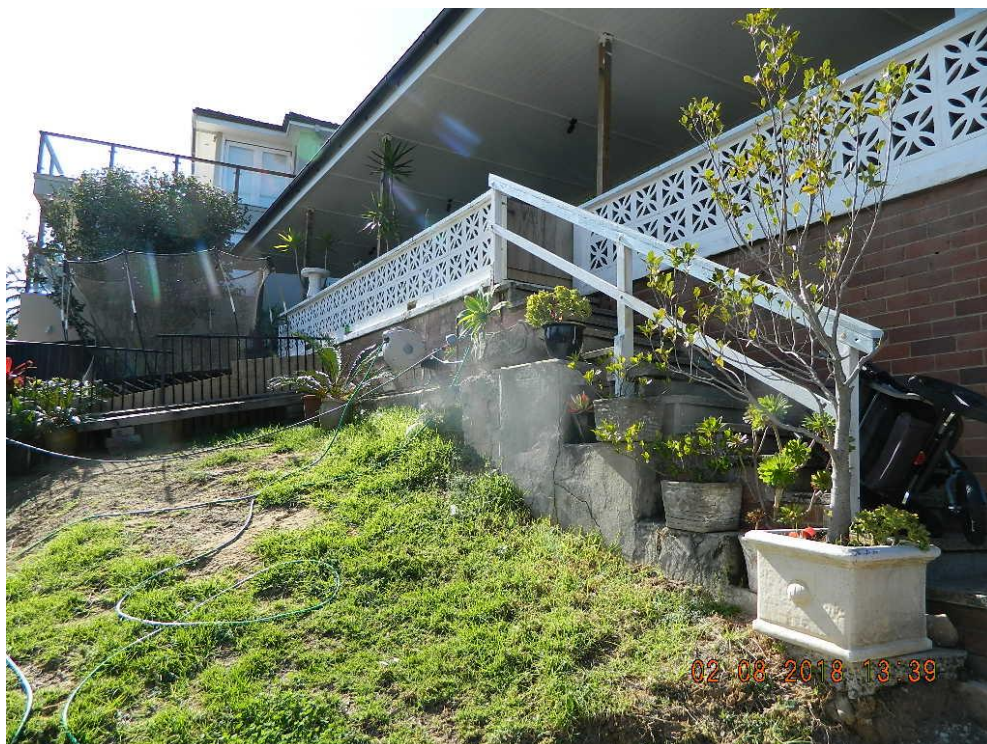
Photo 7

Sandstone bedrock outcrops at the sea cliff face to the E of the property and is visible outcropping down the slope to the house (Photo 7). This is an unusually thick sandstone bed
