GEOTECHNICAL RISK MANAGEMENT POLICY FOR PITTWATER

REPORT TO ROYAL HASKONING DHV

Figure 3: Section A Showing Potential Landslide Hazards

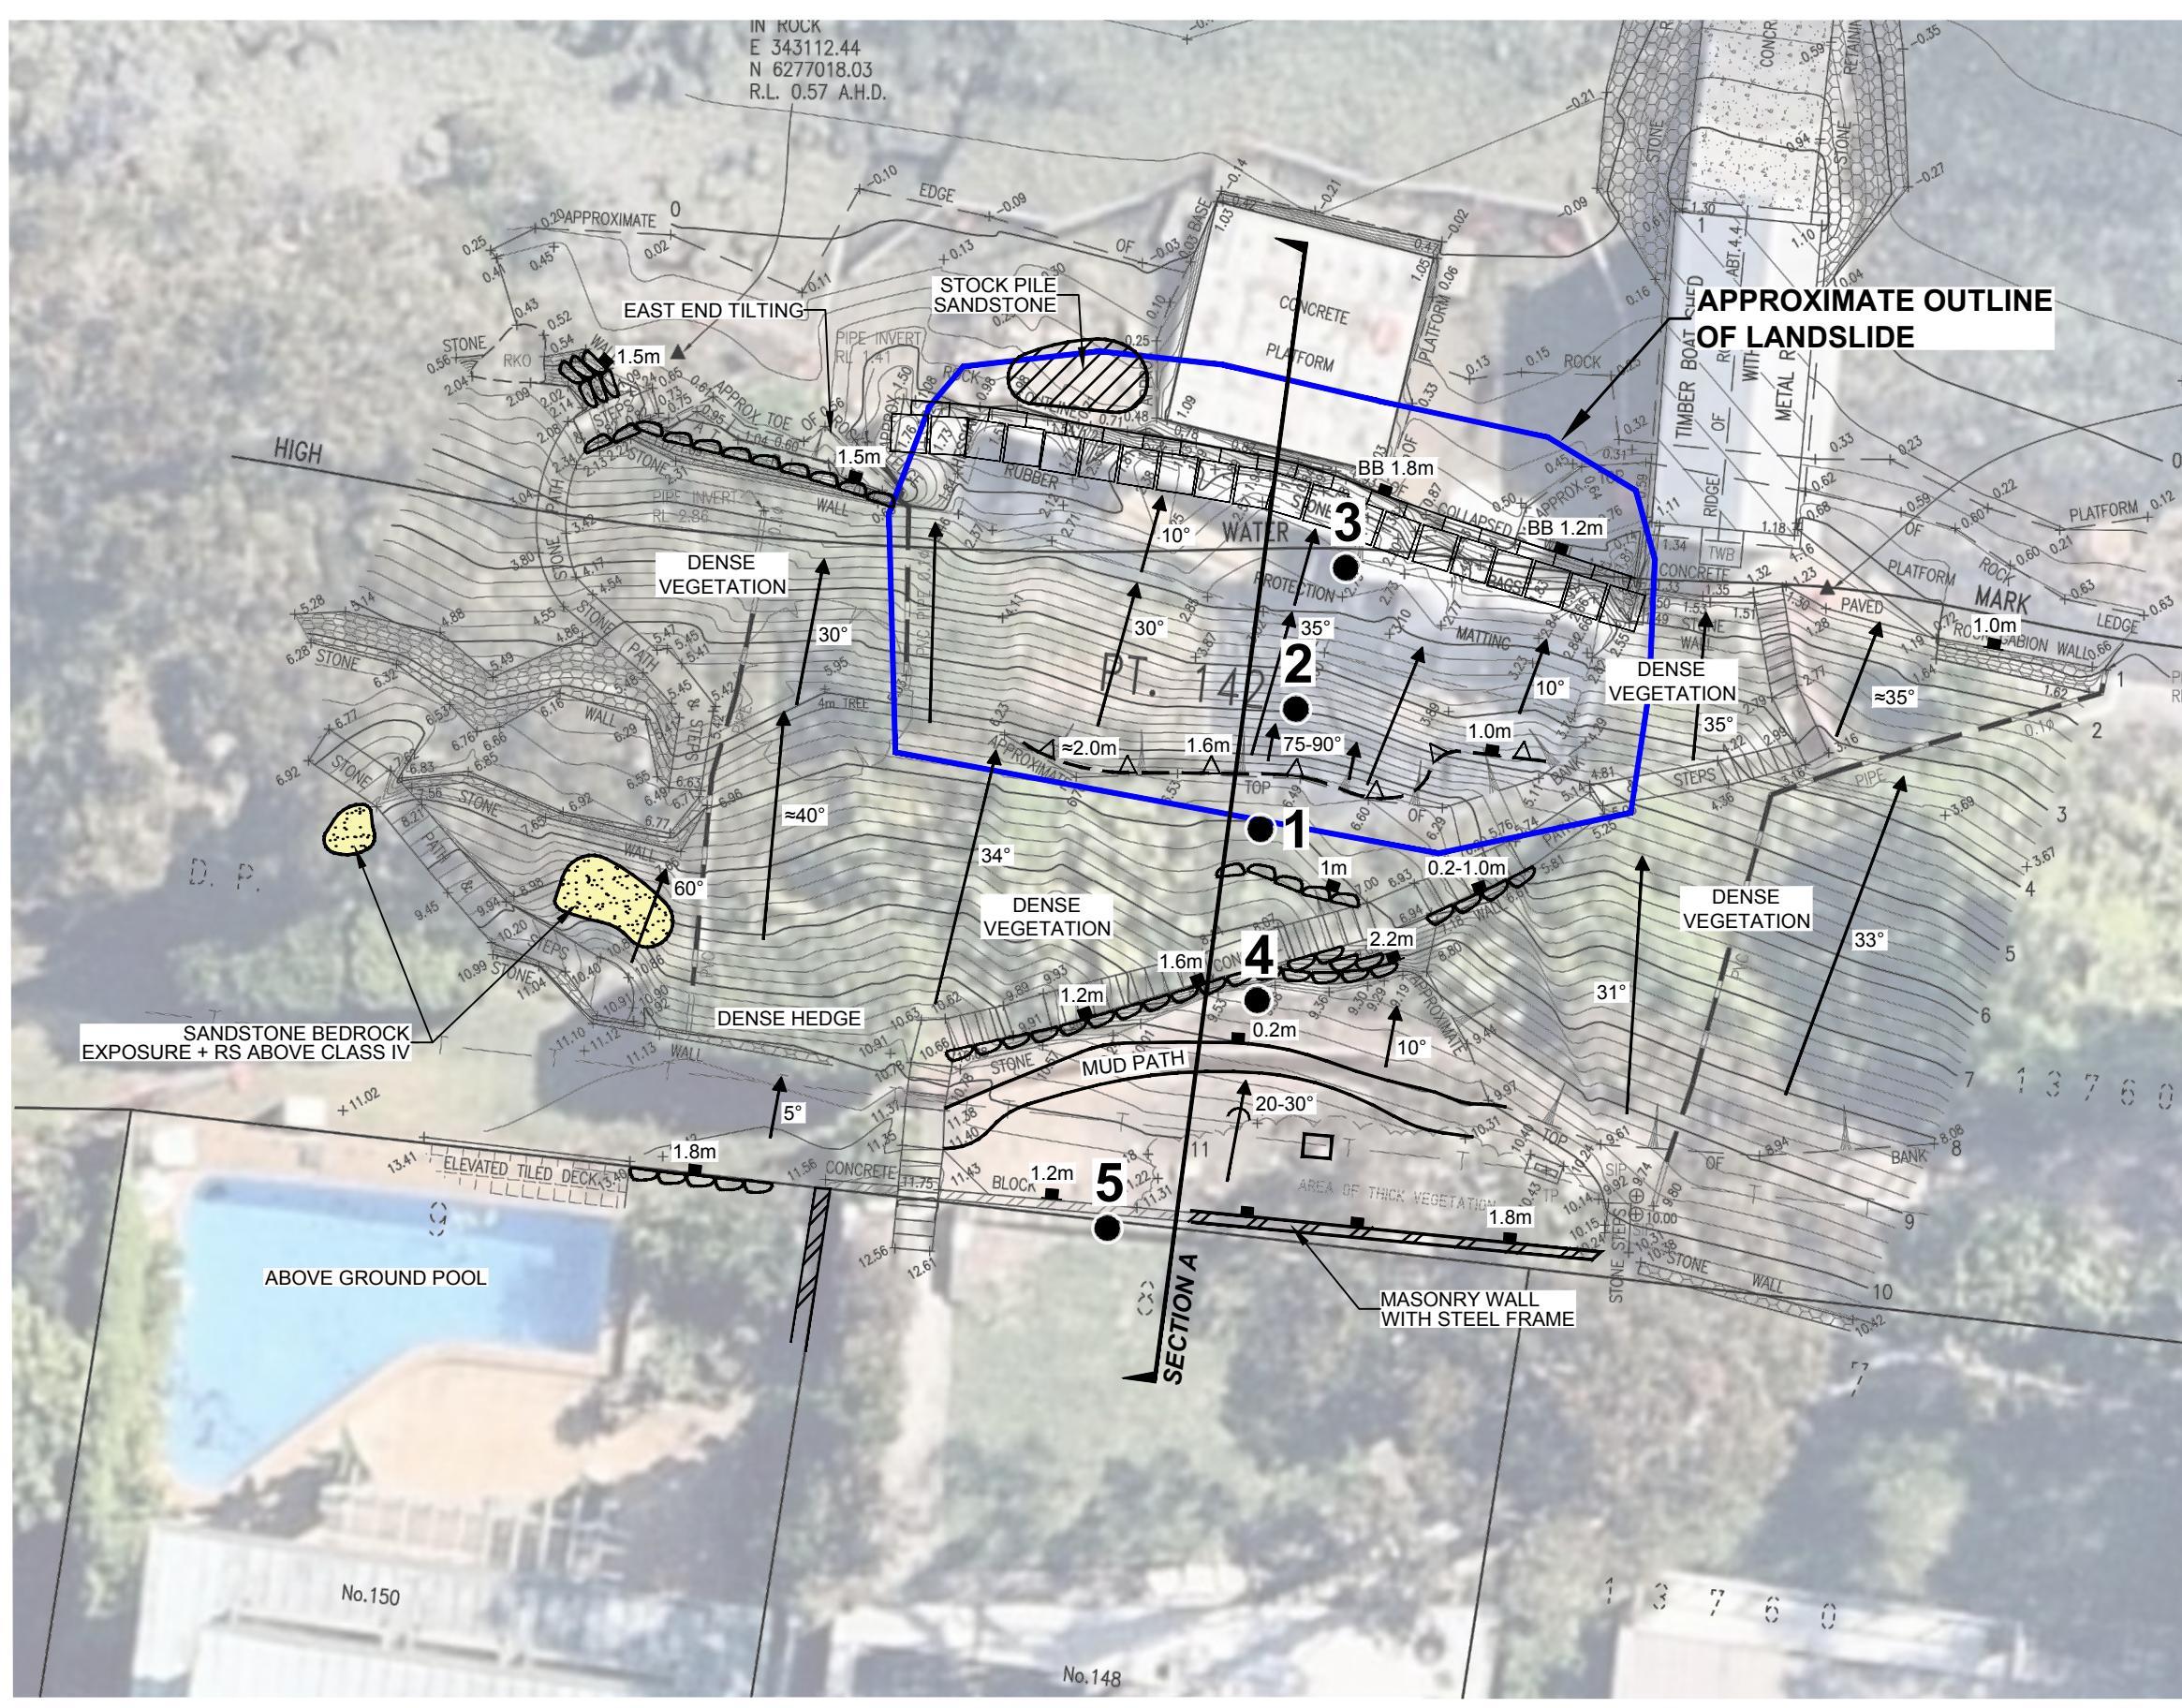
The attached Figure 2 presents a geotechnical sketch plan showing the principal geotechnical features present at the site. Figure 2 is based on aerial imagery sourced form *Nearmap* with the provided survey plan (Plan No A1 – 10981D1^C, dated 11 October 2020) prepared by Byrne and Associates superimposed. Figure 3 also presents a geotechnical section through the site based on the survey data augmented by our mapping observations. Additional features on Figures 2 and 3 have been measured by hand held inclinometer and tape measure techniques and hence are only approximate. Should any of the features be critical to the proposed seawall remediation measures, we recommend they be located more accurately using instrument survey techniques.

- 1. BB1.8m IS HEIGHT OF BULKA BAG WALL.
- 2. FOR SECTION A SEE FIGURE 3.
- FOR EXPLANATION OF GEOTECHNICAL MAPPING SYMBOLS SEE FIGURE 4. 3.
- LEGEND
- BOREHOLES COMPLETED IN 2019.

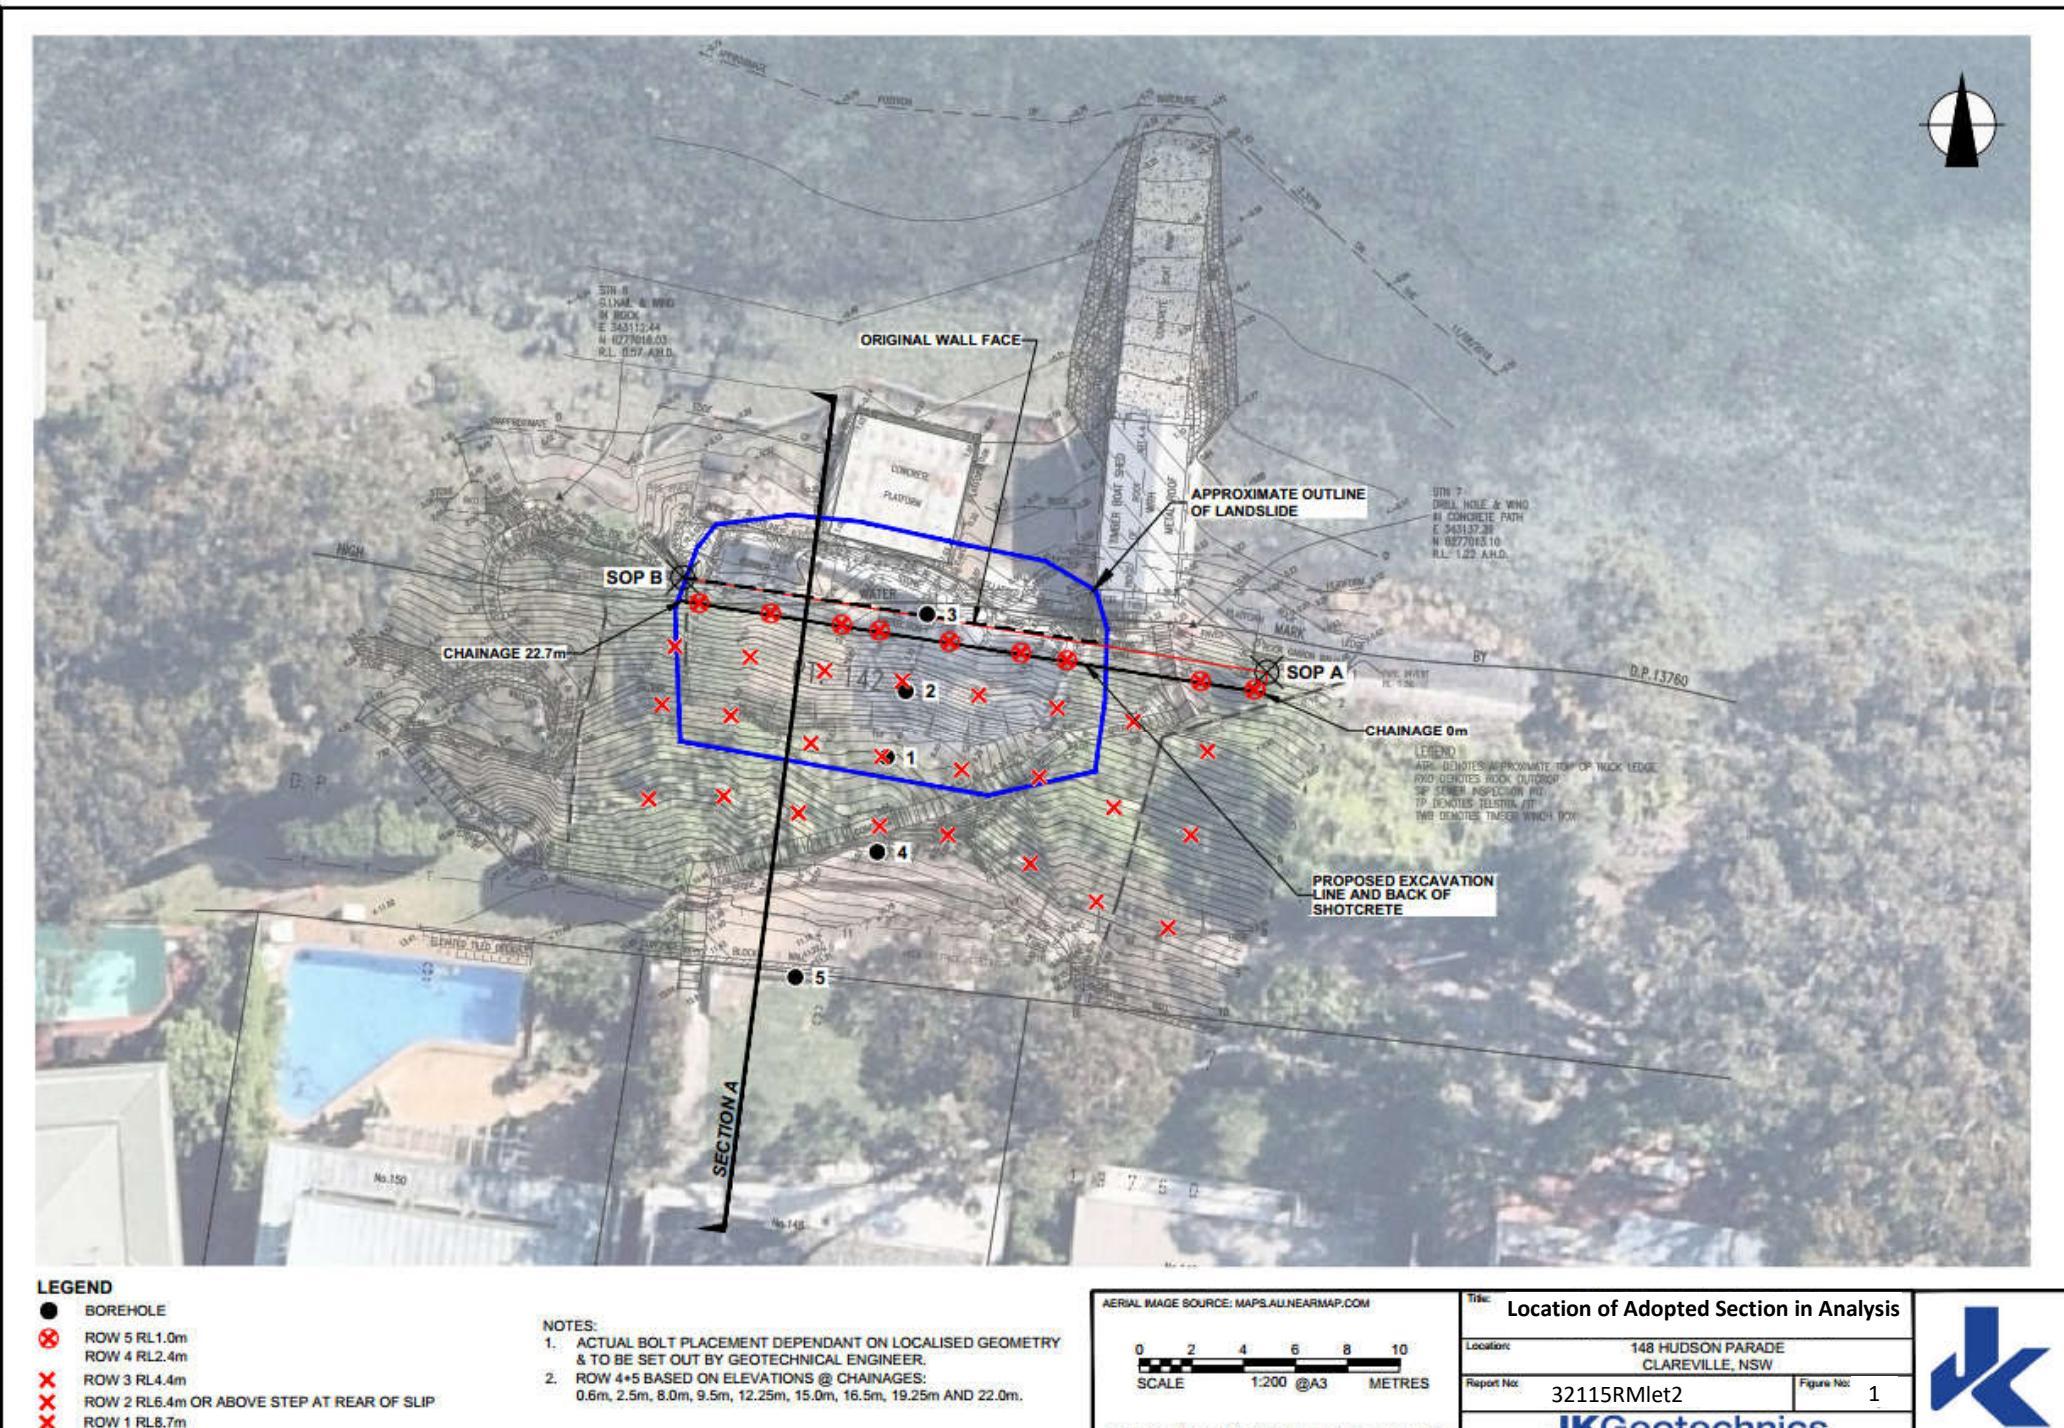
ROW 1 RL8.7m

Row No	1	2	3	4
Minimum Bond Length (m)	3	3	3	3
Inclination (Deg)	25	25	25	25
Hole Diameter (mm)	60	60	60	60
Horizontal Spacing (m)	3	3	3	3
Rock Bolt Head RL (m)	8.7	6.4	4.4	2.4
Pull-out Resistance (kPa)	70	70	70	70
