205400.00  
9 July 2021  
NB:jb  
R.01.Rev1

**214 Hudson Parade, Clareville**  
**Proposed Alterations and Additions to Residential Property**

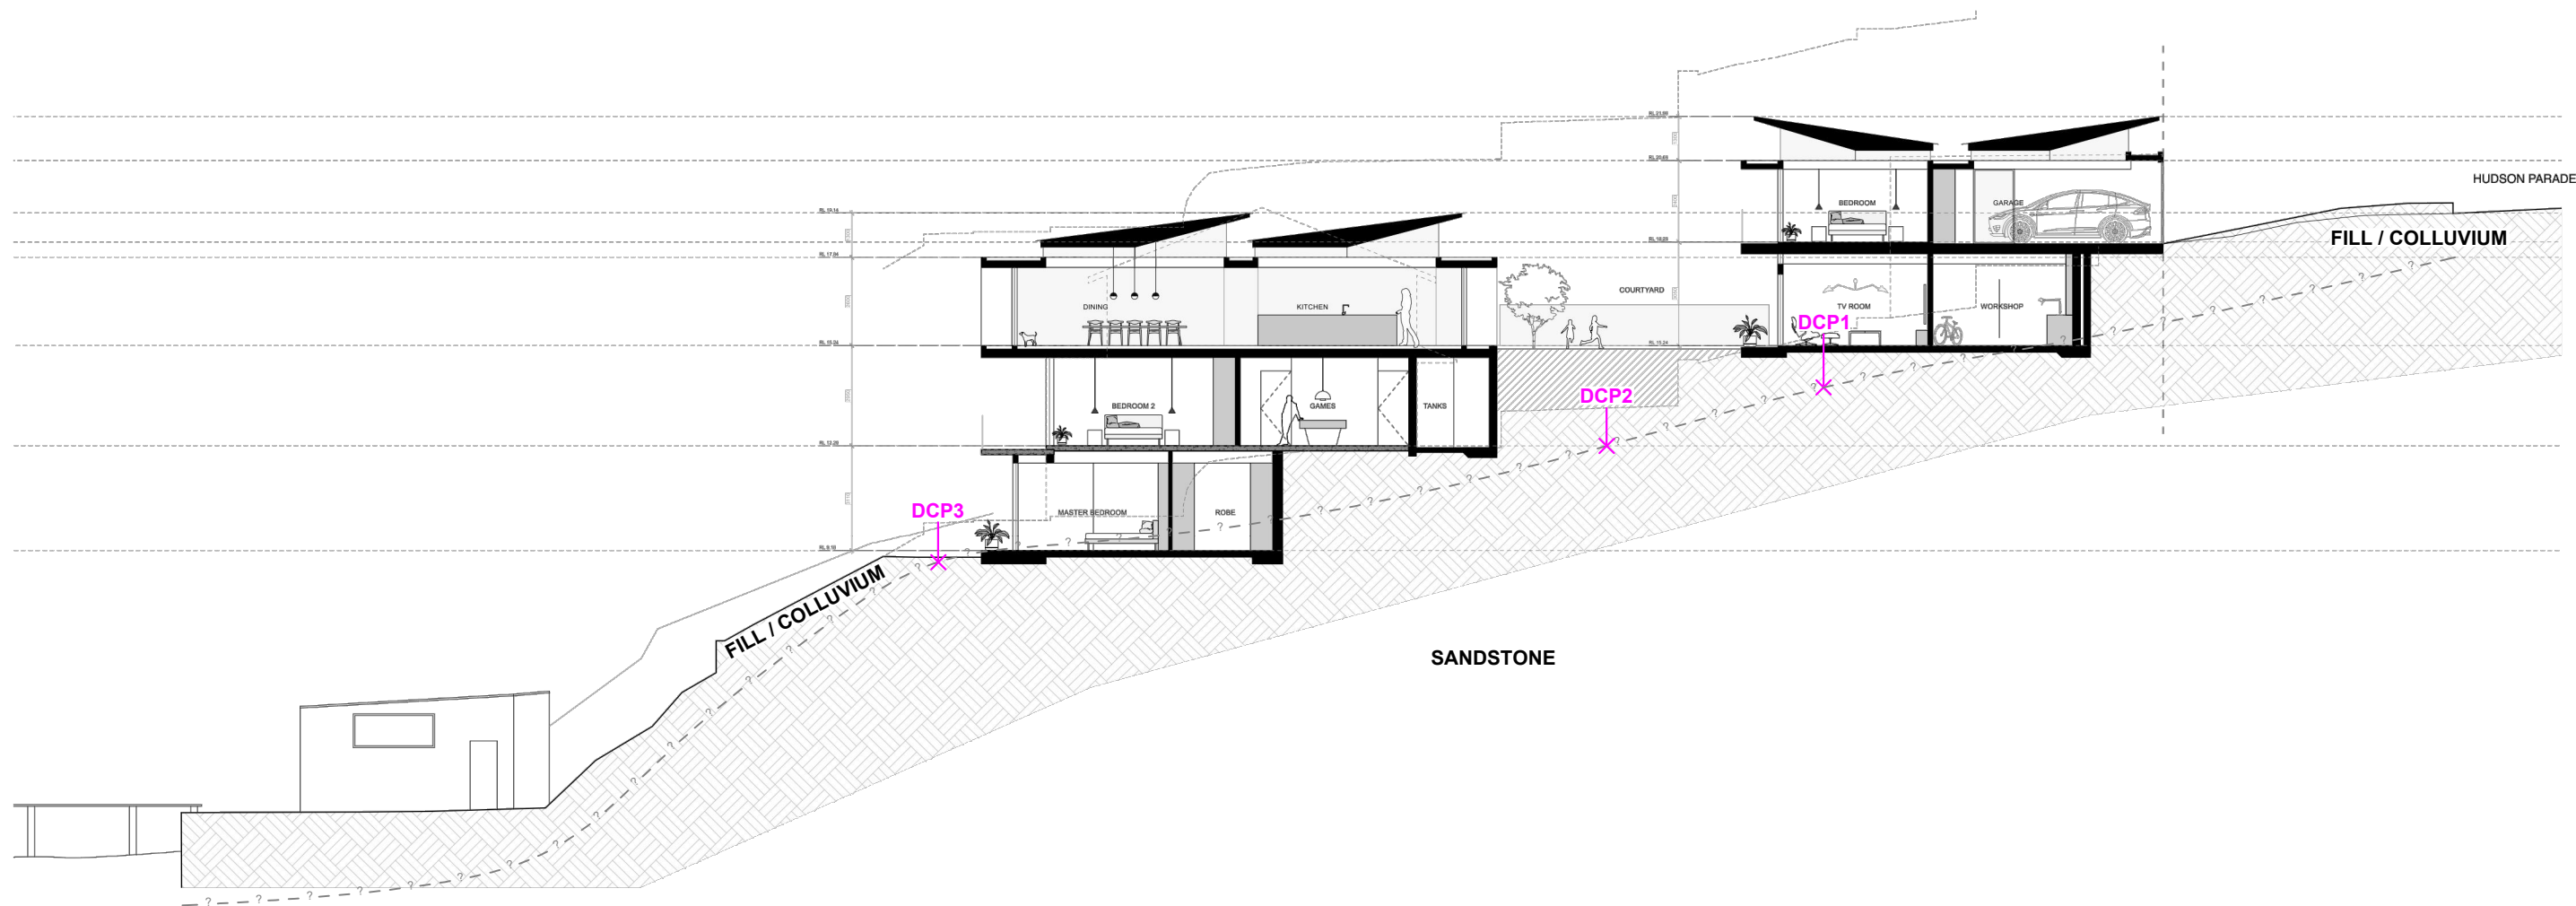
NOTE:  
1: Plan adapted from Drawing No. SK-2, prepared by UTZ Sanby Architects, Project No. 2101

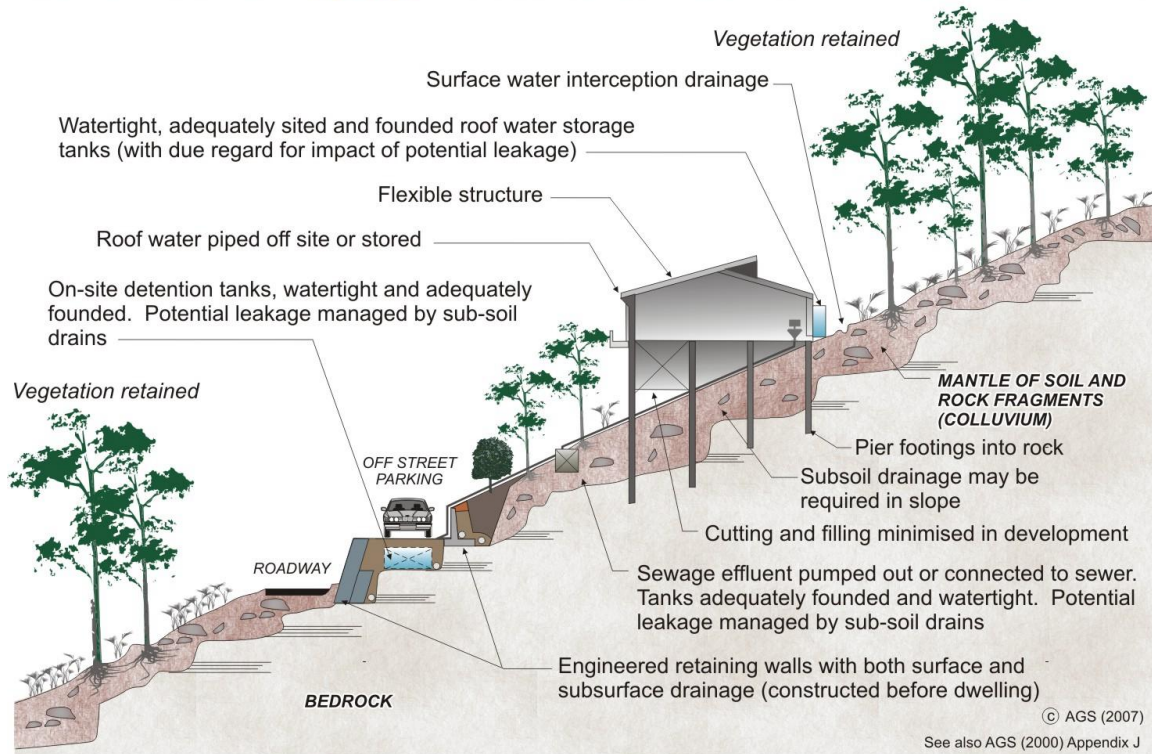
### EXAMPLES OF GOOD HILLSIDE CONSTRUCTION PRACTICE

**Roadways and parking areas** - are paved and incorporate kerbs which prevent water discharging straight into the hillside (GeoGuide LR5).

**Sewage** - whether treated or not is either taken away in pipes or contained in properly founded tanks so it cannot soak into the ground.

**Surface water** - from roofs and other hard surfaces is piped away to a suitable discharge point rather than being allowed to infiltrate into the ground. Preferably, the discharge point will be in a natural creek where ground water exits, rather than enters, the ground. Shallow, lined, drains on the surface can fulfil the same purpose (GeoGuide LR5).

**Surface loads** - are minimised. No fill embankments have been built. The house is a lightweight structure. Foundation loads have been taken down below the level at which a landslide is likely to occur and, preferably, to rock. This sort of construction is probably not applicable to soil slopes (GeoGuide LR3). If you are uncertain whether your site has rock near the surface, or is essentially a soil slope, you should engage a geotechnical practitioner to find out.

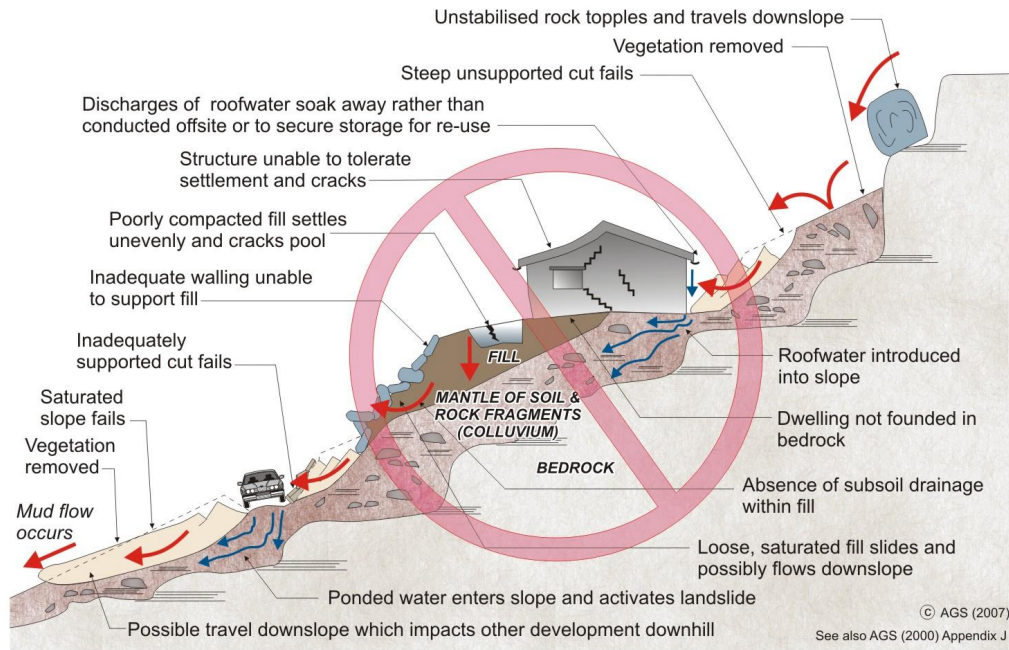
### EXAMPLES OF **POOR** HILLSIDE CONSTRUCTION PRACTICE

**Roadways and parking areas** - are unsurfaced and lack proper table drains (gutters) causing surface water to pond and soak into the ground.

**Retaining walls** - have been avoided, to minimise cost, and hand placed rock walls used instead. Without applying engineering design principles, the walls have failed to provide the required support to the ground and have failed, creating a very dangerous situation.
