REPORT ON GEOTECHNICAL SITE INVESTIGATION

PROPOSED NEW DWELLING

18 ROCK BATH ROAD, PALM BEACH, NSW

Project No.: 2022-085

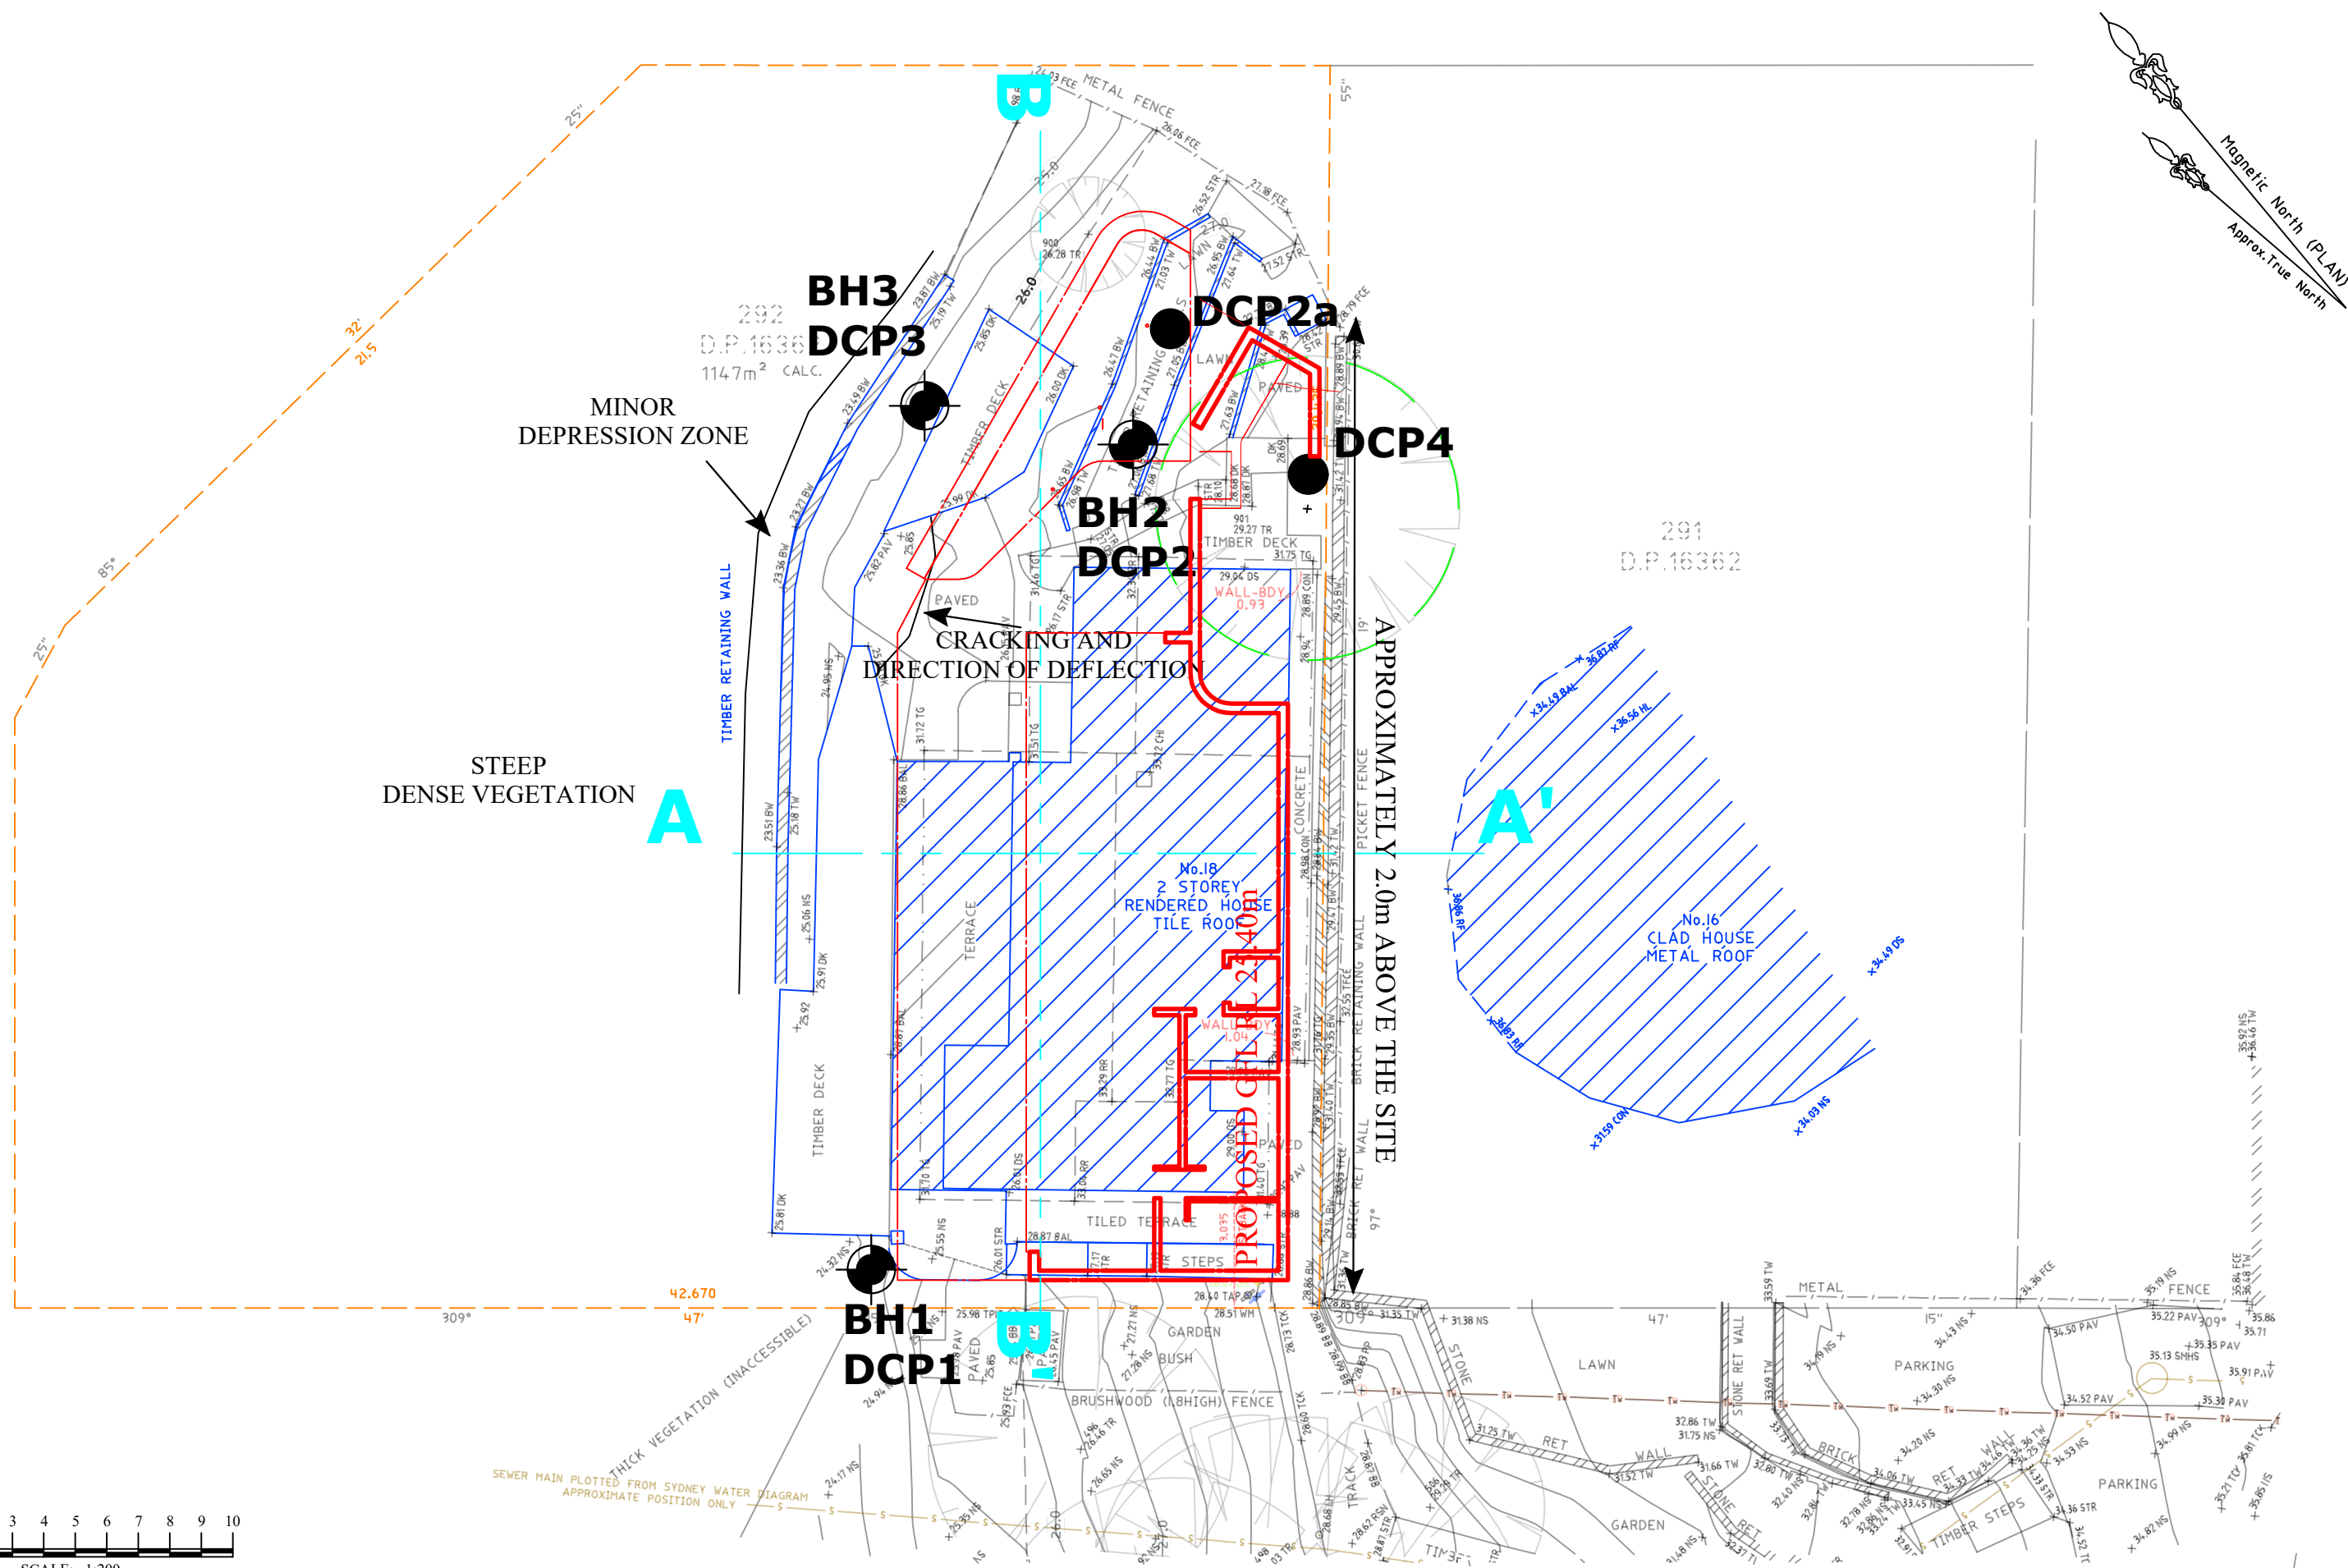
SITE PLAN & TEST LOCATIONS FIGURE 1.

Explanatory notes are included in Appendix: 1. Mapping information and test locations are shown on Figure: 1, along with detailed bore log and DCP sheets in Appendix: 2. Geological model/section are provided as Figure: 2, Appendix: 2.

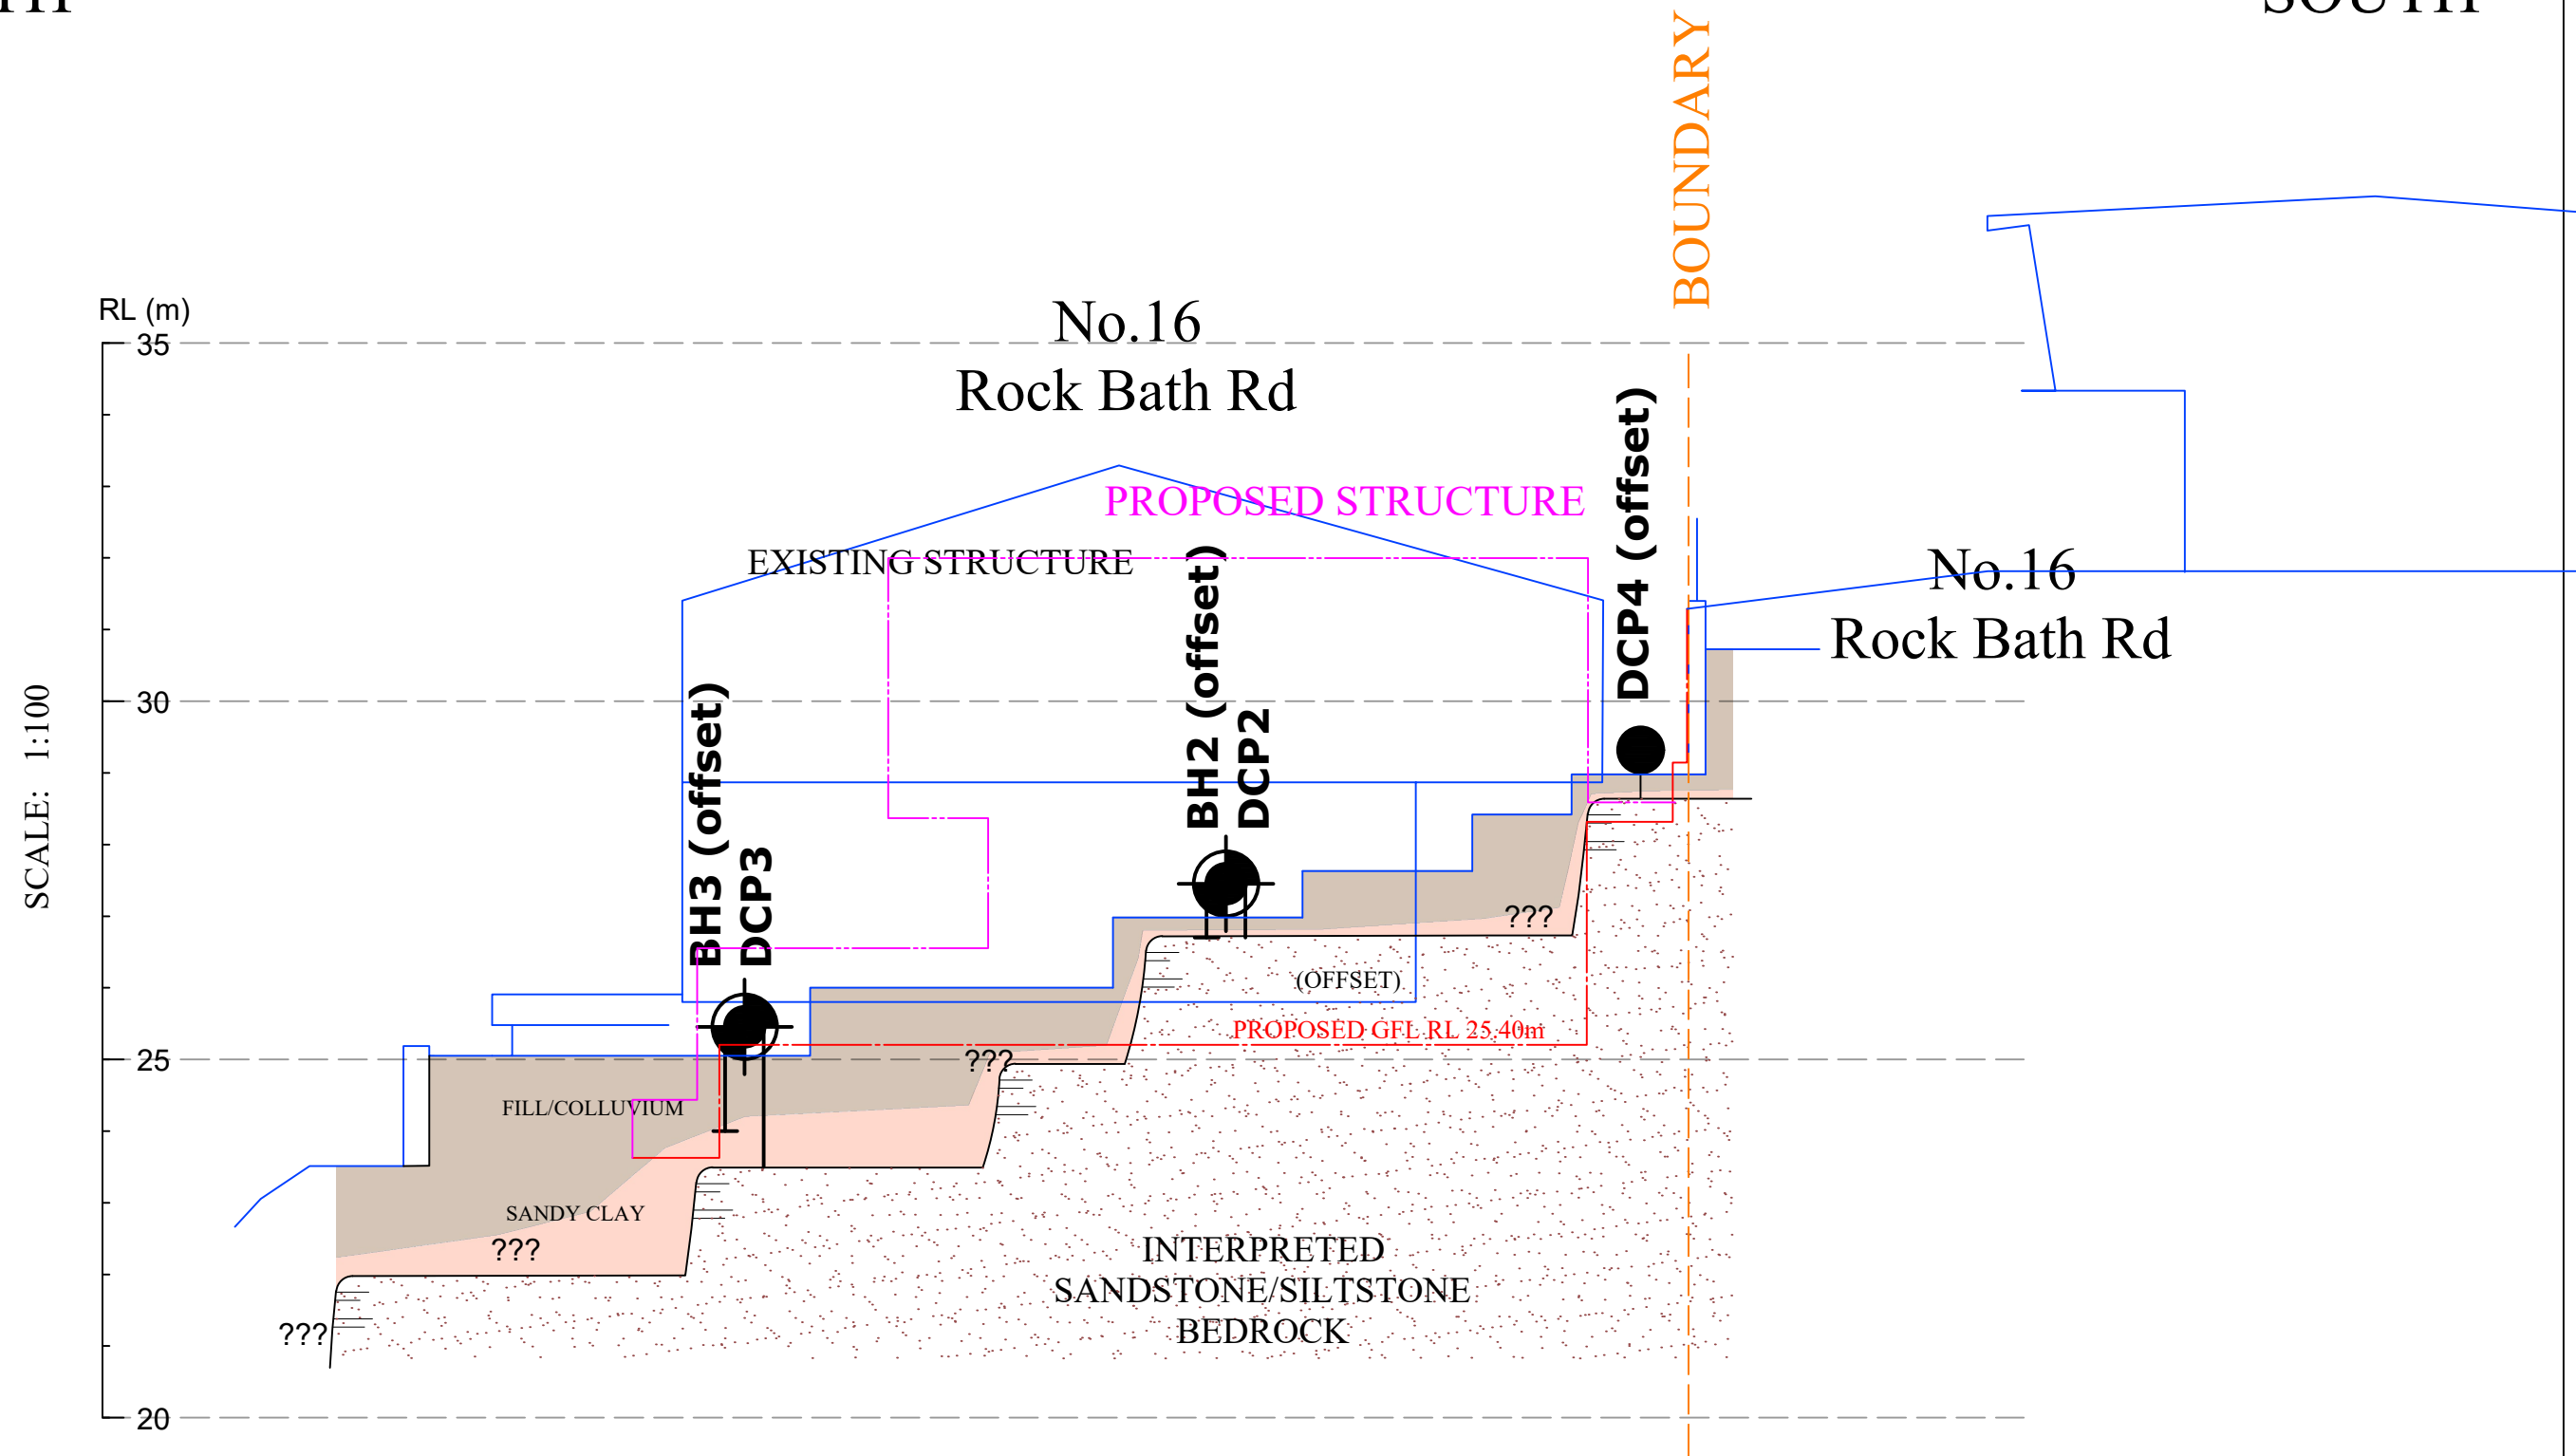
GEOLOGICAL MODEL FIGURE 2.

The site investigation identified the presence of fill down to a maximum depth of ≤ 1.0 m, underlain by sandy clay/clay overlying interpreted sandstone and siltstone bedrock at varying depths between 0.30m (DCP2) and 1.50m (DCP3). A free-standing groundwater table or significant seepage were not encountered at the site and are not anticipated within 5m to 10m below surface based on site location and adjacent topography however minor seepage at the bedrock surface and along defects within it is likely.

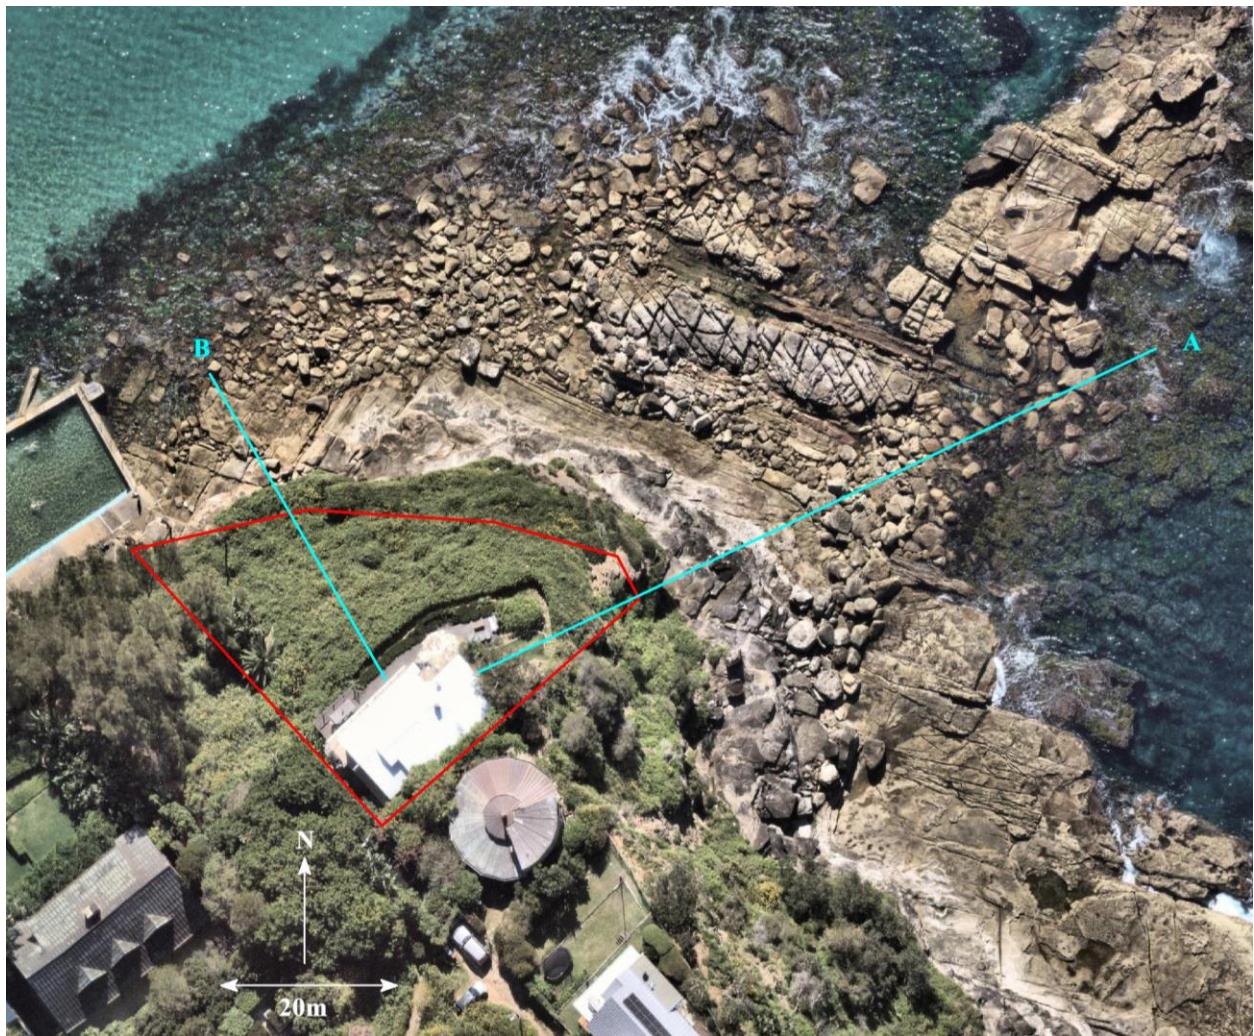
Figure 1: Aerial view of site (approximate property outline in red), with location of Section A and Section B in cyan (aerial photograph taken 1 May 2023)

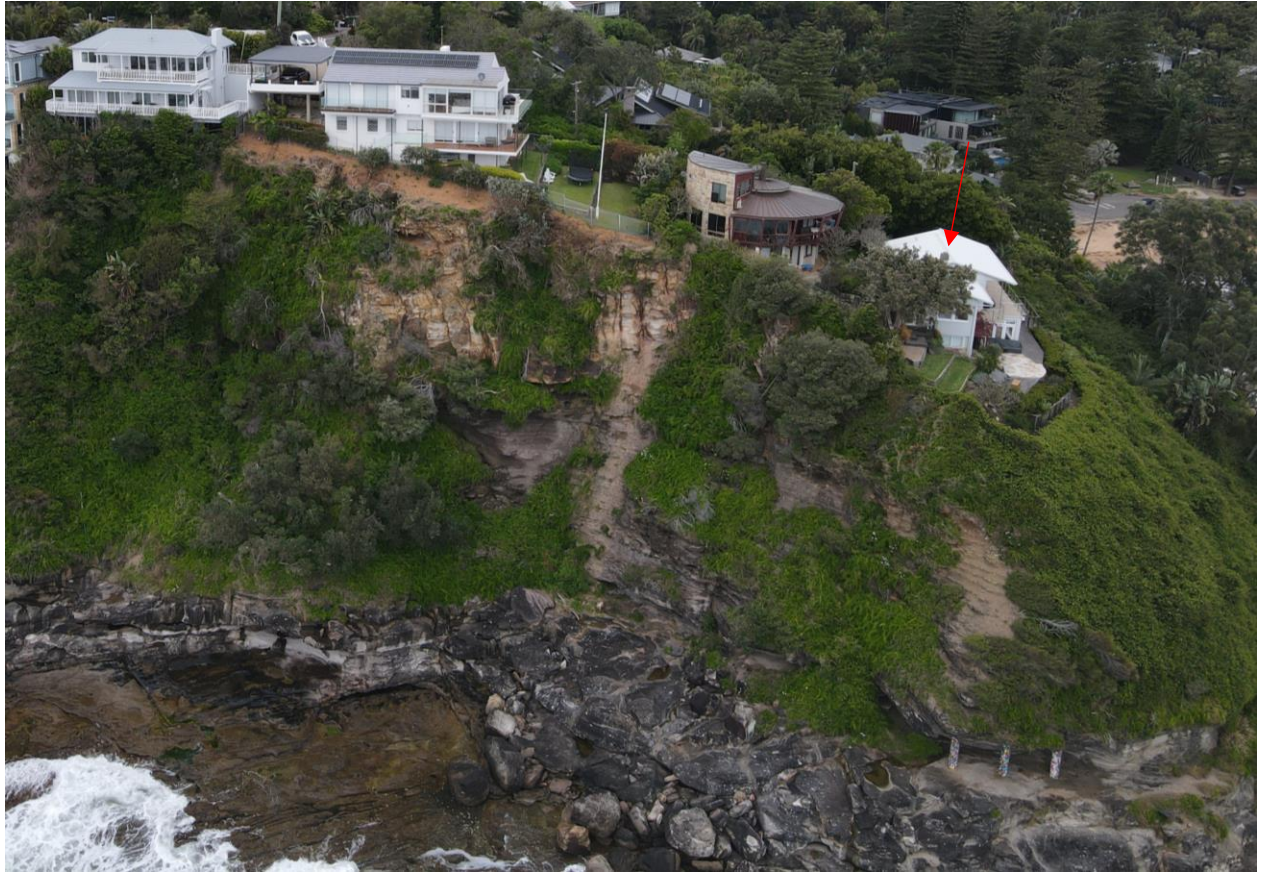
Coffey & Partners (1987) noted that the cliff profiles from Little Head to south Palm Beach have been formed by an interbedded sequence of sandstone and interbedded siltstone/sandstone. An oblique aerial view of the site and adjacent rock platform is provided in Figure 2, with a photograph of the cliffs at the site (taken from the adjacent rock platform) provided in Figure 3 and Figure 4. It is evident that columns have been constructed to support an overhanging rock section near the toe of the NE facing cliff.

Figure 2: Oblique aerial view of site (at arrow) on 13 October 2022, facing SW

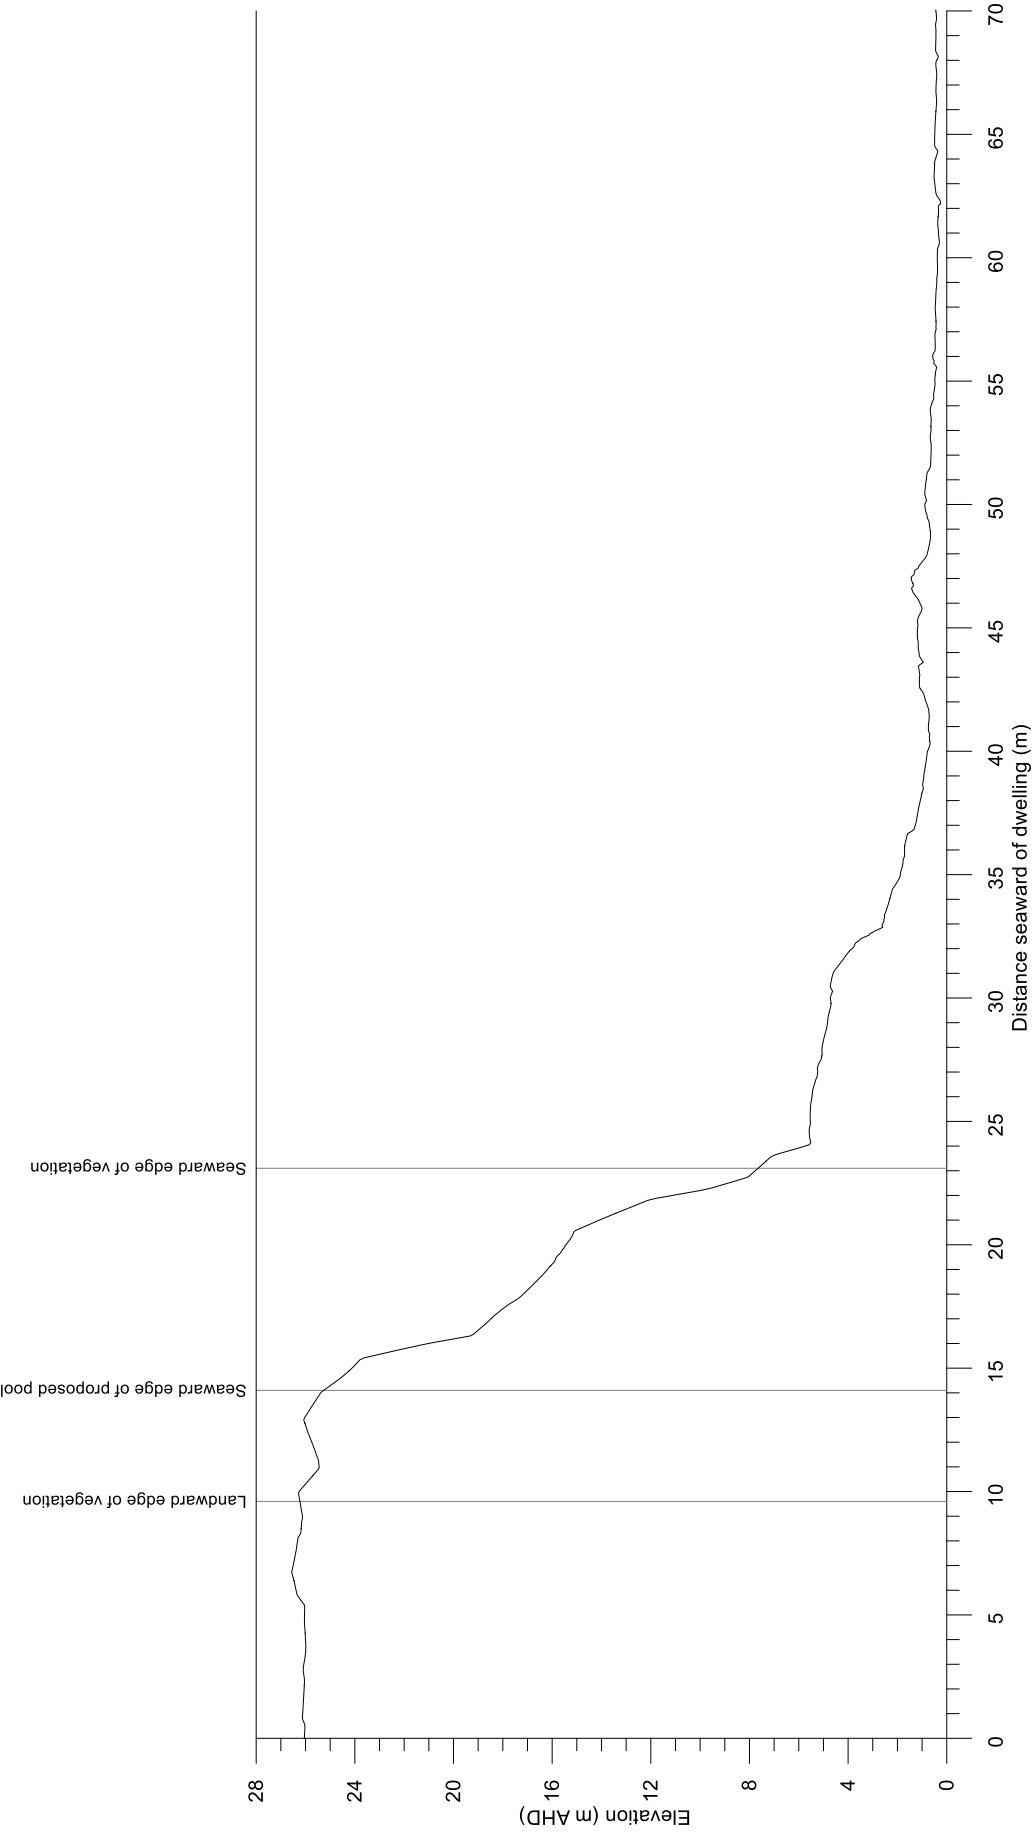
Based on Airborne Laser Scanning (ALS) data captured by the NSW Government in 2020, elevations along Section A and Section B (from Figure 1) perpendicular to the cliff face are depicted in Figure 5 and Figure 6 respectively.

Figure 5: Section A through cliff at site towards ENE

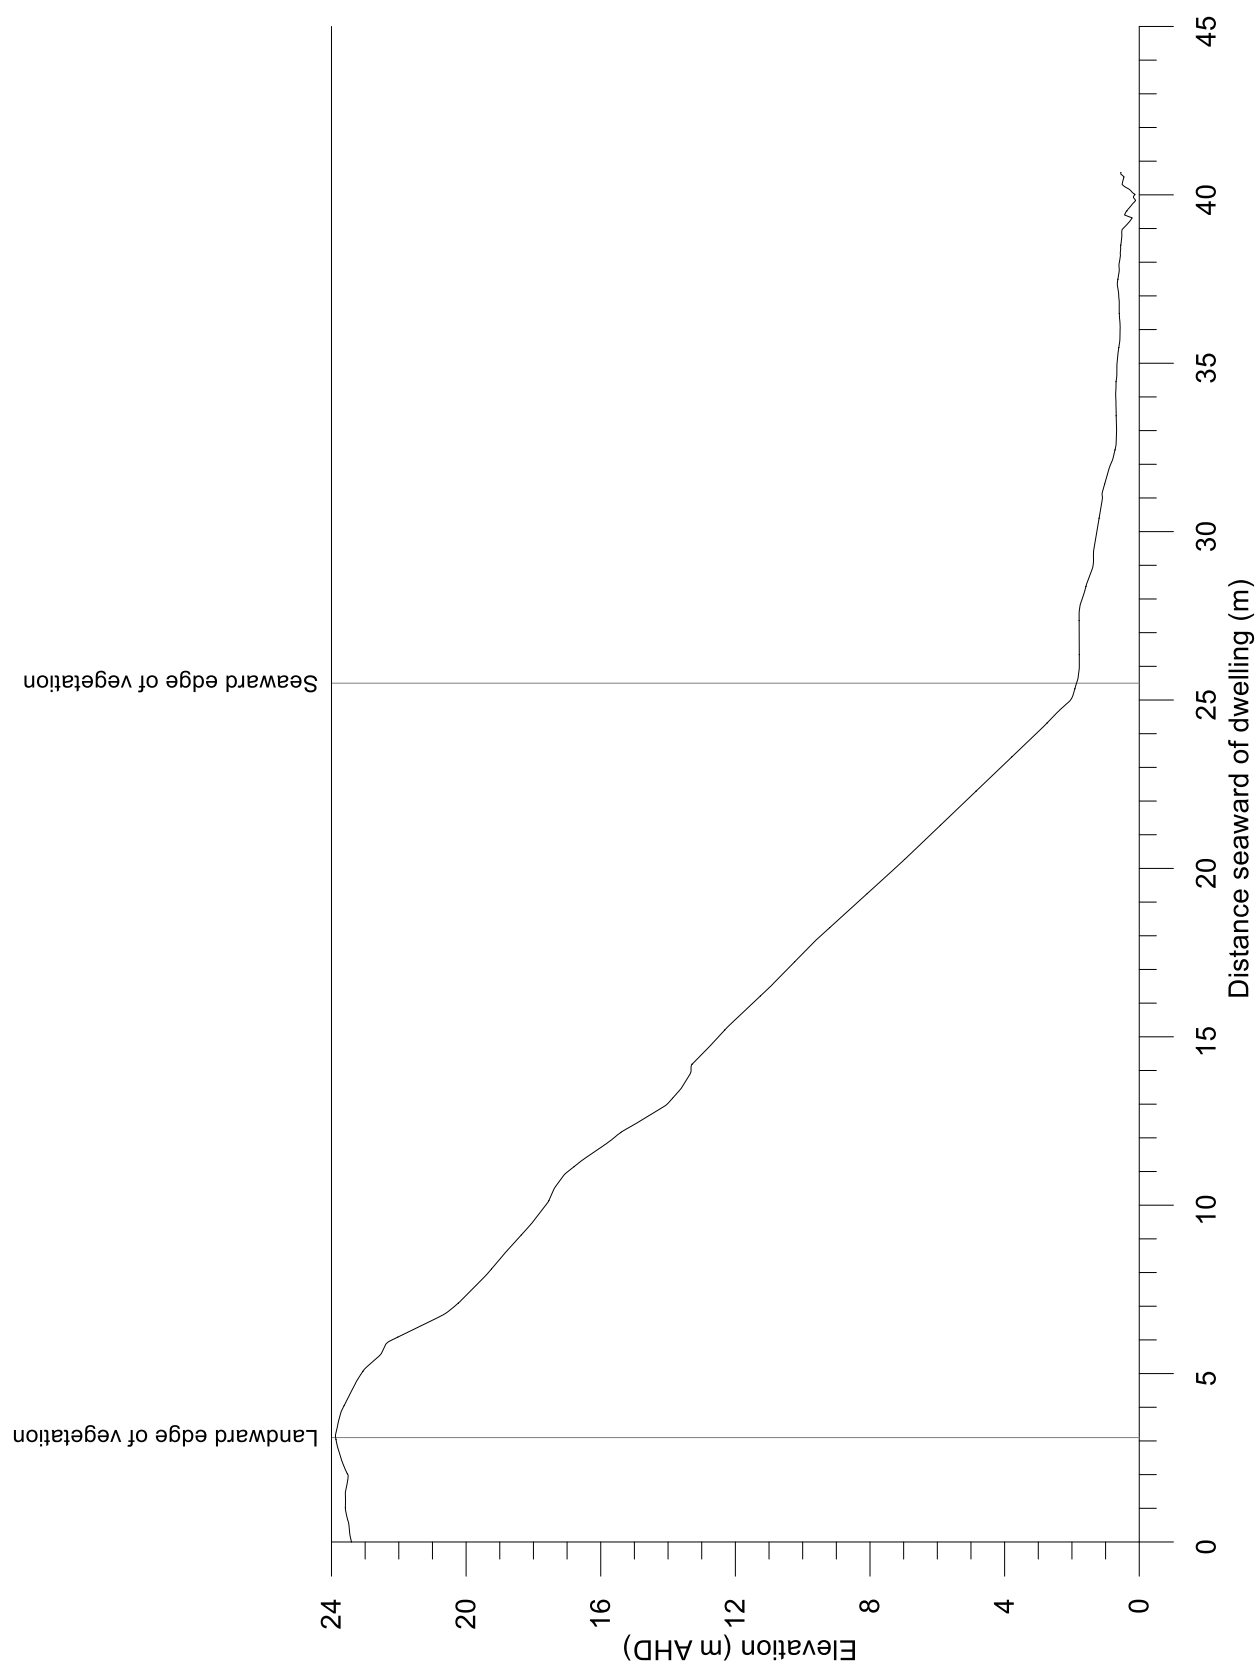
Figure 6: Section B through cliff at site towards NNW

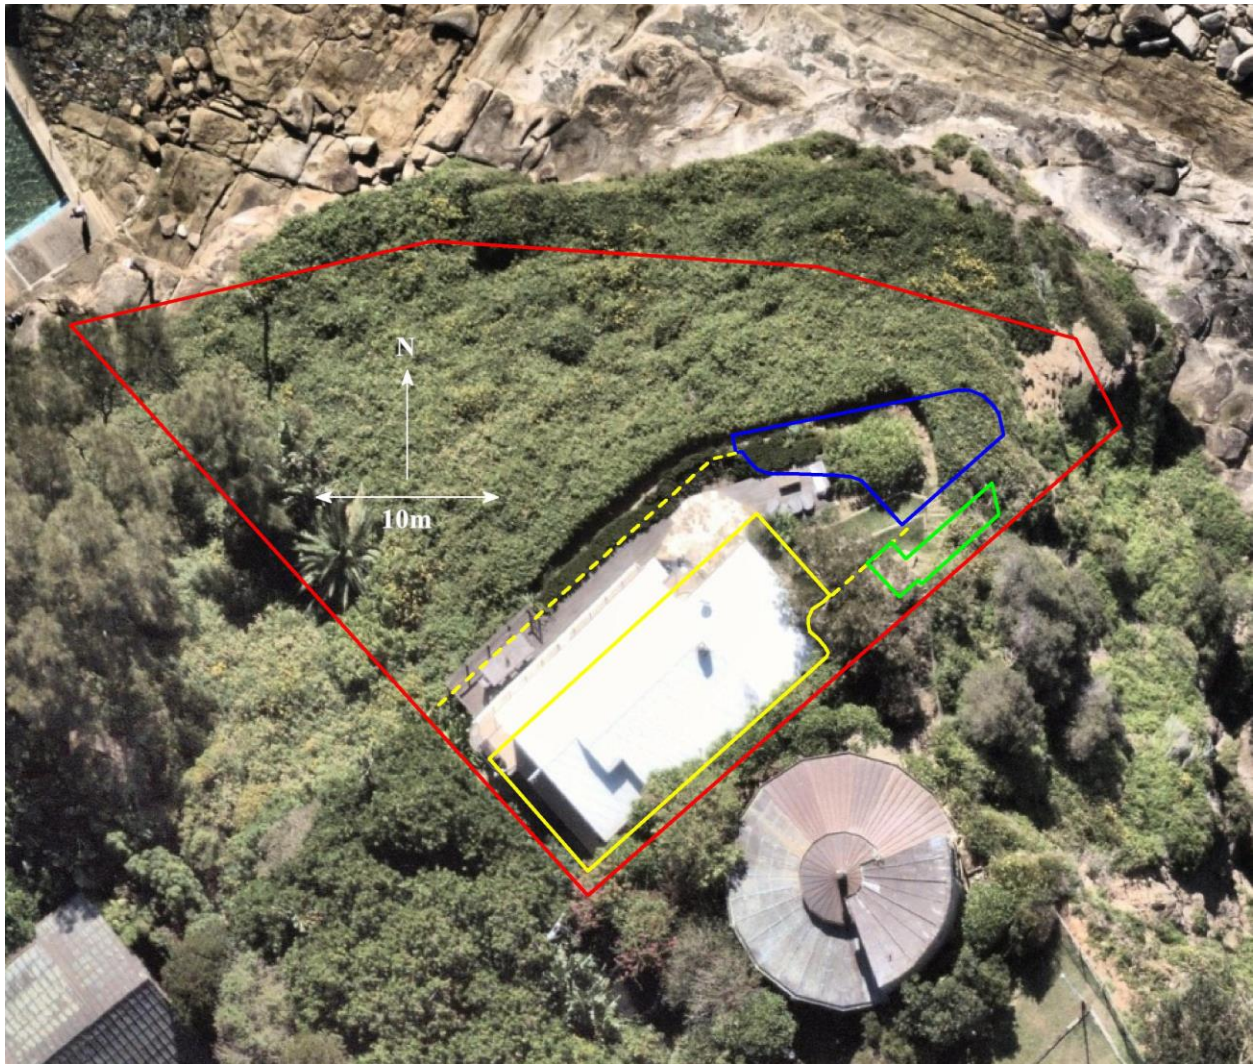
It is proposed to demolish and rebuild the dwelling at the site, with the new dwelling having two levels. The minimum habitable floor level of the proposed dwelling is 25.4m AHD, with a pool also proposed at that level. An outline of the proposed development is provided in Figure 7, with the seaward edge of the proposed pool also depicted in Figure 5.

Figure 7: Outline of proposed development with approximate boundary in red, ground floor in solid yellow (with terrace outer edge dashed), pool in blue, and stairs and pool store in green (aerial photograph taken 1 May 2023)
