Arboricultural Impact Assessment Report

Prepared for: Northern Beaches Essential Services Accommodation

Site: 16 Wyatt Avenue Belrose NSW 2085

Date: June 2021

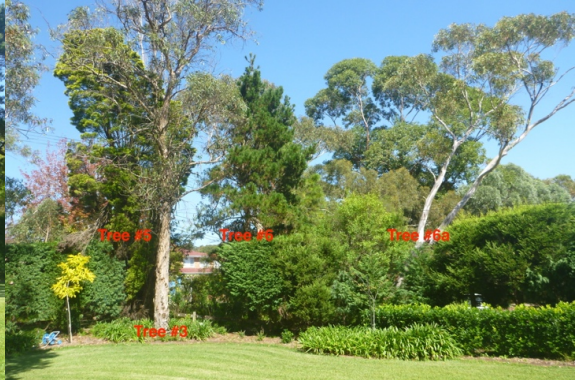
Figure 3 – Trees #3, 5, 6, 6a

3b	<i>Lagerstroemia indica</i> (Crepe Myrtle)	A1	2	1.5	footprint	Tree is located within the footprint of the new entrance pathway. Tree is a small species that can be easily replaced with an advanced specimen	Remove and replace
4	<i>Eucalyptus haemastoma</i> (Scribbly Gum)	A2	7.92	3.63	27.3% Major	The construction of the bin room, front pathway and new kerb and gutting will result in a 27.3% incursion into the TPZ of the tree which is considered major under section 3.3.3 of AS4970-2009. Excavations required for the bin room (6.08%) and front pathway (7.87%) are to be done by hand under the supervision of the project	Retain

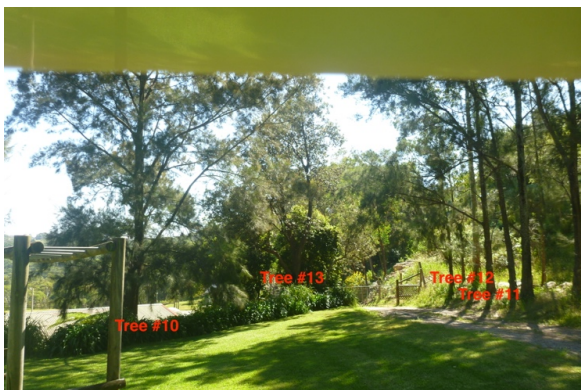
Figure 6 - Trees 10, 11, 12, 13

12	<i>Eucalyptus saligna</i> (Sydney Blue Gum)	A2	4.56	2.5	0%	Construction works occurring outside of protection zone below grade of tree, due to topography and location, tree protection is not required.	Retain
13	<i>Banksia integrifolia</i> (Coast Banksia)	A1	5.04	2.57	0%	Construction works occurring outside of protection zone below grade of tree, due to topography and location, tree protection is not required.	Retain
14	<i>Cinnamomum camphora</i>	Z3	10.2	3.68	Footprint driveway	Tree identified as an exempt species under the Northern Beaches Council Tree Regulatory Controls	Remove and replace

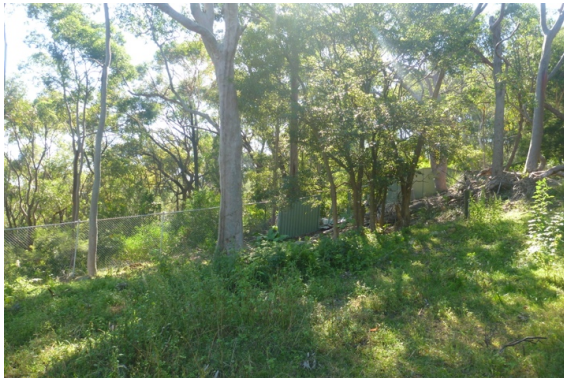
Figure 8 - Trees 16 - 19a, away from development area

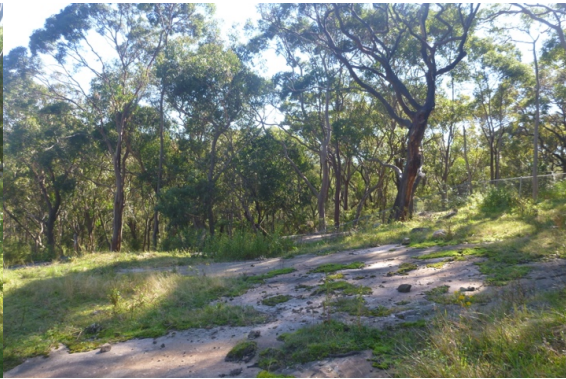
Figure 9 – Trees 20-25, away from development area

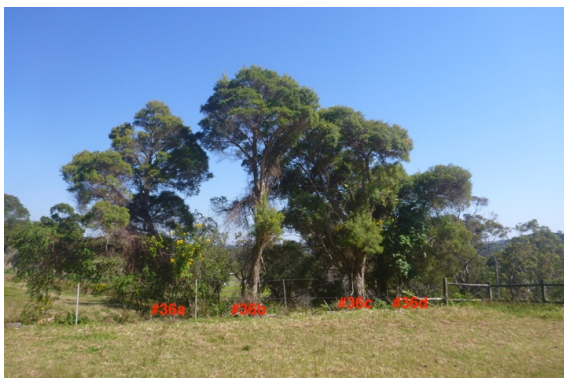
Figure 12 - Trees 36a, b, c, d away from development area

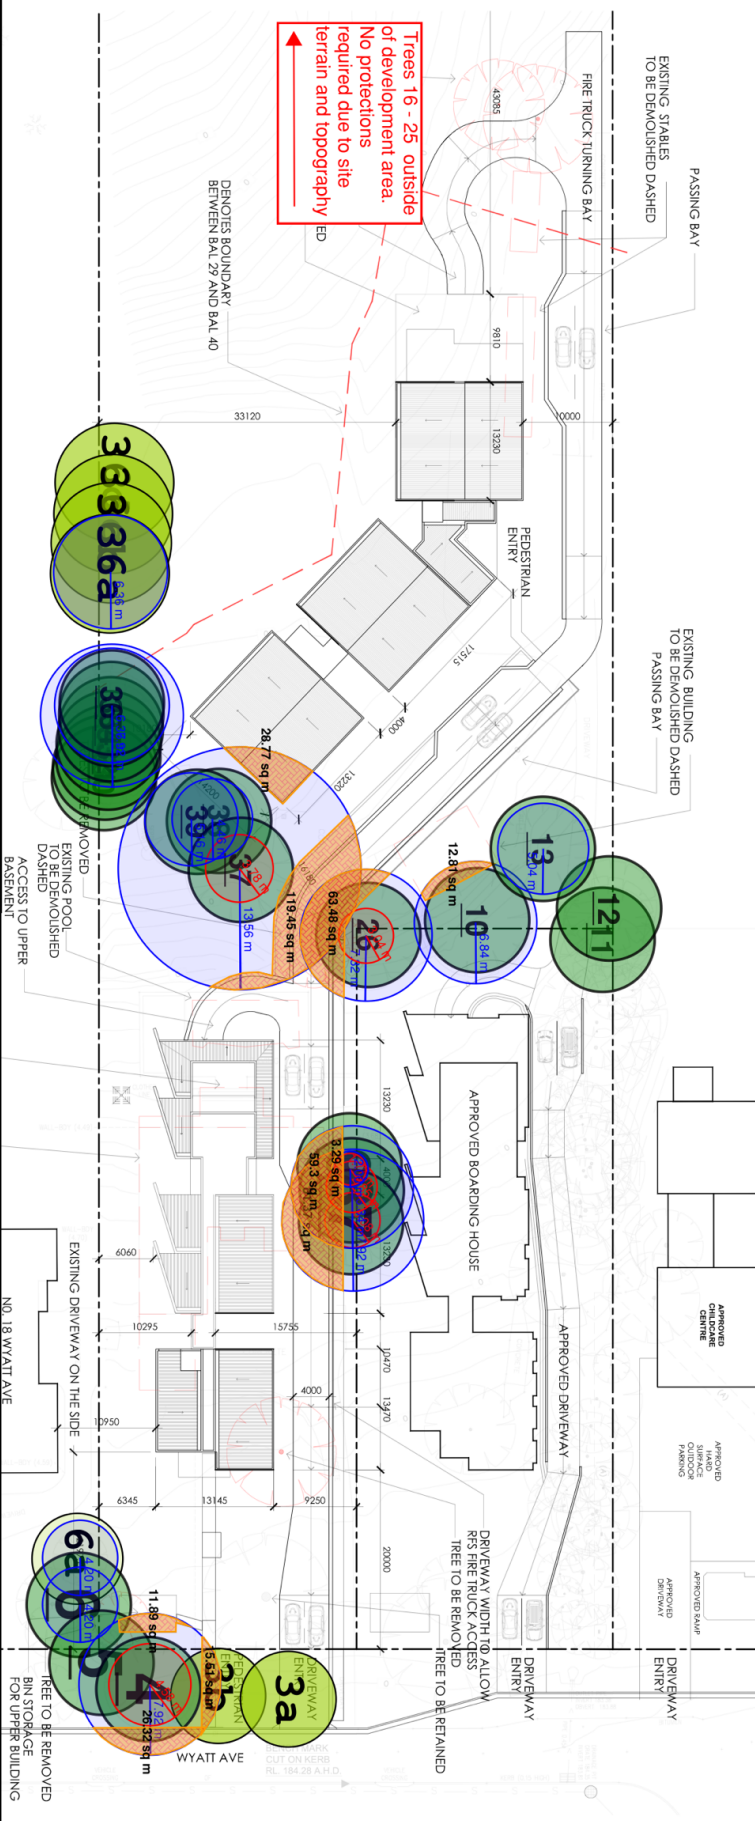
Building Incursion Plan
 16 Wyatt Avenue Belrose NSW 2085
 Scaled using Site Plan 1:500 A3
 Axiom Arbor Tree Services
 June 2021

Tree Number	Tree Protection Zone	Structural Foot Zone	Area of Incursion
40	7.30 m	5.88 m	92.24 sq m
