Geotechnical Investigation and Slope Risk Assessment Report 8 Beverley Place, Curl Curl NSW

Morrow Geotechnics Pty Ltd conducted geotechnical investigations at 8 Beverley Place, Curl Curl NSW (the site). The purpose of this investigation was to provide geotechnical advice and recommendations for proposed development at the site based on project details available at the time of the investigation.

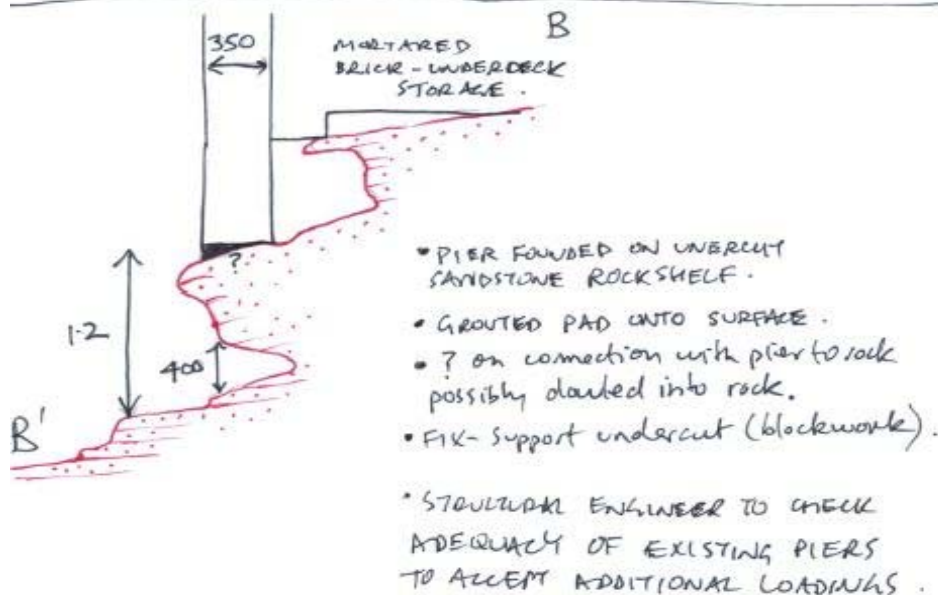
SECTIONS A A' B B'

- Evacuating in wall most likely poorly founded section of wall down slope from sandstone.
- low risk failure (immediate)
- will develop over time.
- underpin lower section wall to rock.
