Geotechnical Assessment

Project: New Dwellings
41 Ferguson Street, Forestville NSW

Ref: AG 24481
11 December 2024

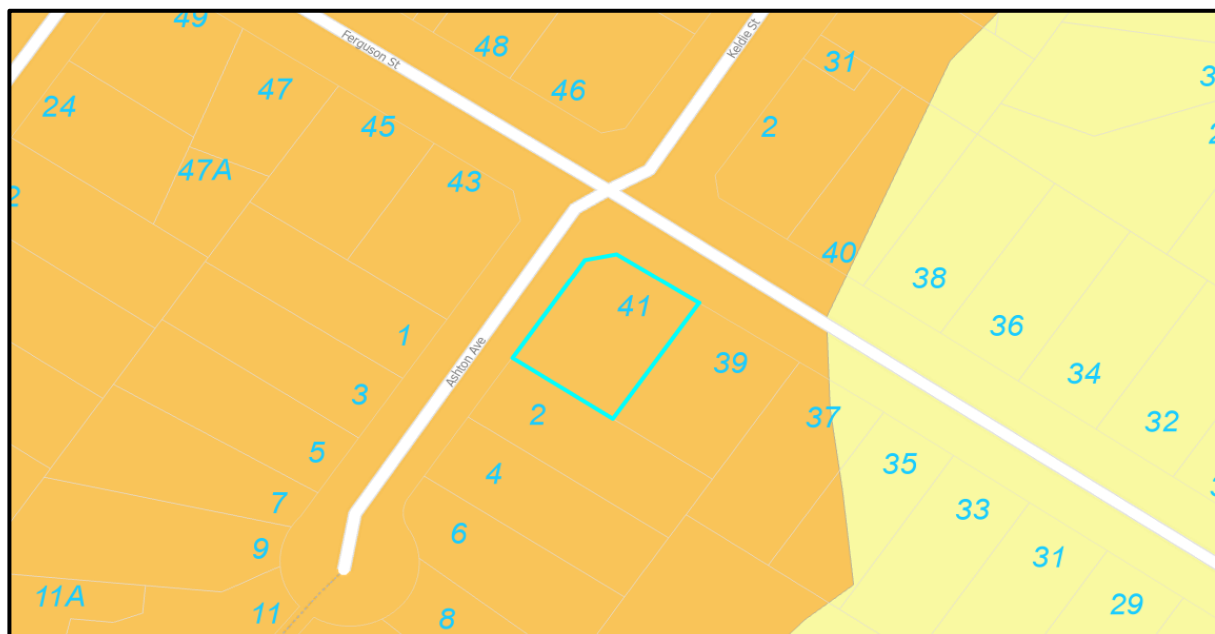
Image 2. Warringah Landslip Risk Map:
41 Ferguson Street, Forestville (© NBC Maps)

- No evidence of significant soil creep, tension cracks or landslip instability were identified across the site or on adjacent properties as viewed from the subject site at the time of our inspection.
- The property is classified as **Area B** with reference to Northern Beaches Council WLEP – Warringah Landslip Risk Map (**Image 2**).

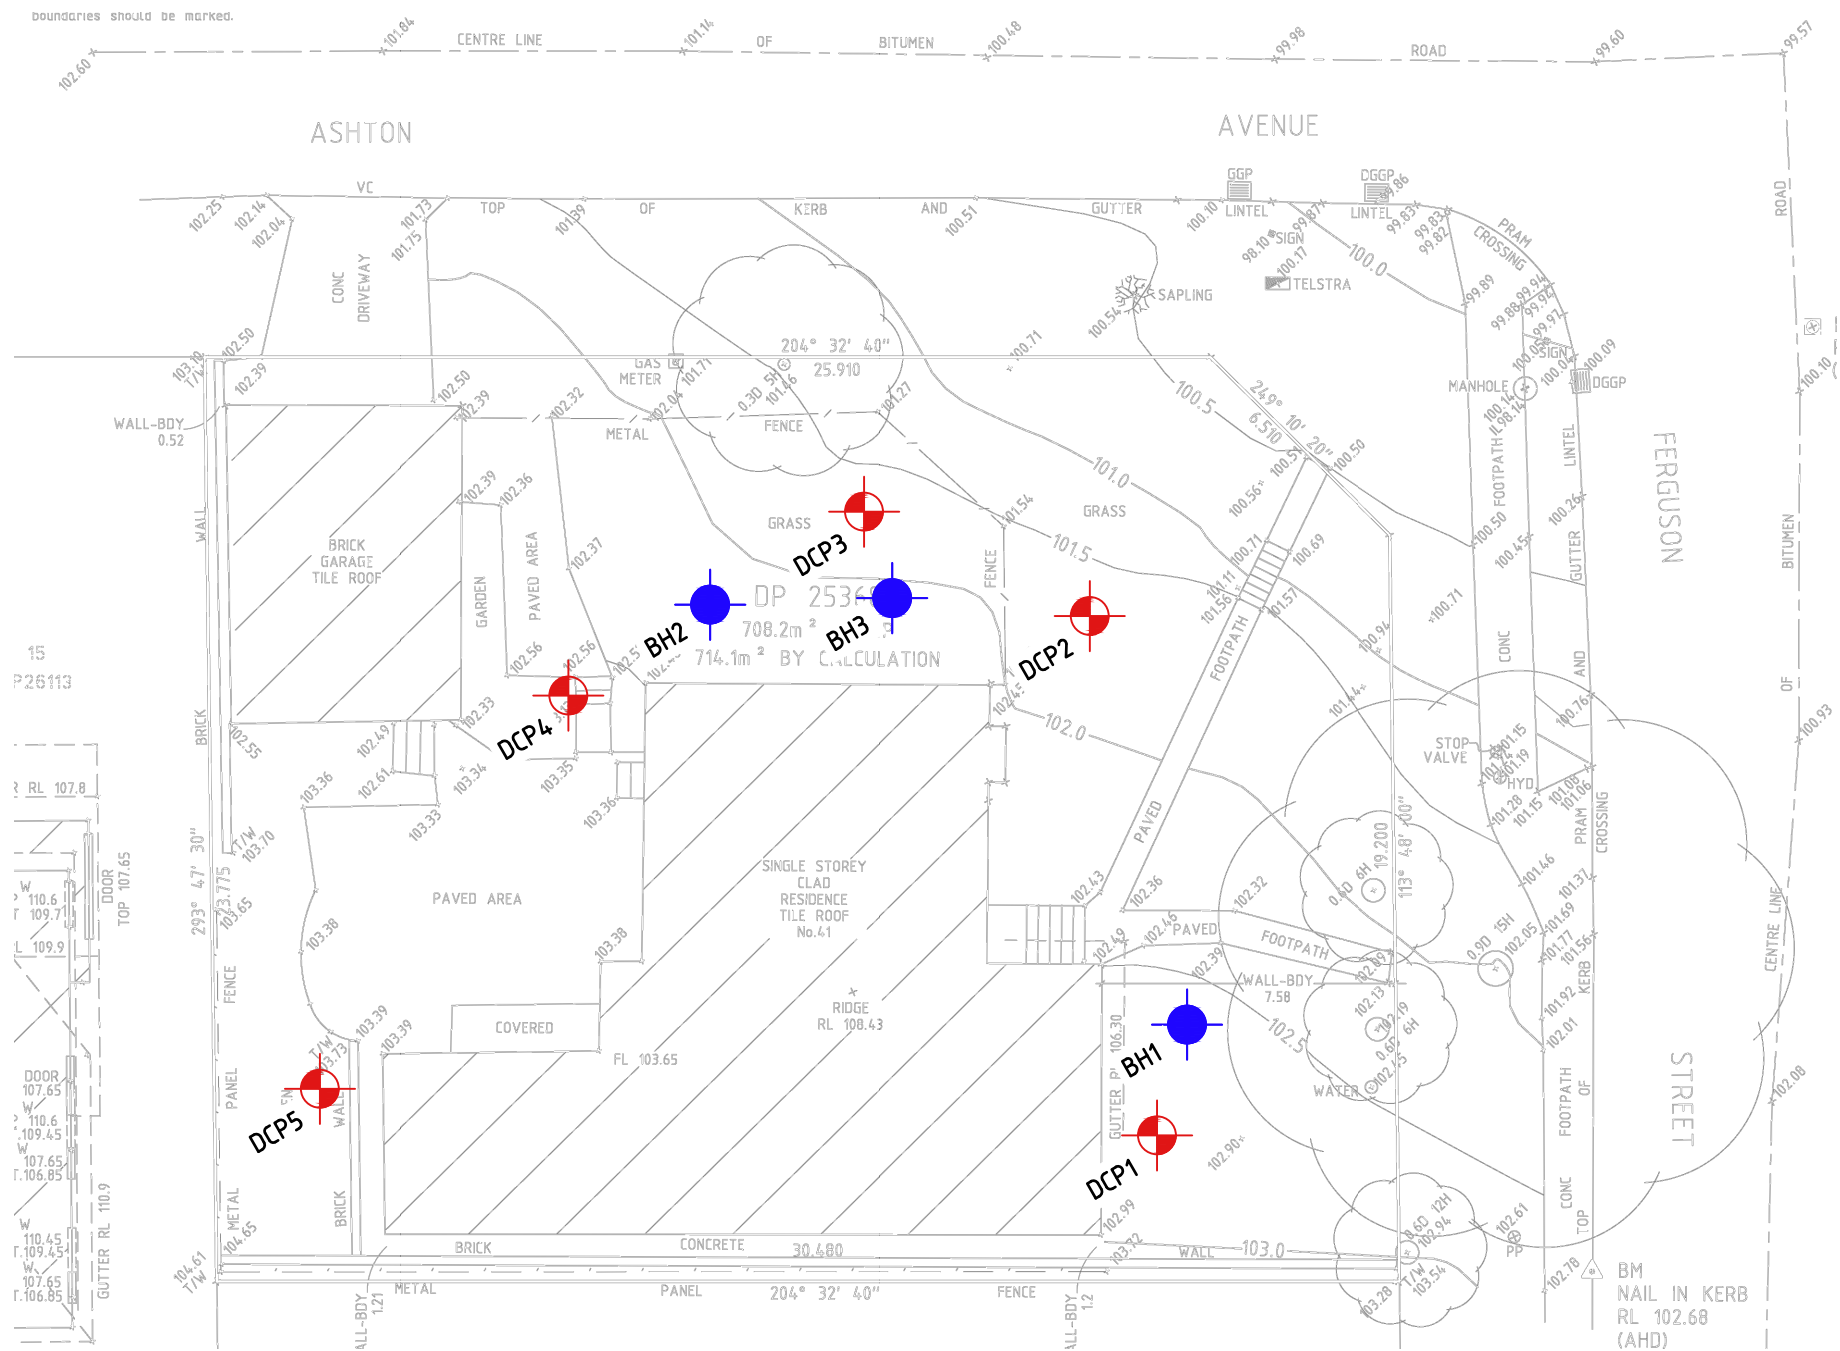
SITE PLAN/GROUND TEST LOCATIONS
SCALE NTS

Test	DCP 1	DCP 2
Summary	Refusal @ 1.0m Bouncing on bedrock. Brown sand on moist tip.	Refusal @ 0.9m Bouncing on bedrock. Brown sand on moist tip.
Test	DCP 3	DCP 4
Summary	Refusal @ 1.0m Bouncing on bedrock. Brown sand on moist tip.	Refusal @ 1.5m Bouncing on bedrock. Brown sand on moist tip.
Test	DCP 5	-
Summary	Refusal @ 1.1m Bouncing on bedrock. Brown sand on moist tip.	-
