## **GEOTECHNICAL REPORT**

### **PROPOSED NEW DWELLING**

**18 HILLCREST AVENUE, MONA VALE NSW**

**Project No.: 2022-039.1**

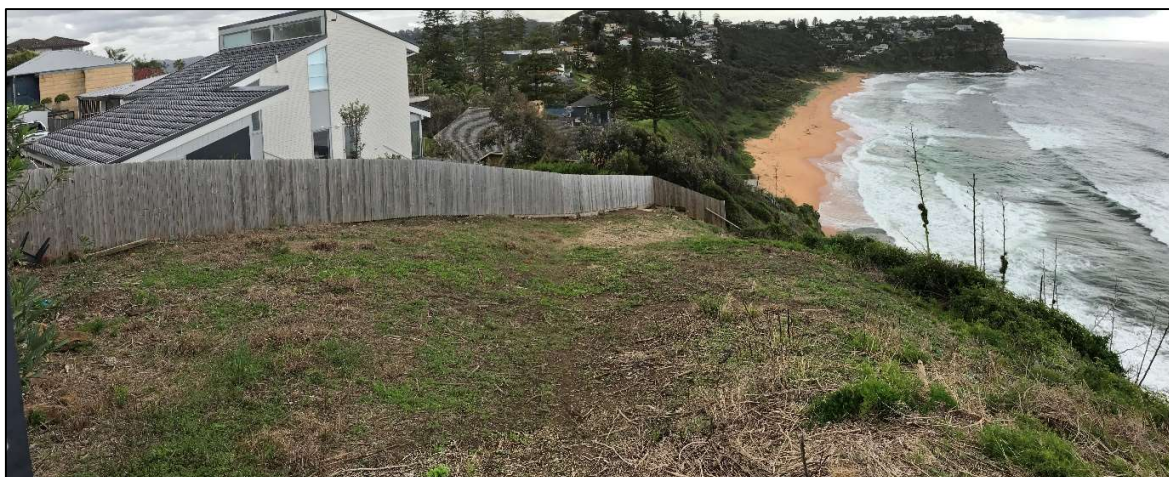
*Photograph 2: View of the site looking north from near Borehole 1.*

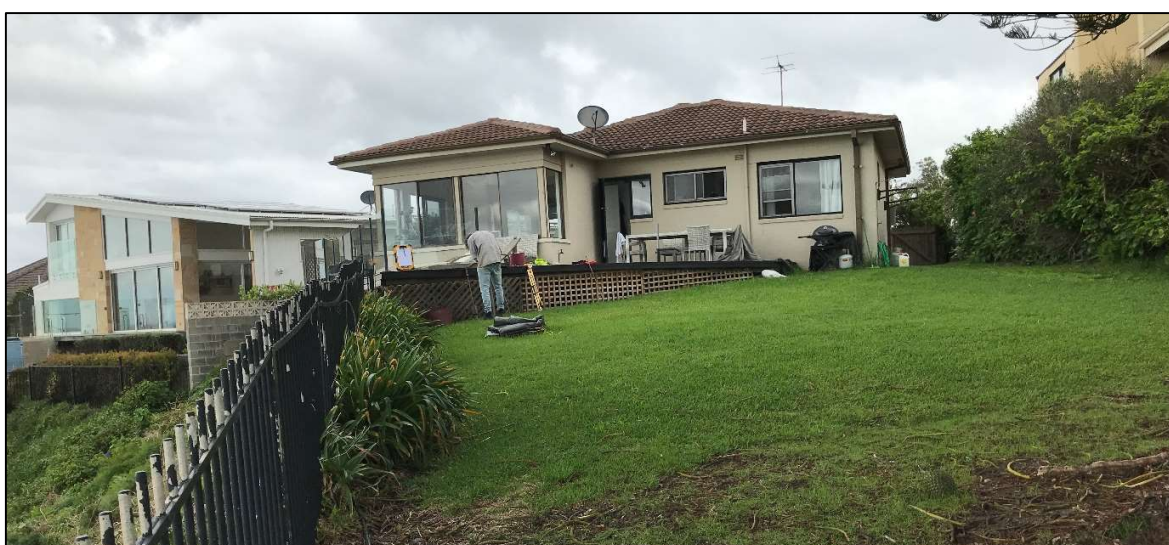
*Photograph 3: View of the site looking south from the rear garden*

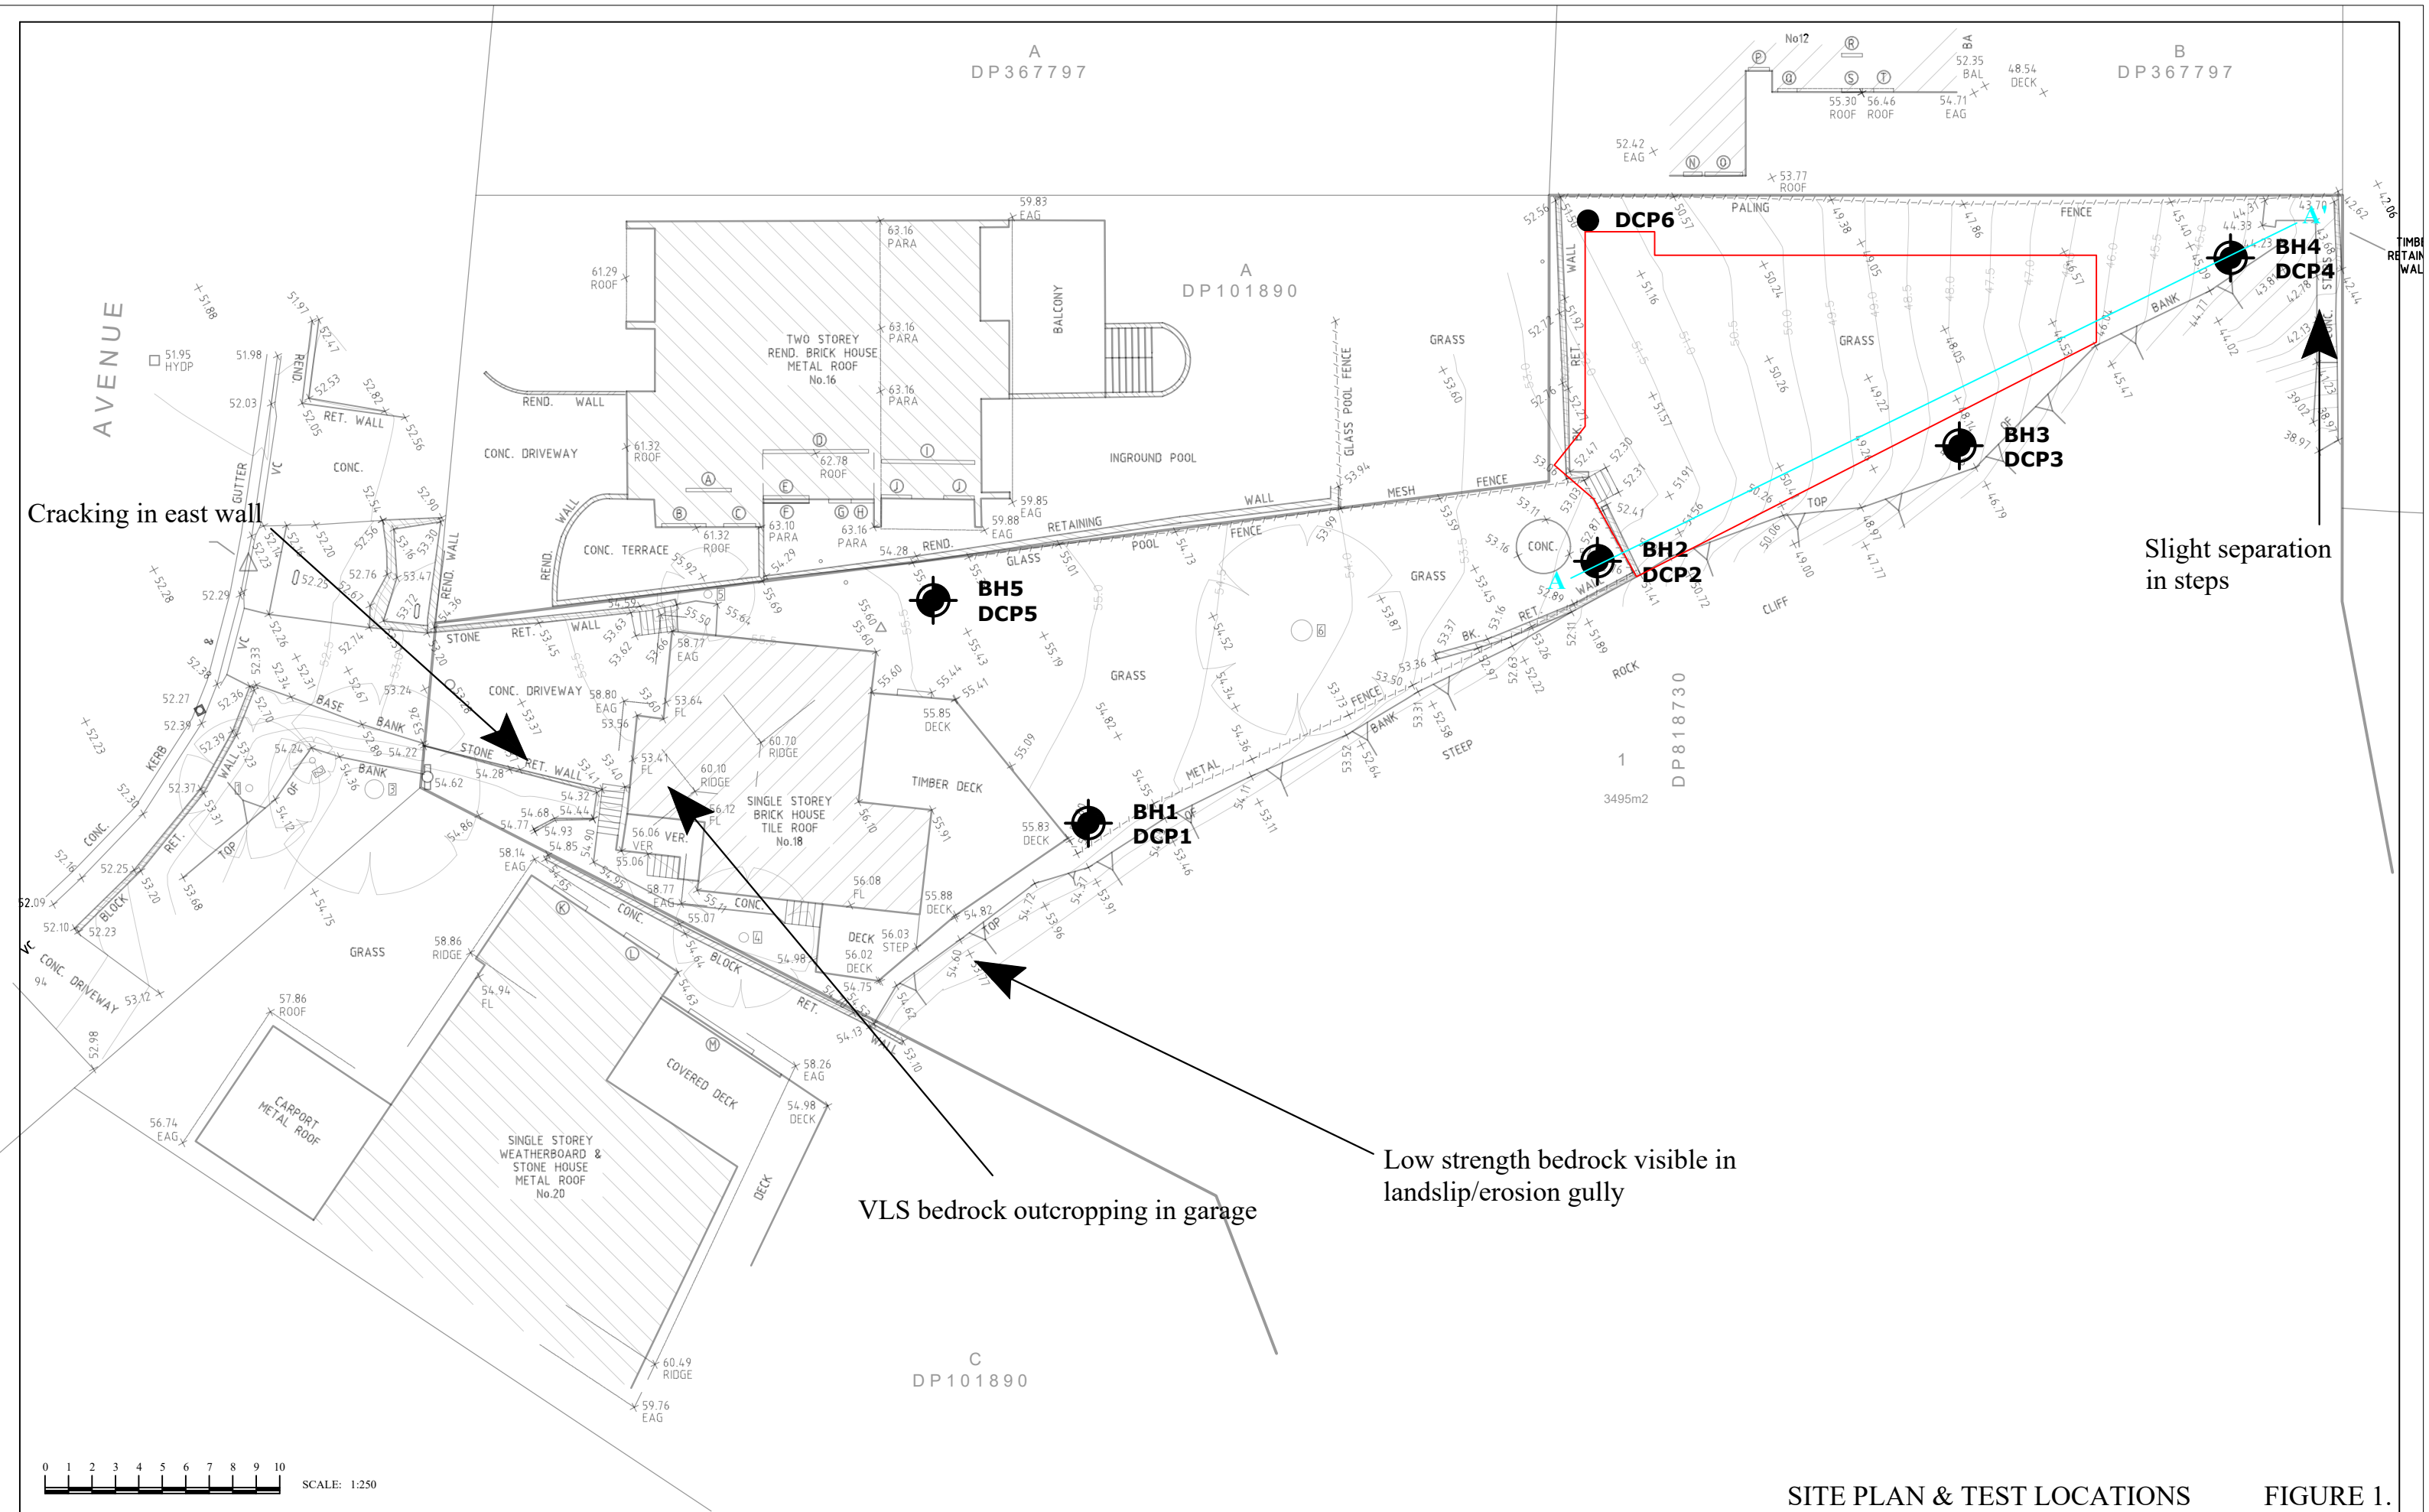
SITE PLAN & TEST LOCATIONS FIGURE 1.

Explanatory notes are included in Appendix: 1. Mapping information and test locations are shown on Figure: 1, and a geological section is provided as Figure: 2 along with detailed Borehole log sheets and Dynamic Penetrometer Test Sheet in Appendix: 2.

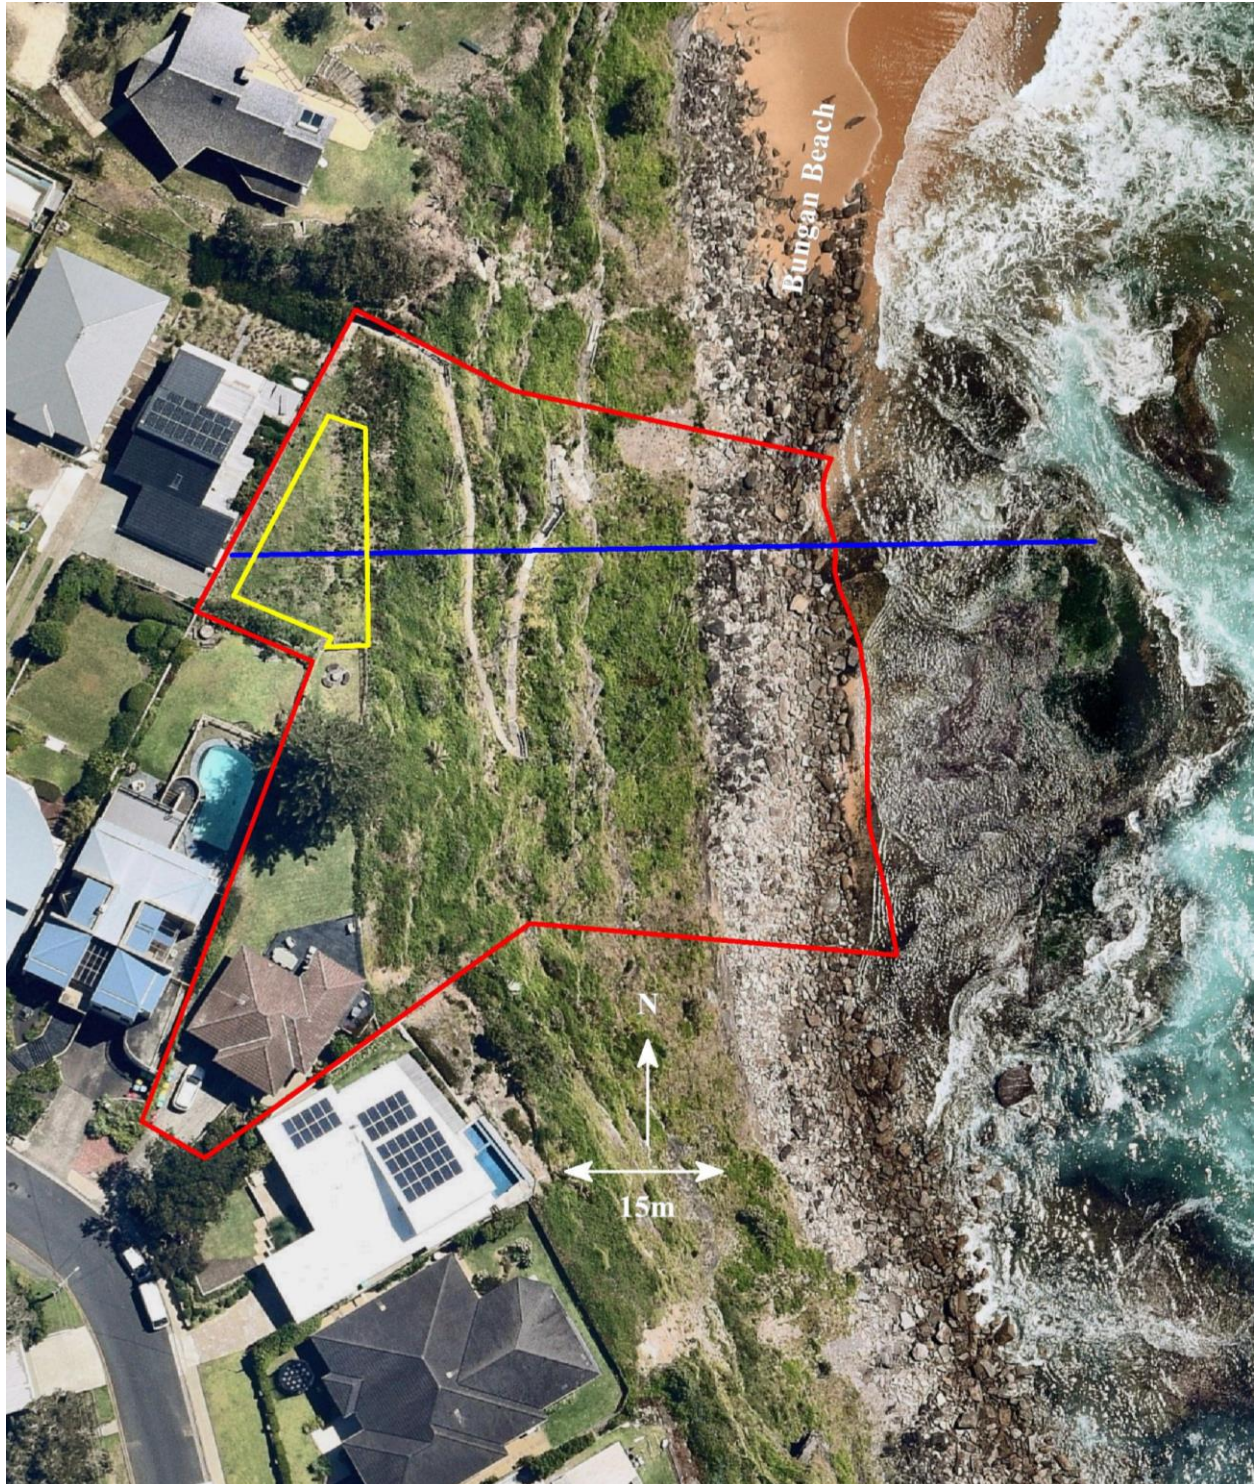
The subject property is located at the northern end of Mona Vale Headland, and adjacent to a rock platform and cliff at the southern end of Bungan Beach. A vertical aerial view of the property is provided in Figure 1, with a section location denoted as Section A also depicted in Figure 1<sup>2</sup>.

**Figure 1: Aerial view of subject property (red outline), with location of Section A shown in blue and outline of proposed development in yellow (aerial photograph taken 23 November 2022)**

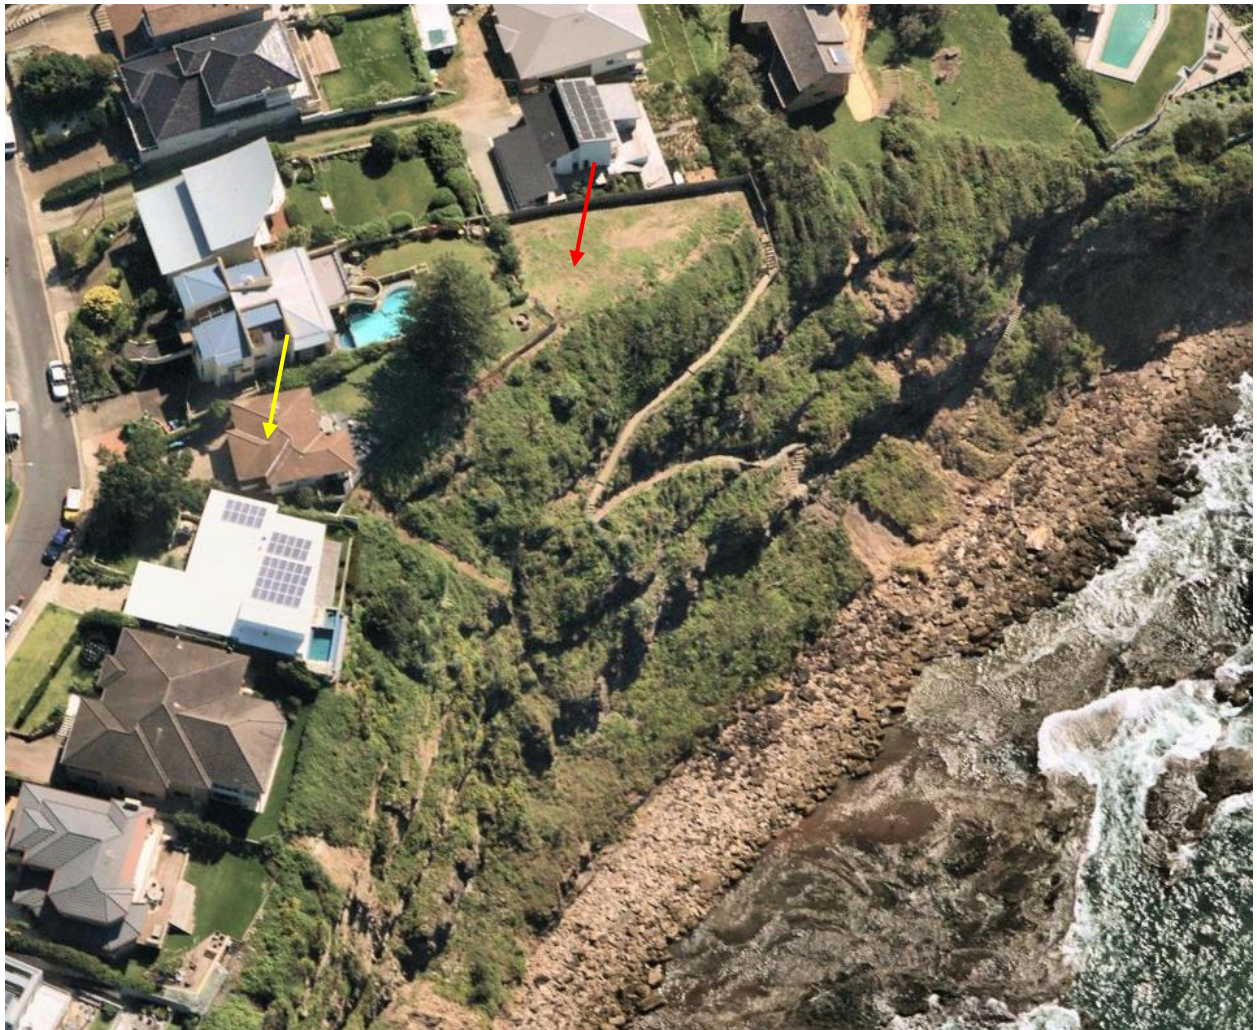
**Figure 2: Oblique aerial view of subject property (existing dwelling at yellow arrow, and proposed location of secondary dwelling at red arrow) on 5 April 2022, facing NW**

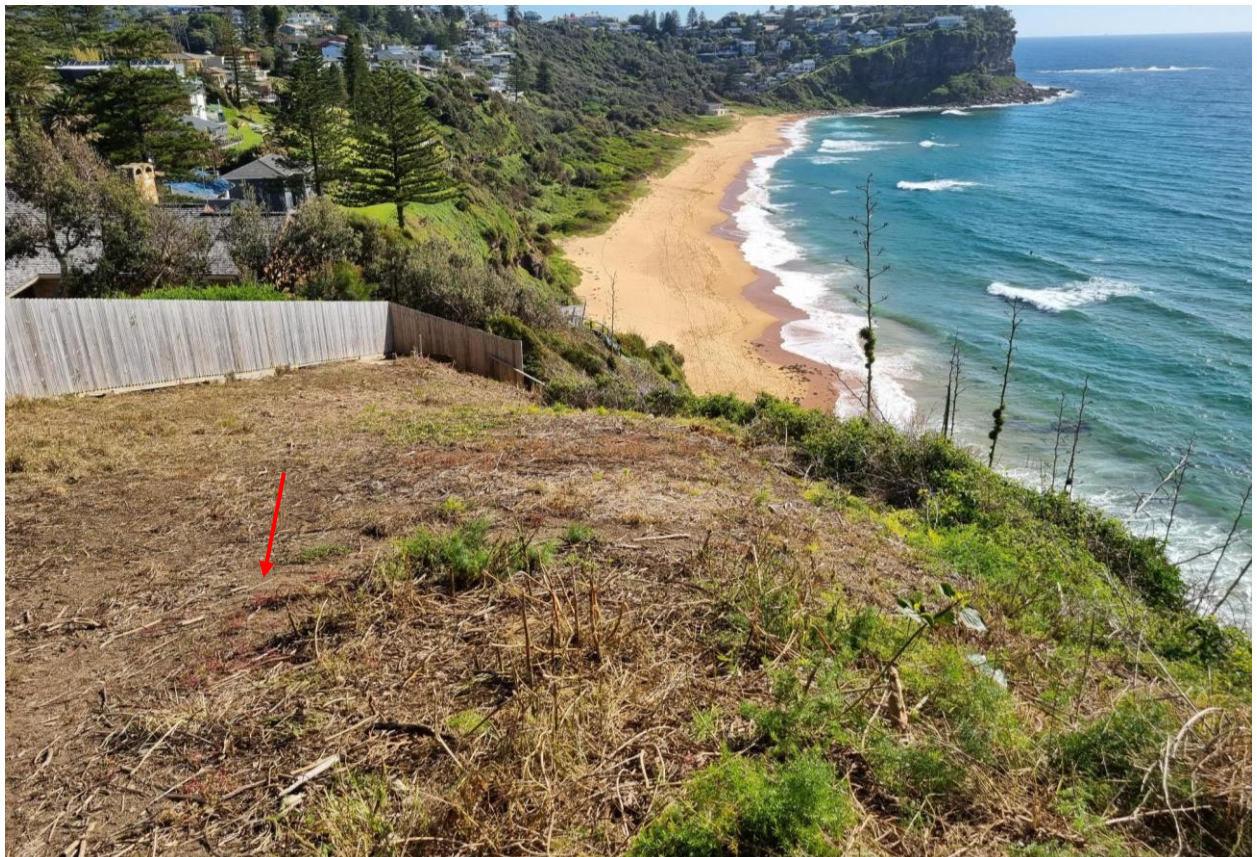
**Figure 4: View of area proposed to be developed (at arrow) on 17 February 2022, facing NNE**

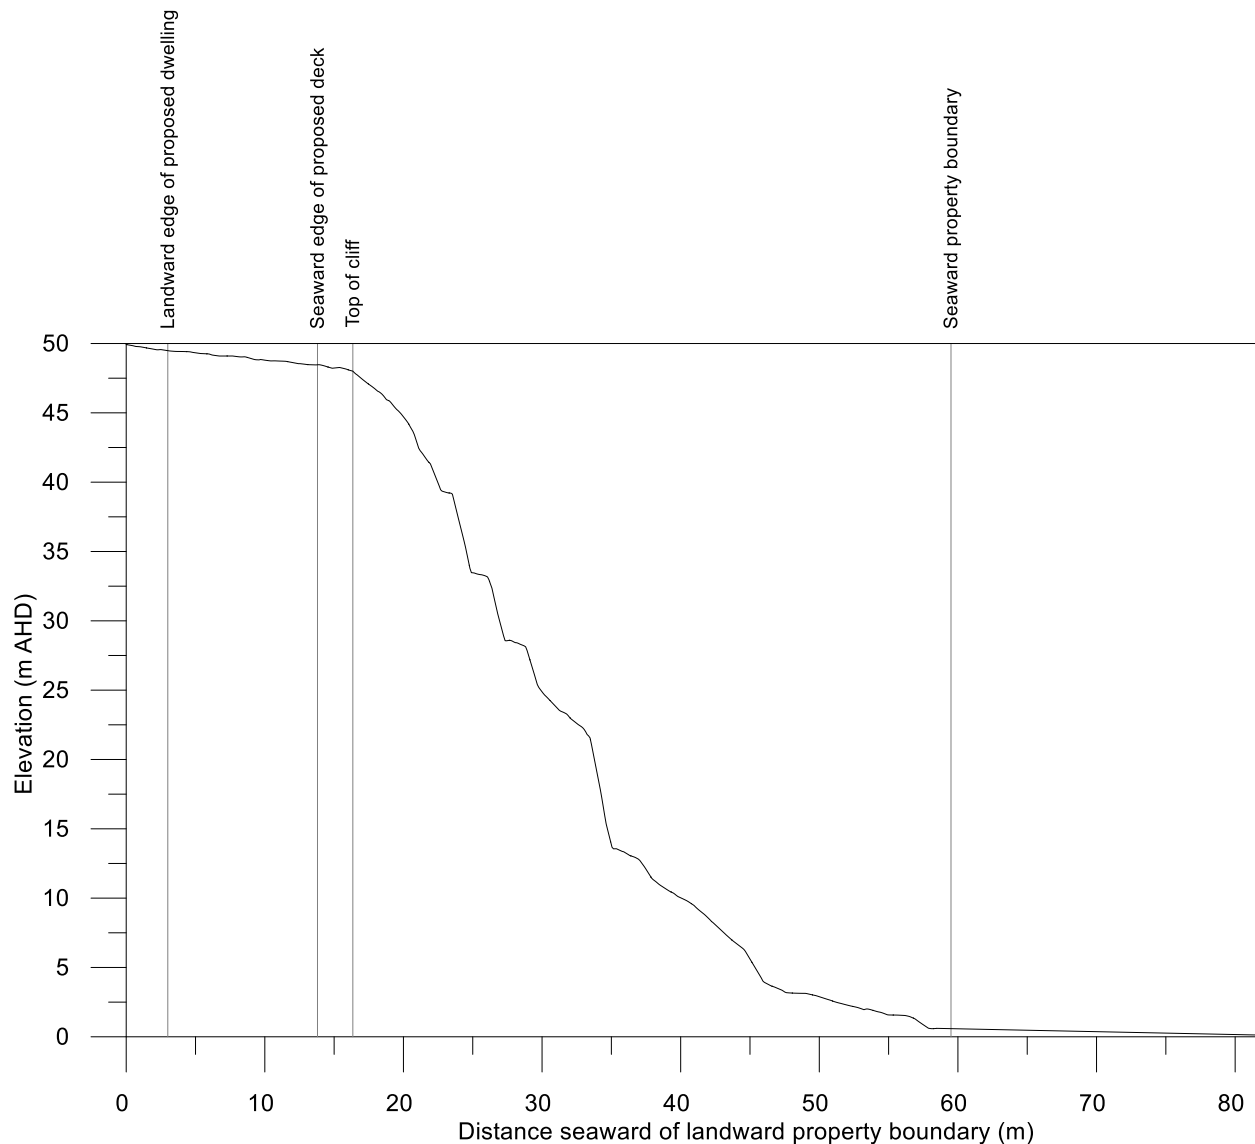
Based on Airborne Laser Scanning (ALS) data held by Horton Coastal Engineering that was collected in 2020, elevations along Section A (from Figure 1) perpendicular to the cliff face are depicted in Figure 5. Ground elevations along Section A approximately vary from about 50m AHD in the development area, 48m AHD at the top of cliff, and 0.6m AHD at the seaward property boundary. The upper section of the cliff (down to about 13.6m AHD) has an average slope of 1:0.5 (vertical:horizontal, V:H) or 61°. The lower section of cliff to the seaward edge of vegetation (which can be considered as the cliff toe) at about 4.0m AHD is flatter at an average slope of about 1V:1.1H or 42°. Below this, where boulders are exposed, the average slope is flatter again at about 1V:3.5H or 16° down to the rock platform at about 0.6m AHD.

**Figure 5: Section A through subject property including cliff face and rock platform**
