Report Title: Geotechnical Report 54 McCarrs Creek Road, Church Point
Report Date: 19/4/21

GEOTECHNICAL INVESTIGATION:

Alterations and Additions at **54 McCarrs Creek Road, Church Point**

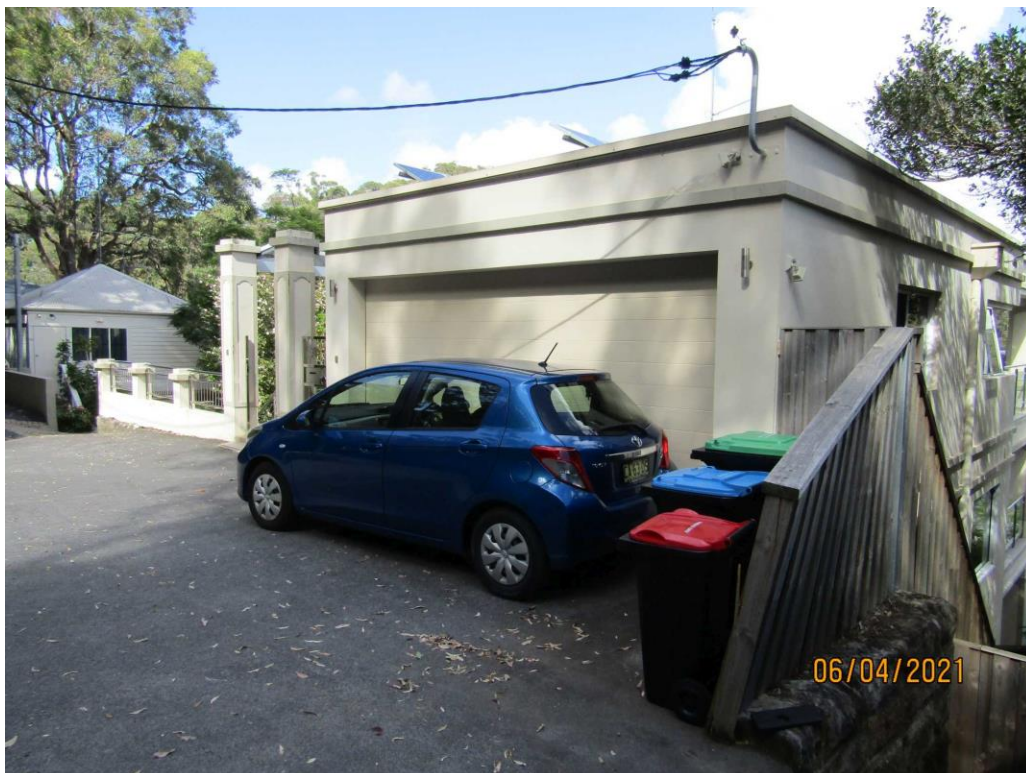
Photo 2

- 2.1** The site was inspected on the 6th of April, 2021.
- 2.2** This waterfront residential property is on the low side of the road and has a SW aspect. It is located on the steeply graded lower reaches of a hillslope. The natural slope falls across the property at an average angle of ~27°. The slope above the property continues at similar steep angles for ~70m before gradually easing.
- 2.3** Sandstone bedrock is outcropping on the uphill side of the road (Photo 1). At the road frontage, a concrete right of carriageway (ROW) runs to a garage attached to level 3 of the house (Photo 2). The three storey rendered masonry house is supported
