Arborist Report

Project **812 Pittwater Road and 4 Delmar Parade**
Dee Why NSW 2099
Ref: 2021-1061
Job: 65488

Client **Dee Why 3 Pty Ltd & Dee Why 4 Pty Ltd**
c/o Willow Frank
Suite 110 , Level 1
13A Montgomery St
Kogarah NSW 2217

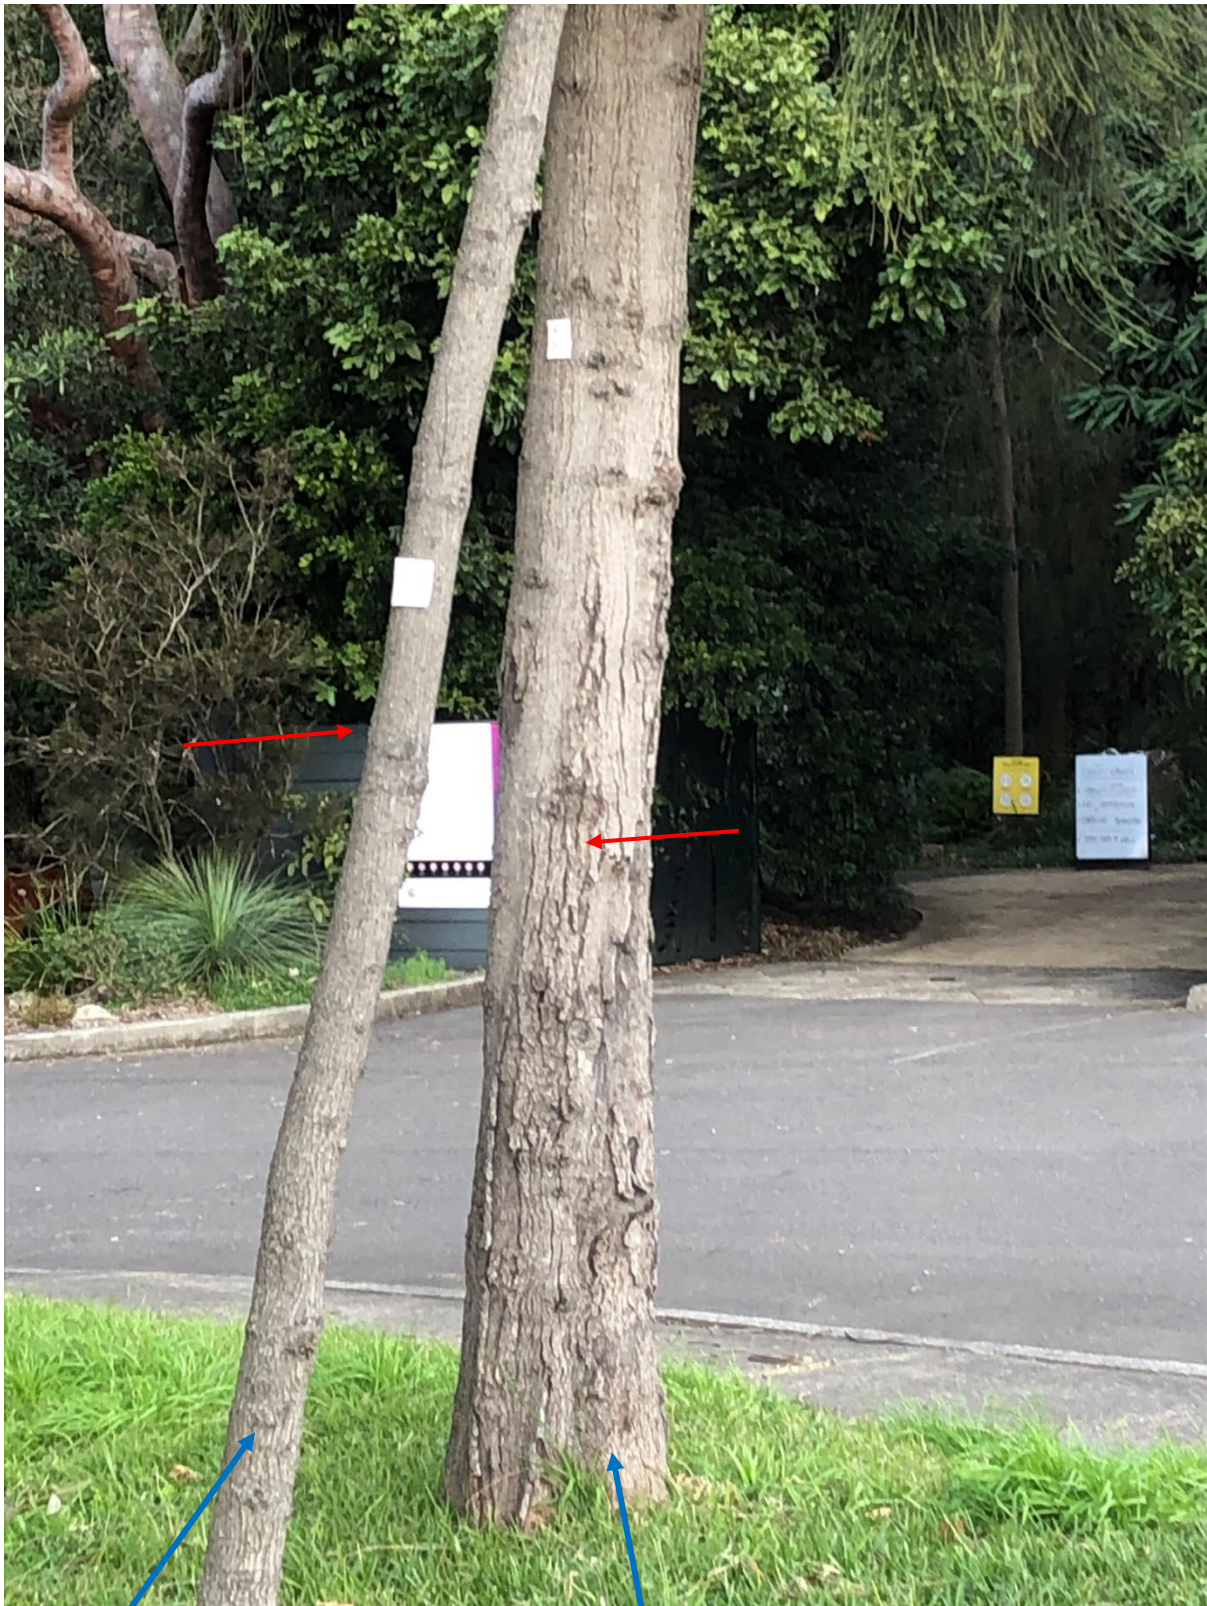
PHOTO 4

- 4.39 Tree 61 - Casuarina - has a trunk diameter of 30 cm, a height of 12 metres with a canopy spread of 4 metres. The tree is mature in age with a health rating of 5 out of 5 and a structure rating of 3 out of 5. It is dominant tree with 85% canopy cover. The tree has trunk inclusion at the 7.5 metre mark. Trees 60 and 61 are growing next to each other, as seen in photograph 4.

Trees 60 - Casuarina

Tree 61 - Casuarina

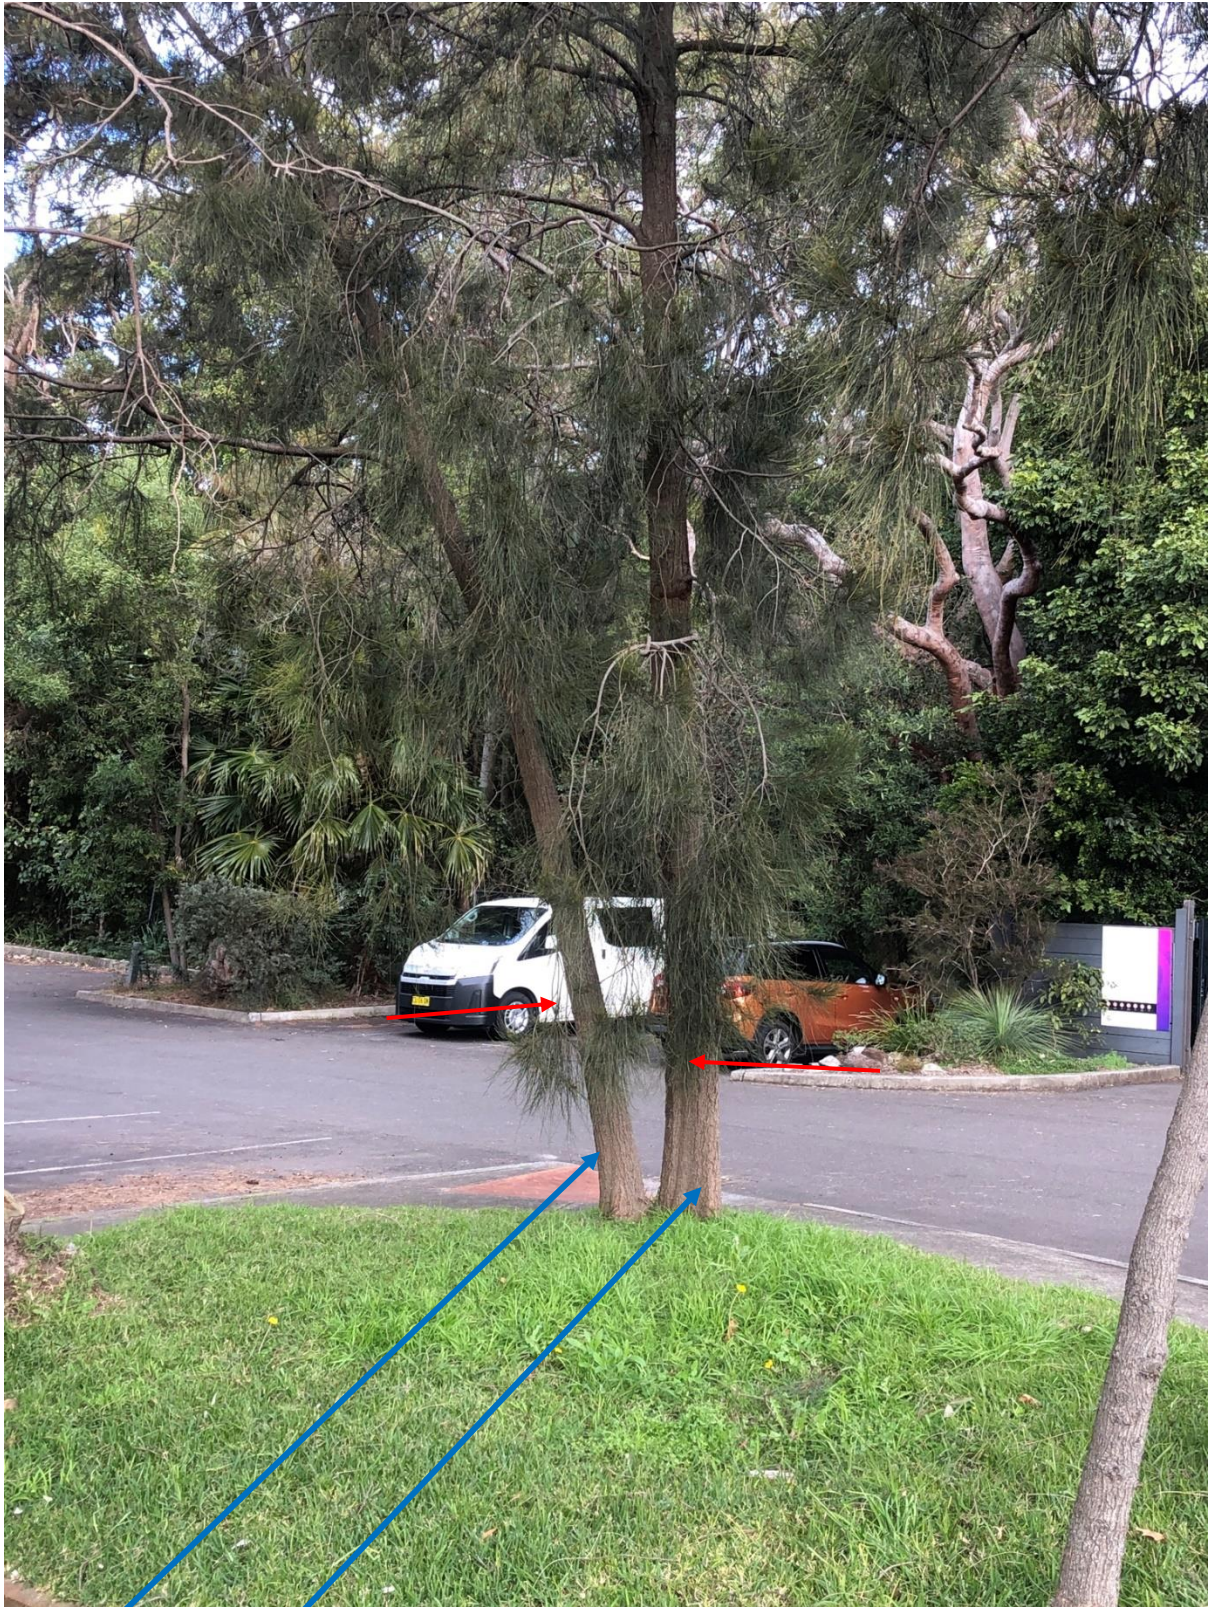
PHOTO 5

- 4.40 Tree 62 - Casuarina - has a trunk diameter of 20 cm, a height of 12 metres with a canopy spread of 6 metres. The tree is mature in age and a health rating of 5 out of 5 with a structure rating of 3 out of 5. It has a dominant canopy with 85% canopy cover. There is a trunk inclusion of the 8-metre mark with major swelling. It is growing next to Tree 63, as seen in photograph 5.

Trees 62 and 63 Casuarina - growing on council land

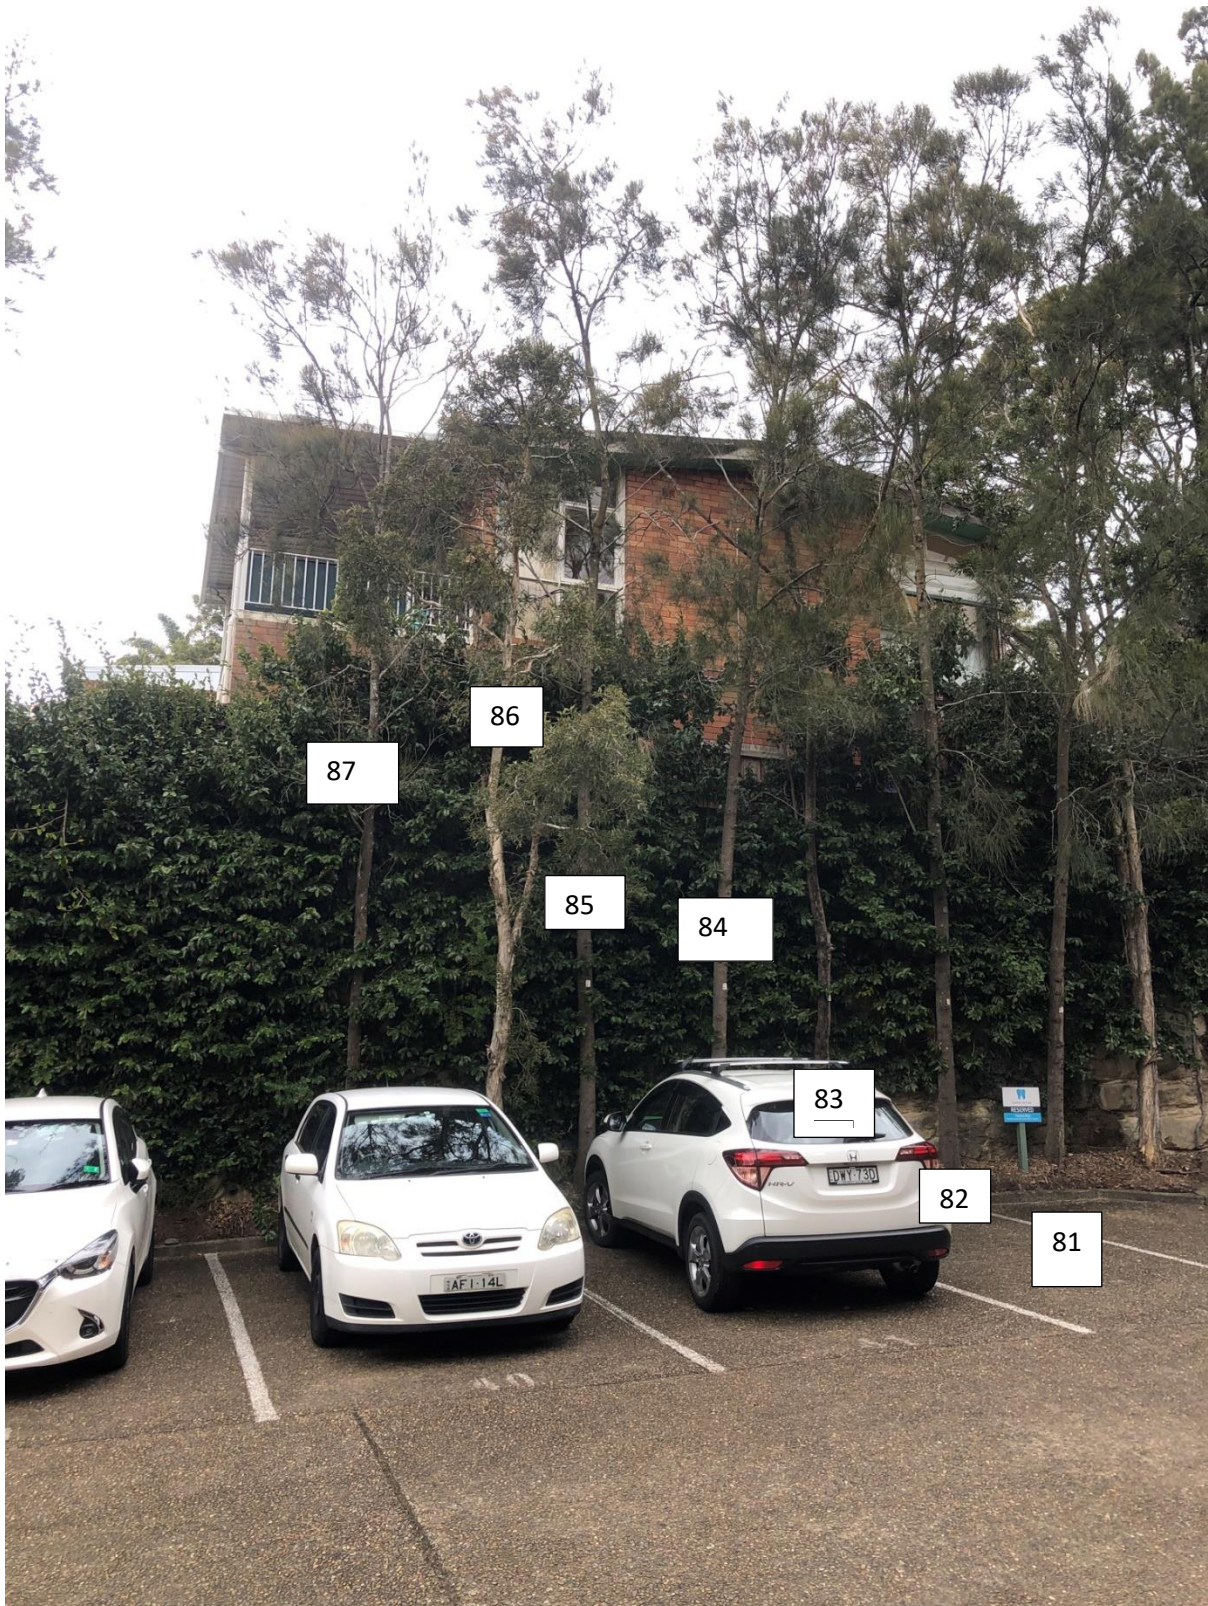
PHOTO 23

- 4.31 Trees 72 and 73 - Banksia trees - are growing on Council pathway on southern boundary.
- 4.32 Trees 74 to 79 (as seen in photograph 17) and Trees 81 to 90 (as seen in photographs 23 and 24) are growing along eastern boundary, next to sandstone embankment on eastern side of trees and car park on northern side of trees. These trees are in shallow soil and are non-significant specimens due to limited root run. They are a mix of Casuarina and Melaleuca trees.

Trees 79,81,82,83,84,85,86 – trees growing in narrow garden bed with rock face behind and driveway in front shallow soil .

Trees 87,86,85,84,83,82,81

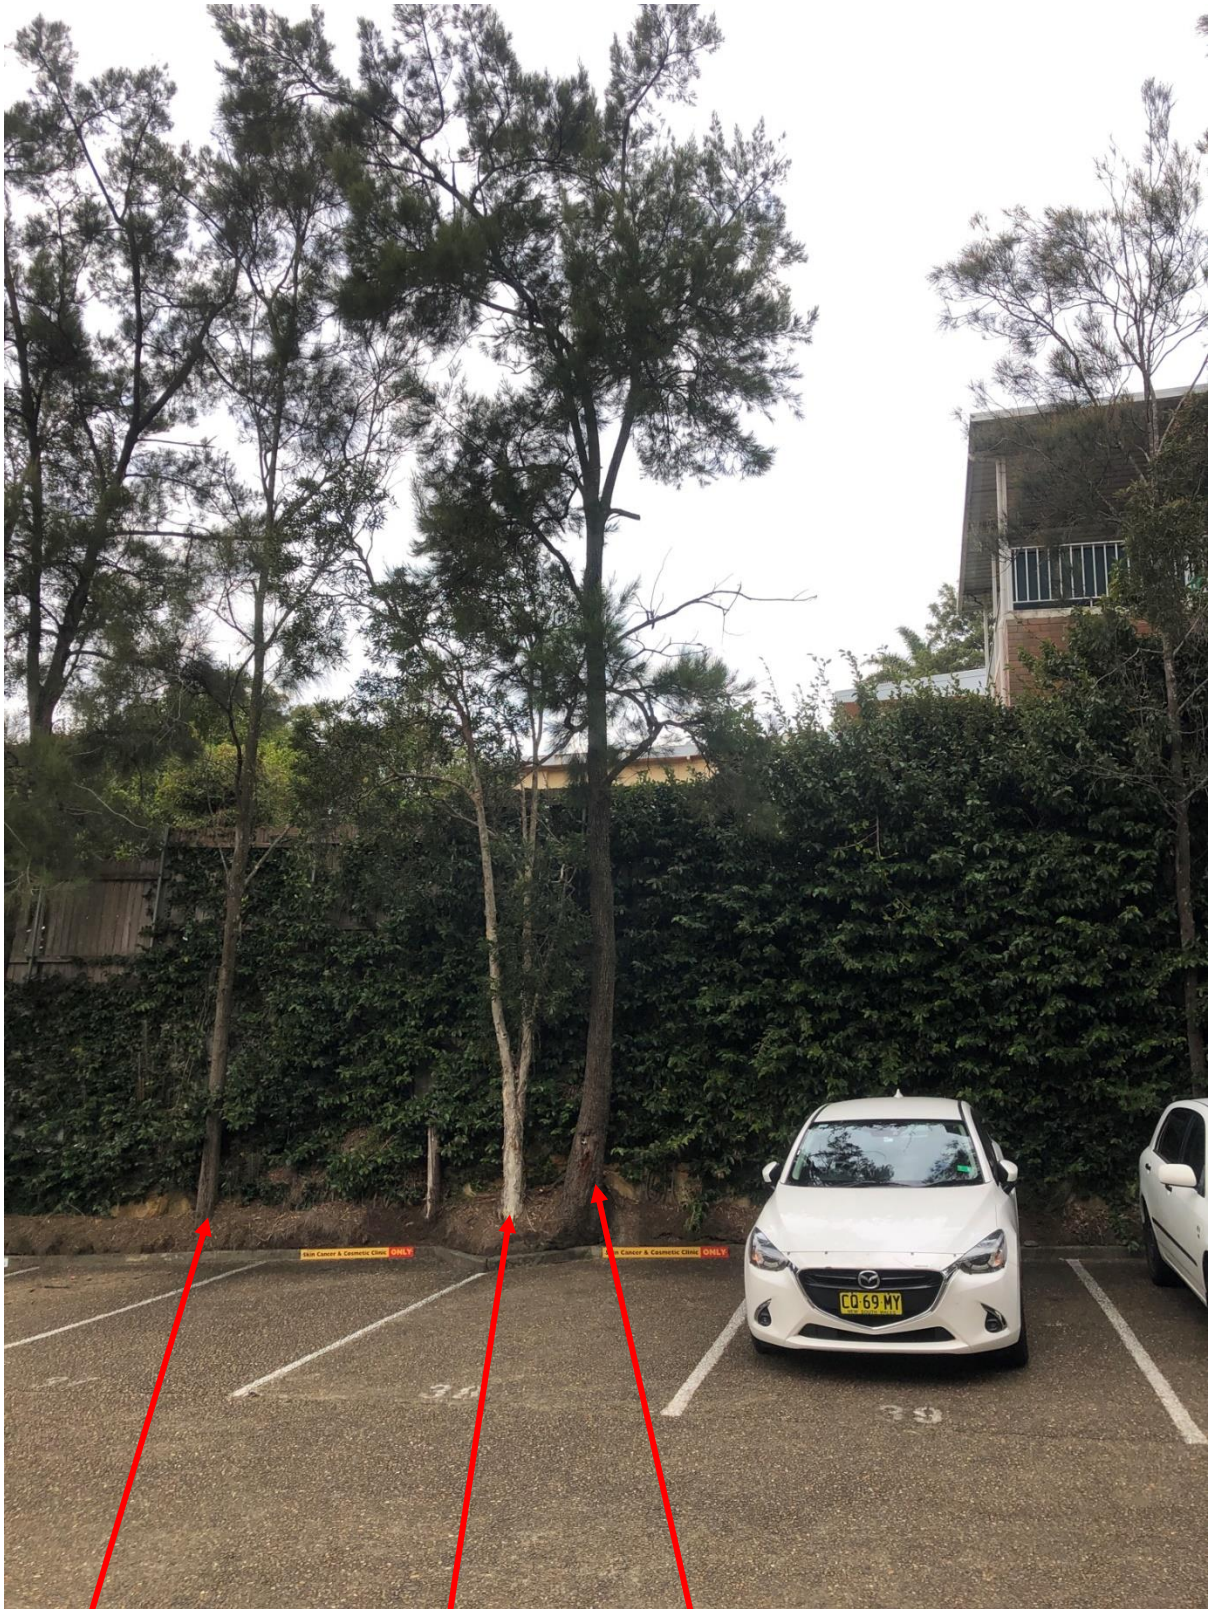
PHOTO 24

Tree 90 Casuarina

Tree 89 Melaleuca
