REPORT ON GEOTECHNICAL INVESTIGATION

PROPOSED ALTERATIONS AND ADDITIONS

52A CONSUL ROAD, BROOKVALE, NSW

Project No.: 2023-183

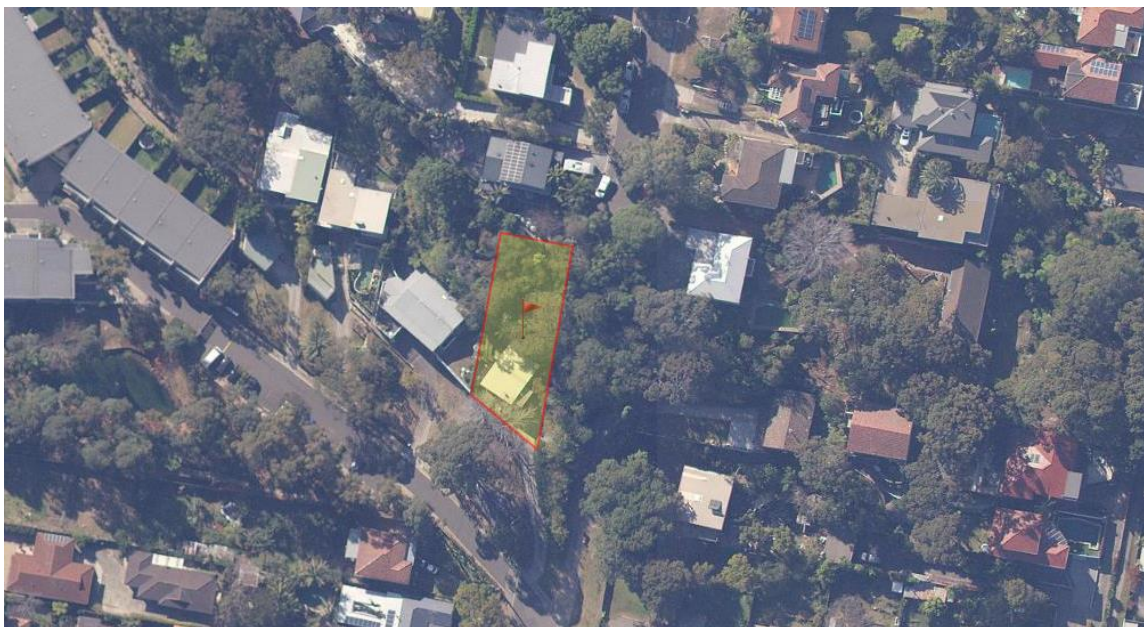
Photograph 1: Aerial site view and surrounds (NSW Government Six Map Spatial Data)

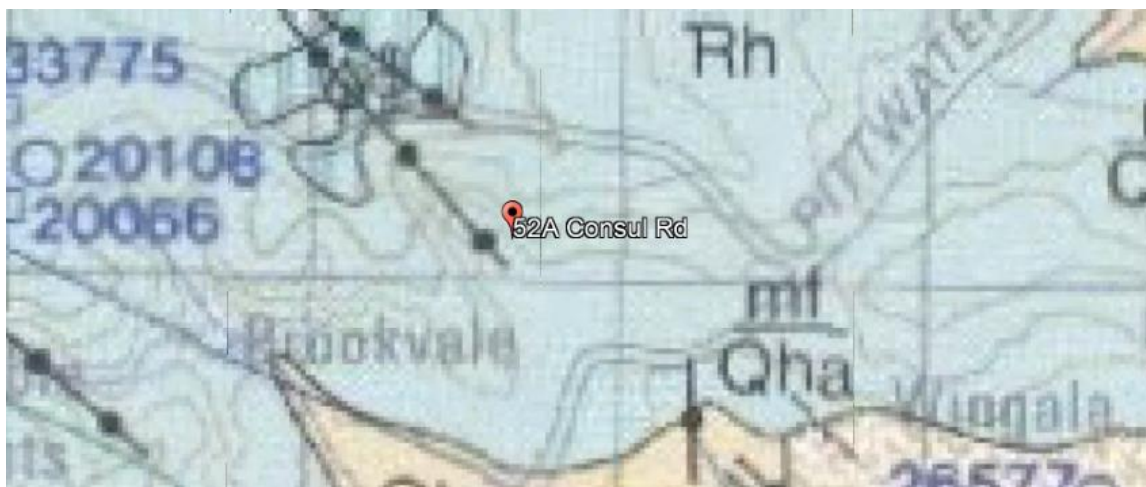
Reference to the Sydney 1:100,000 Geological Series sheet indicates that the site is underlain by Hawkesbury Sandstone which is of middle Triassic Age. The Hawkesbury Sandstone rock unit typically comprises of medium to coarse grained quartz sandstone with minor lenses of shale and laminate. Morphological features often associated with the weathering of Hawkesbury Sandstone are the formation of near flat ridge tops with steep angular side slopes that consist of sandstone terraces and cliffs in part covered with sandy colluvium.

Extract of Sydney (9130 Geological Series Map): 1: 100,000 – Geology underlying the site
