Arboriculture Construction Impact & Management Statement

August 2022

Site:	Lot 8 in DP 14630 103 Bynya Road PALM BEACH, NSW
Client:	Mark Eggers & Leanne Peterson
	c/- Rachel Hudson Architect
	Attention: Rachel Hudson
X	Email: rachel@rachelhudson.com.au
Author:	Kyle A Hill
14 6 3	Registered (Arb Aus #1884) Practising & Consulting Arbor
	Post Graduate Certificate in Arboriculture, Uni of Melb
	Diploma of Horticulture-Arboriculture TAFE, Grow SA
	Certificate of Horticulture, TAFE
	Certificate Advanced Tree Care TAFE
	Founder -Growing My Way Tree Services (1977)
	Member of International Society of Arboriculture
	Member of Arboriculture Australia

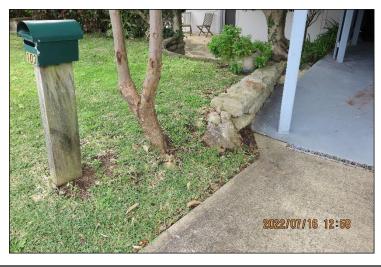
Figure 6: Above confirms the location of Tree #2. Below confirms the location of Tree #3.

Tree #3: This tree is confirmed to be a NBC protected species. It is assessed as NOT able to be viably retained by implementation of standard AS4970-2009 *guideline provisions*. On this basis, we support it to be removed & replaced. Tree removal must only be undertaken by persons familiar with & able to abide by the *WorkSafe* (*WorkCover*) *Amenity Tree Industry* 'Code of practice', 1998.
