GEOTECHNICAL INVESTIGATION:

New Spa at **39 Seaforth Crescent, Seaforth**

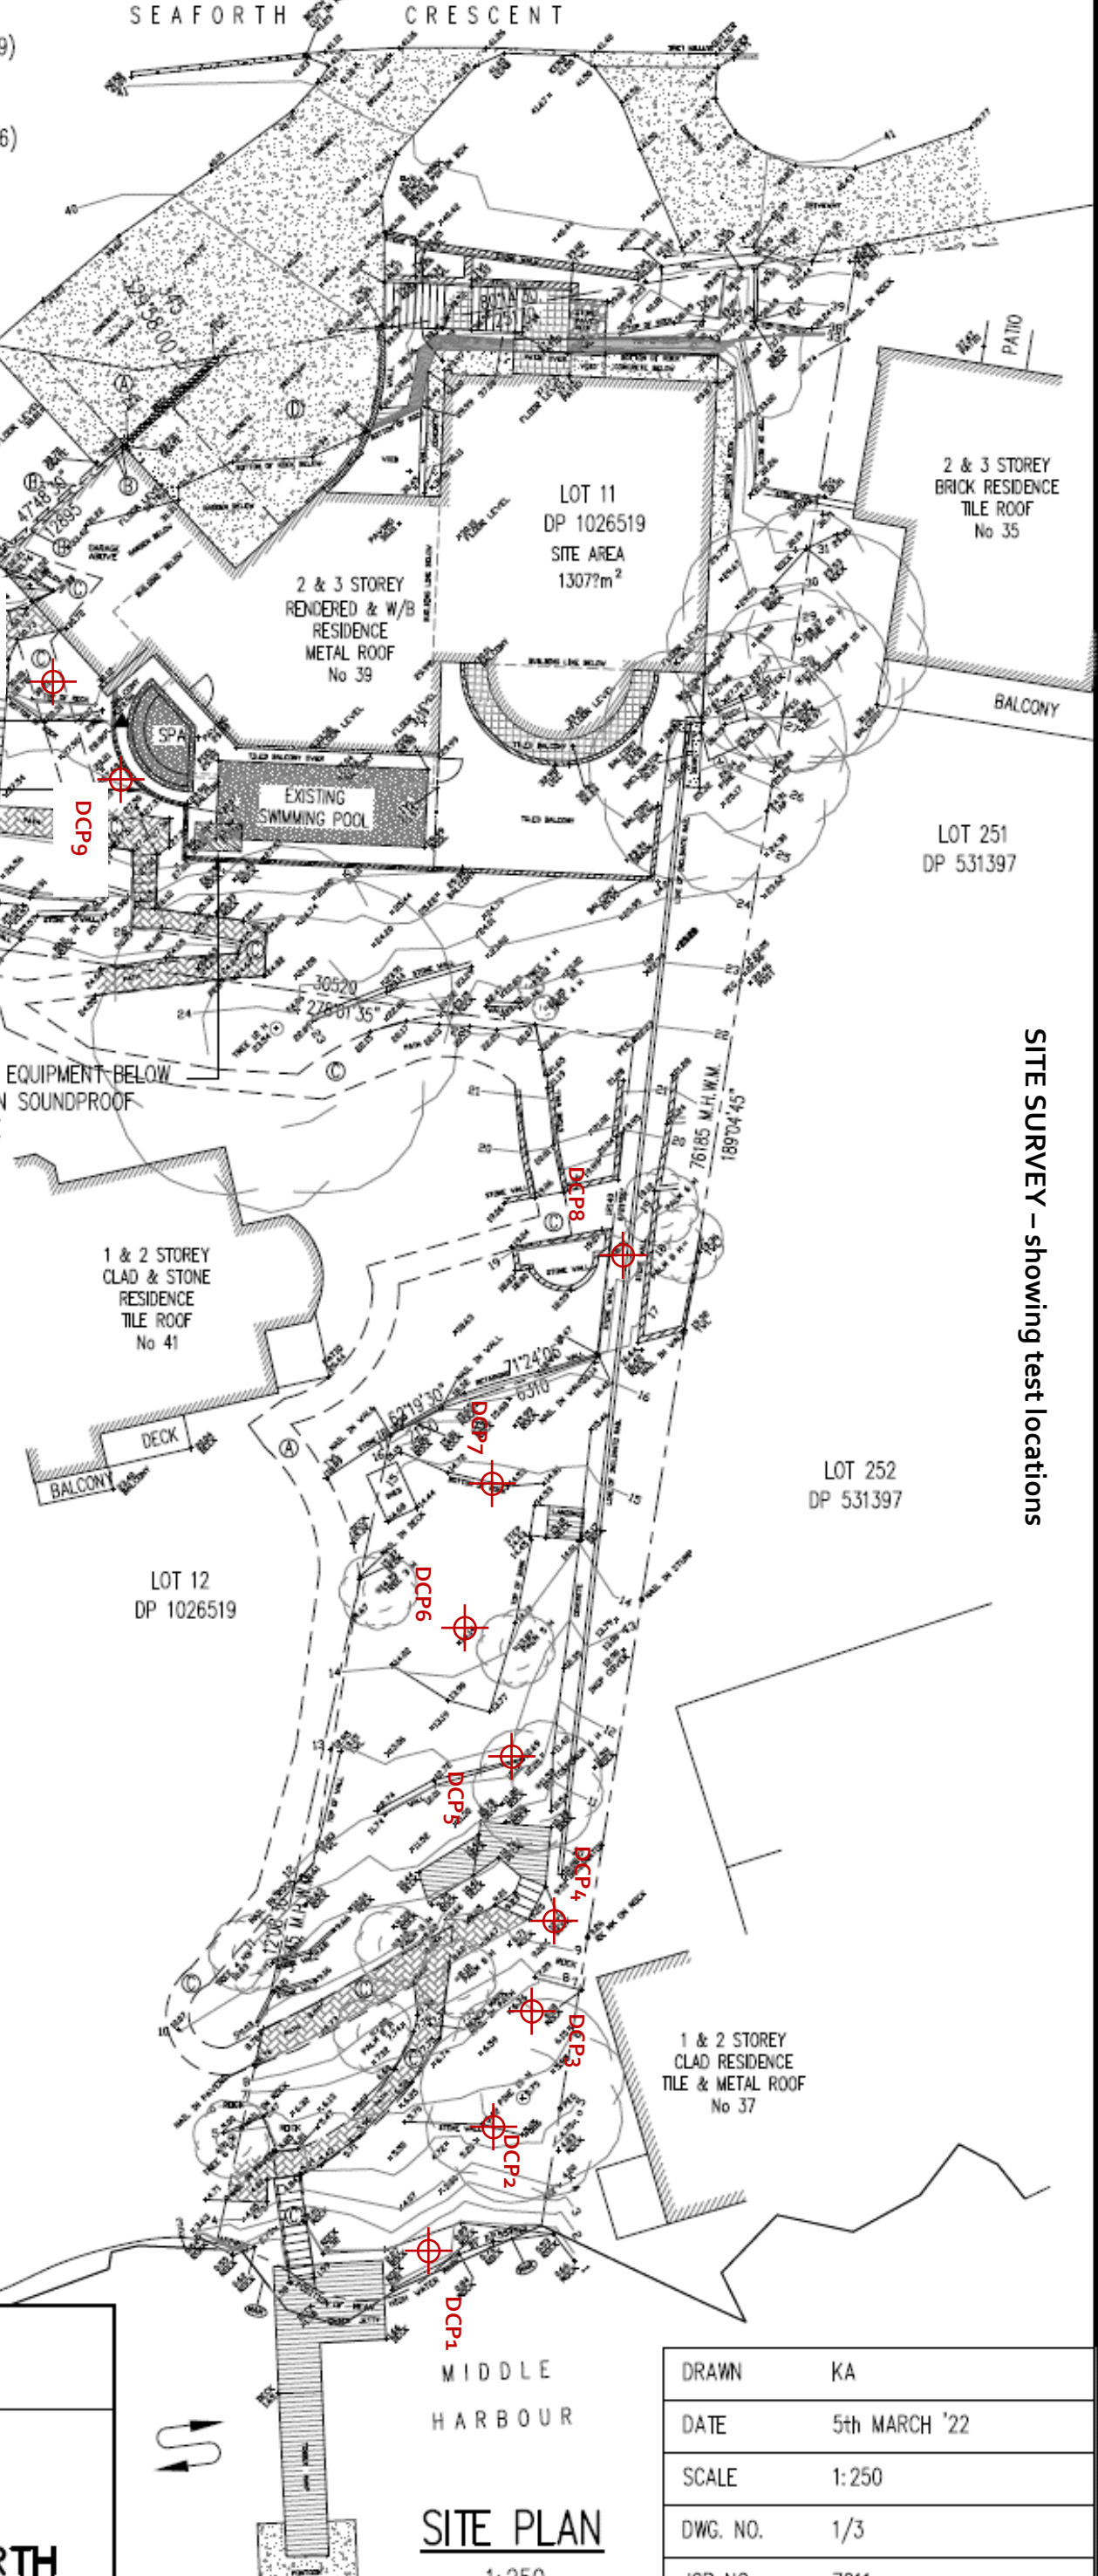
SITE SURVEY – showing test locations

DCP1 – Rock exposed at surface.

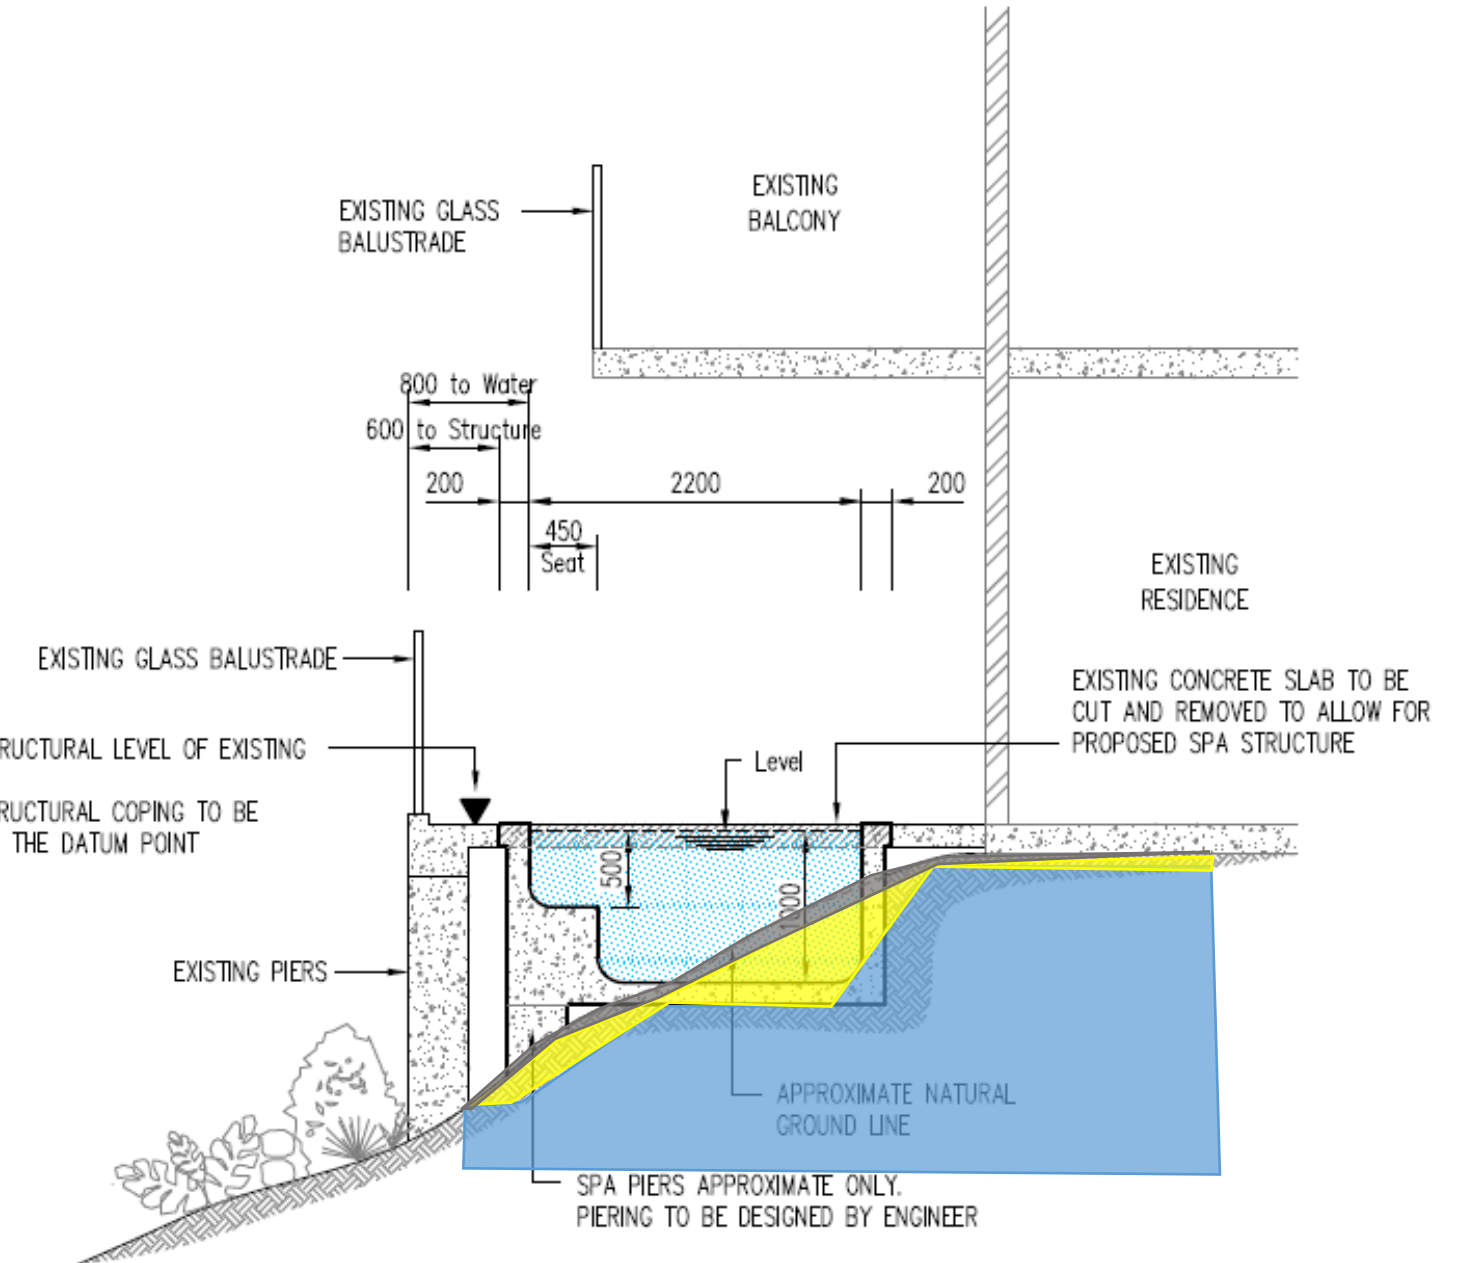
SECTION A – A

Expected Ground Materials

- Fill
- Topsoil
- Clay – Firm to Stiff
- Hawkesbury Sandstone – Medium Strength

Due to the steep grade of the slope below the location of the proposed spa, piers potted at least ~0.3m into Medium Strength Sandstone are suitable footings for the proposed works. Alternatively, suitable rebar can be grouted / epoxied ~0.3m into a level rock surface to fix the foundation to the rock. Where this material is not exposed, it is expected at depths of between ~0.3 and ~0.9m below the current surface.
