Email majbruce@hotmail.com ARBORICULTURAL IMPACT ASSESSMENT OF A TREE LOCATED ON 47 ARTHUR STREET, FORESTVILLE

Malcolm Bruce

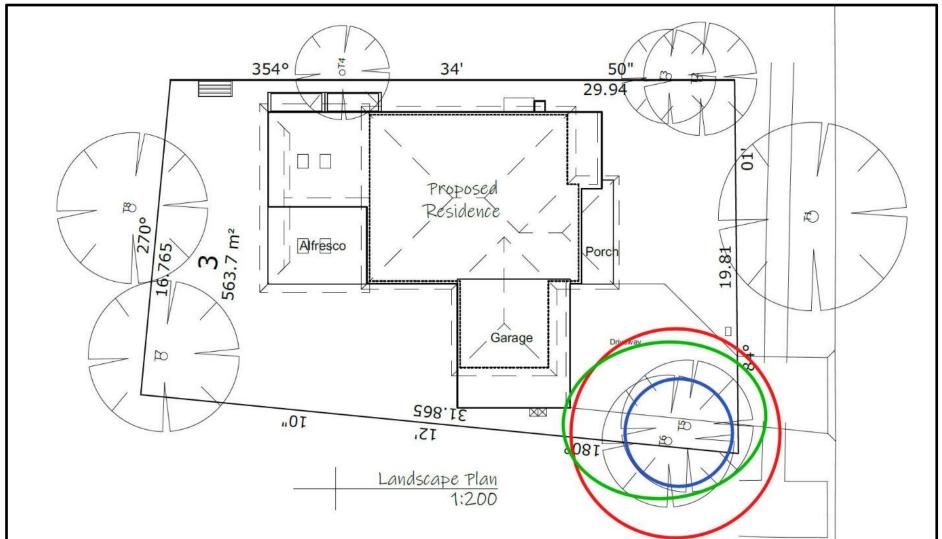
Figure 3: Position of the trees with calculated Tree Protection Zones outlined in red, the calculated Structural Root Zones outlined in blue and the Crown Limits in green. Scale 1:200. From Landscape Plan of 47 Arthur Street, Forestville by Accurate Design and Drafting, dated 3/5//2022

The subject tree is labelled as Trees 5 and 6 in the Landscape Plan (See Figure 3). Trees 5 and 6 are actually a single highly coppiced *Tristaniopsis laurina* (Water Gum). (See Figure 5) The tree has formed as a multi-trunked form as a result of removal of the original stem or damage to the base of the original stem. (See Figure 6) There is some indication of damage to the base of the original stem, resulting in the coppicing as well as signs of decay in the lower trunk. The close growth of the trunks has resulted in the formation of several bark inclusions, which Mattheck (2007) P.131, describes as a "low-level compression fork. (See Figure 7) This formation has a high chance of failure. Several bark inclusions have formed in the crown. Several of these have formed as longitudinal cracks. (See Figure 8 to Figure 10) Formations with bark inclusions and longitudinal cracks have been described by Mattheck as potentially dangerous (Mattheck and

- 6.1 Trees 5/6 should be removed;
- 6.2 Removed trees must be replaced. The replacement trees should be locally endemic species from the Gymea soil landscape, such as, *Angophora costata* and *Banksia serratifolia*, and grown as specified in AS 2303 of 2015 *Tree stock for landscape use* (Standards Australia, 2015), in 20 litre containers and between 1 and 2 metres in height.
