Interim Occupation Certificate

Certificate No 2007/2412A

FINAL CONDITIONS REPORT

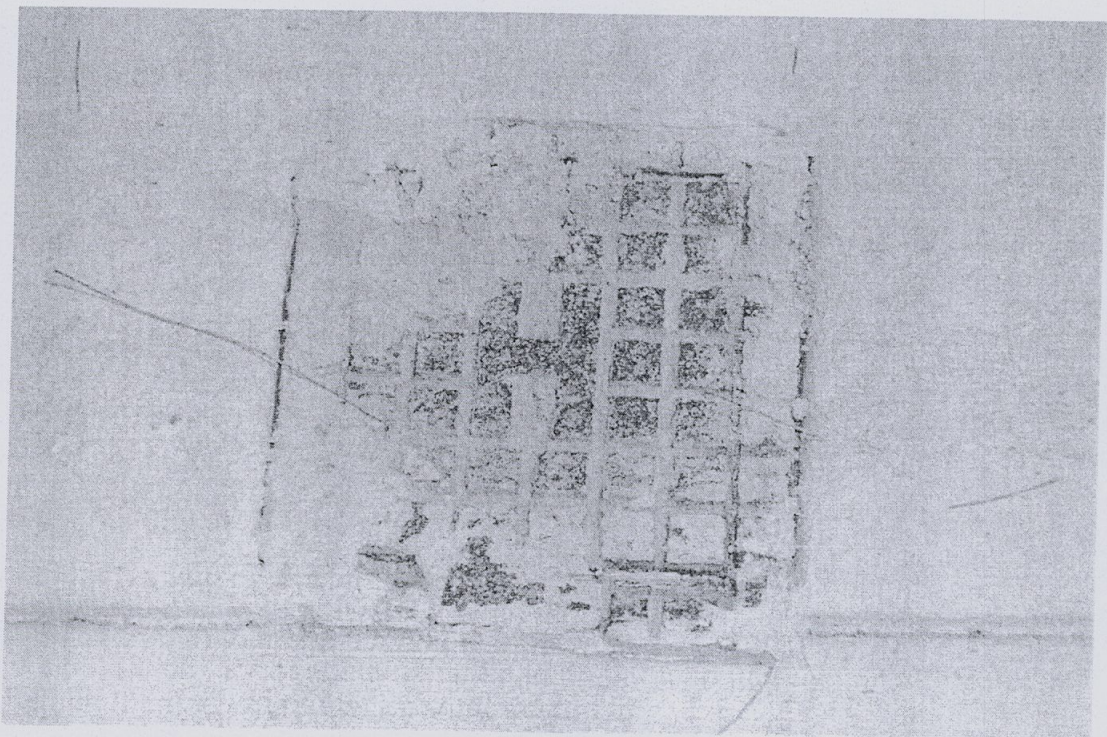
DSC_0047.JPG

Bayview Golf Club. Adjacent public property. Pittwater Road. Facing north-west along Pittwater Road between power poles no. MV2746 & MV2745. Area compares to photo DSC_0062 from the original report. Noting the previous hydrant valve in the new concrete paved footpath. Noting the concrete on the valve lid.

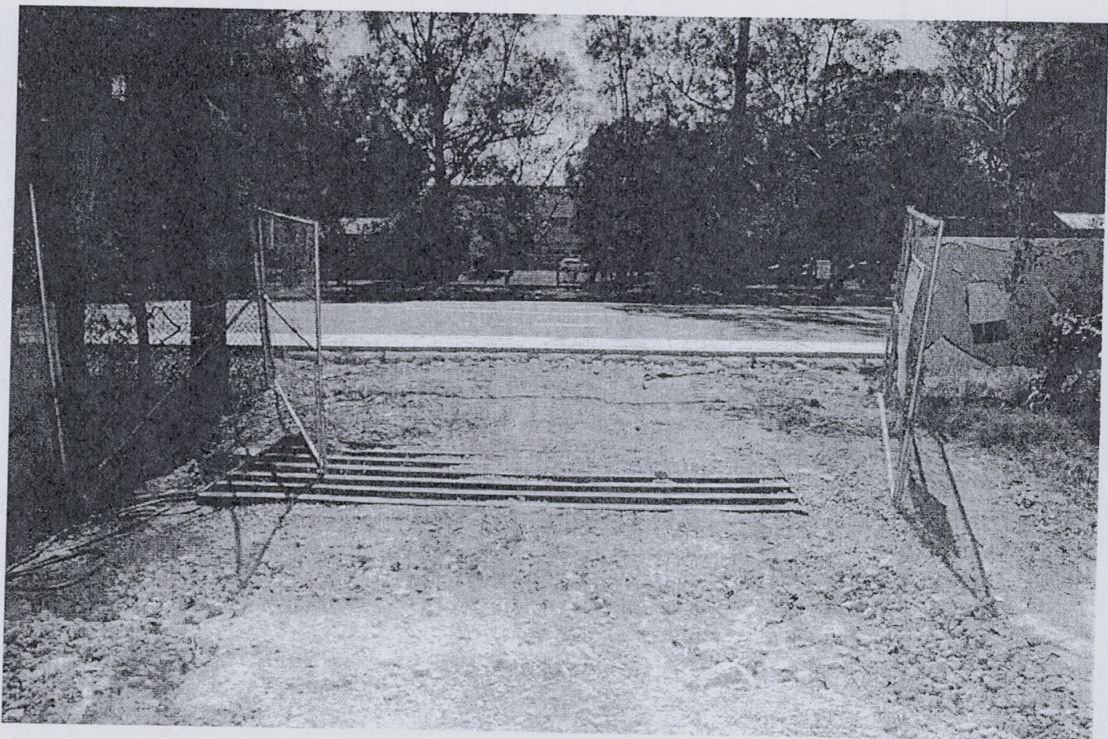
DSC_0049.JPG

Bayview Golf Club. Adjacent public property. Pittwater Road. Facing west from the site to the temporary cross-over to Pittwater Road.

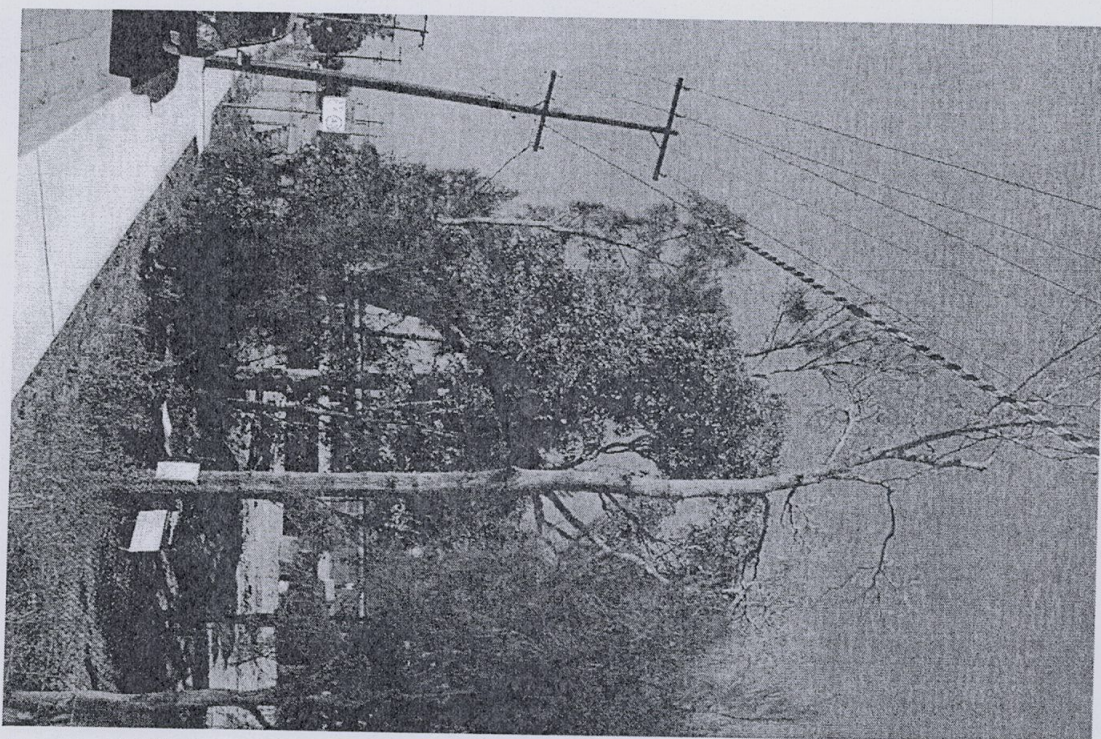
DSC_0050.JPG

Bayview Golf Club. Area to the north of the site of the proposed golf club. Trees along the boundary between the golf course and Pittwater Road. Area adjacent to power pole no. MV2746. Area compares to photo DSC_0125 from the original report dated 28.11.07. Dead tree in the foreground. —>

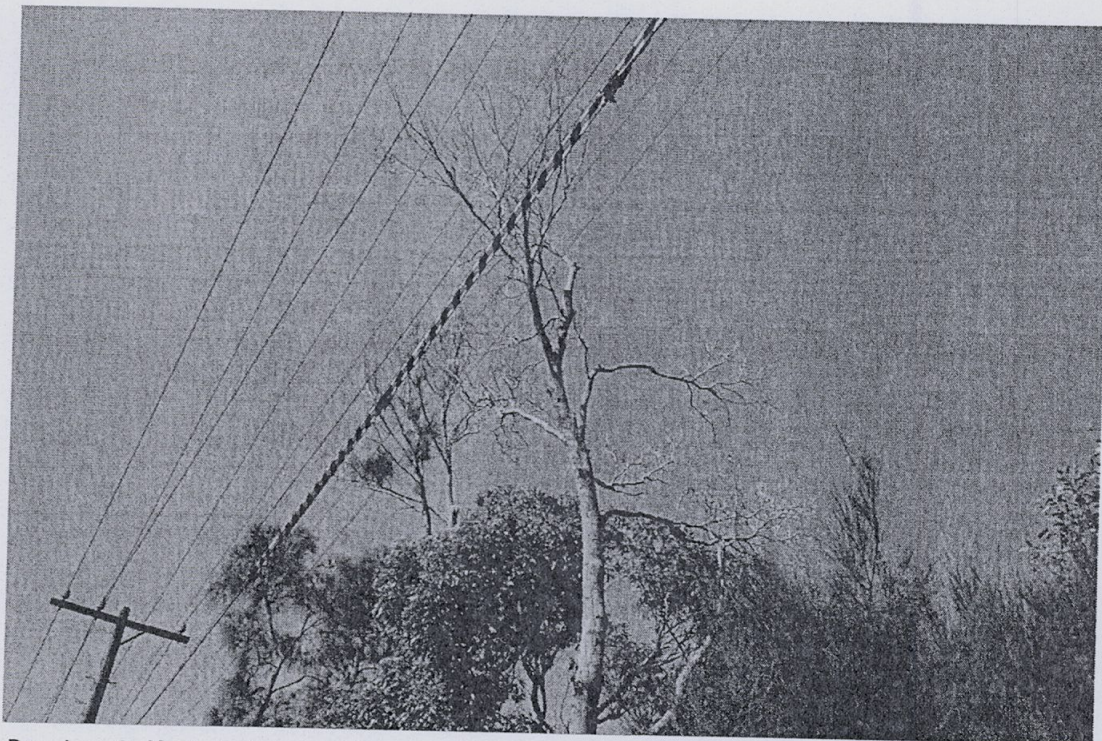
DSC_0051.JPG

Bayview Golf Club. Area to the north of the site of the proposed golf club. Trees along the boundary between the golf course and Pittwater Road. Area adjacent to power pole no. MV2746. Area compares to photo DSC_0125 from the original report dated 28.11.07. Dead tree in the foreground.

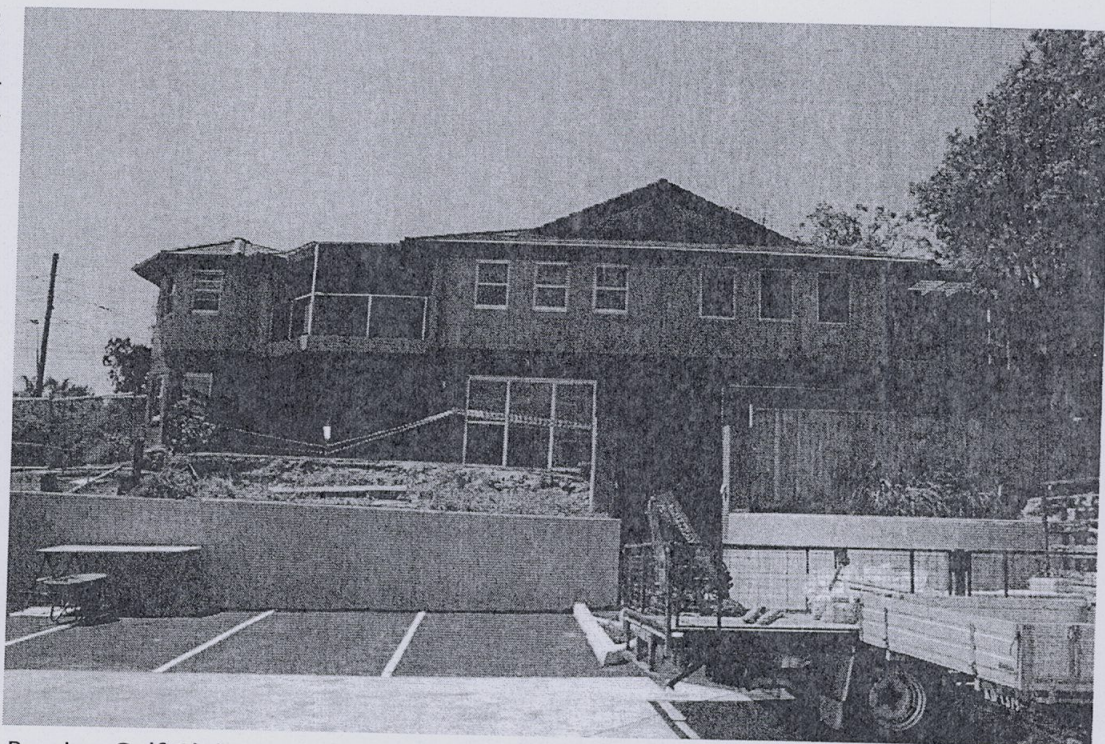
DSC_0053.JPG

Bayview Golf Club. Facing south from the site of the new golf club to the north-western elevation of the newly completed development to the south of the site.

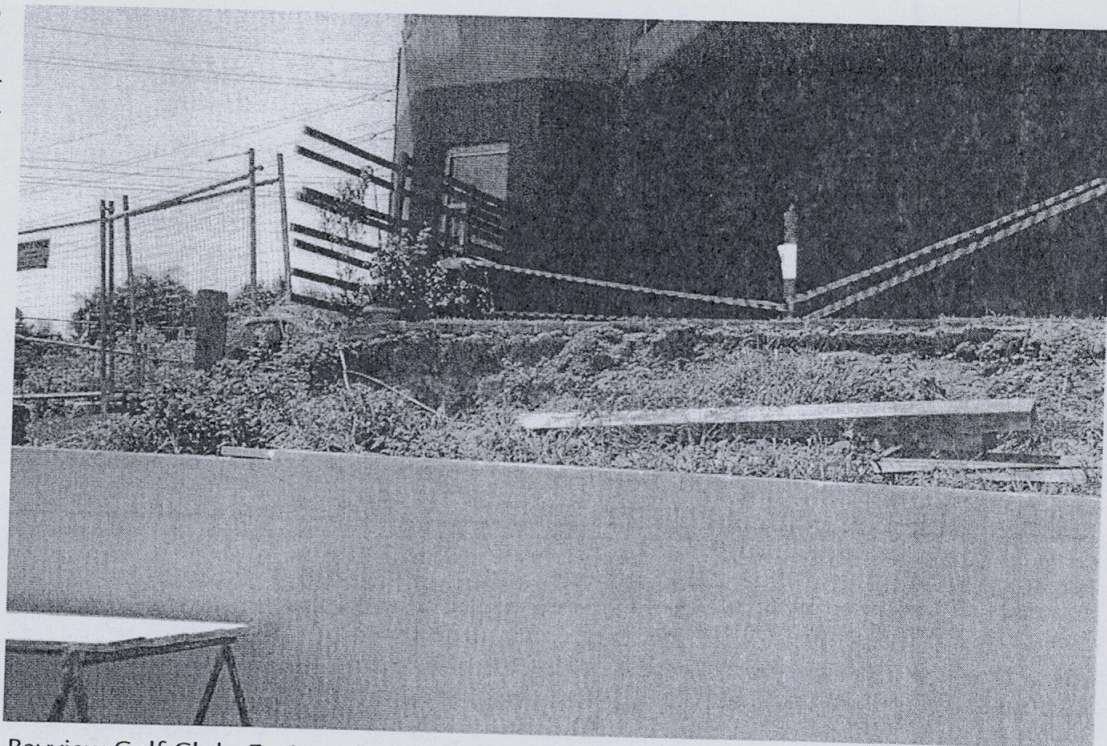
DSC_0054.JPG

Bayview Golf Club. Facing south from the site of the new golf club to the north-western elevation of the newly completed development to the south of the site. Detail of the area seen in photo DSC_0053. Noting the unretained bank above the retaining wall.

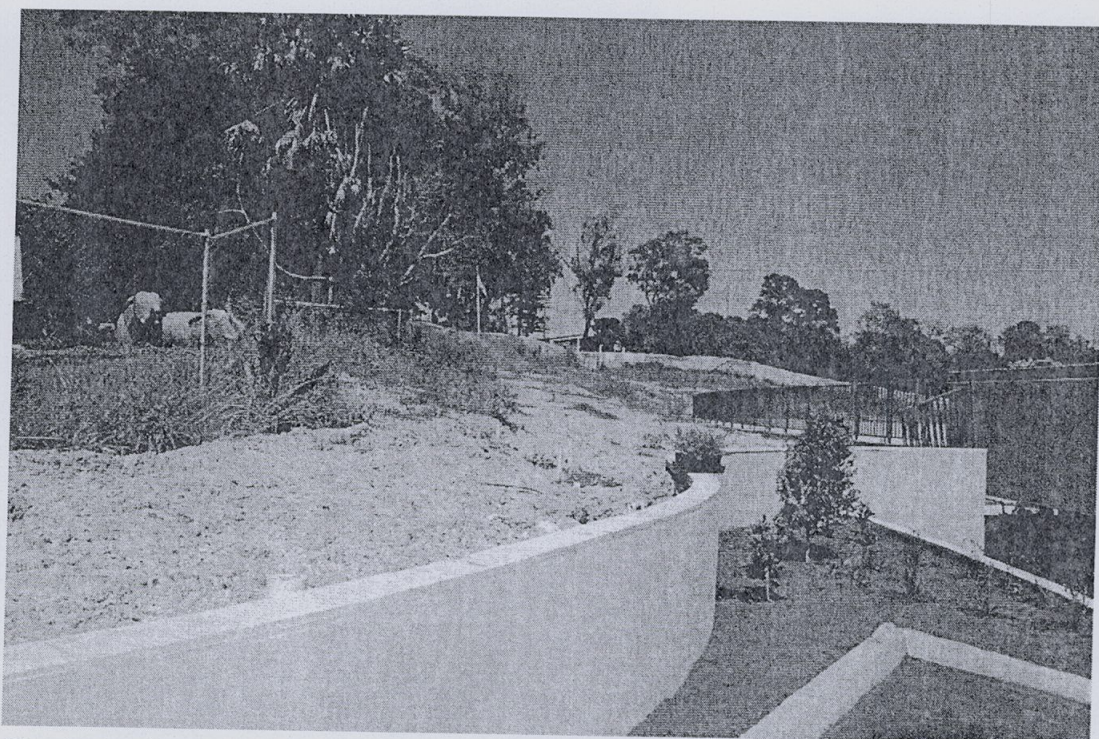
DSC_0058.JPG

Bayview Golf Club. Facing south-west to the southern side of the site of the new club house. Noting the slight raked bank above the retaining wall.

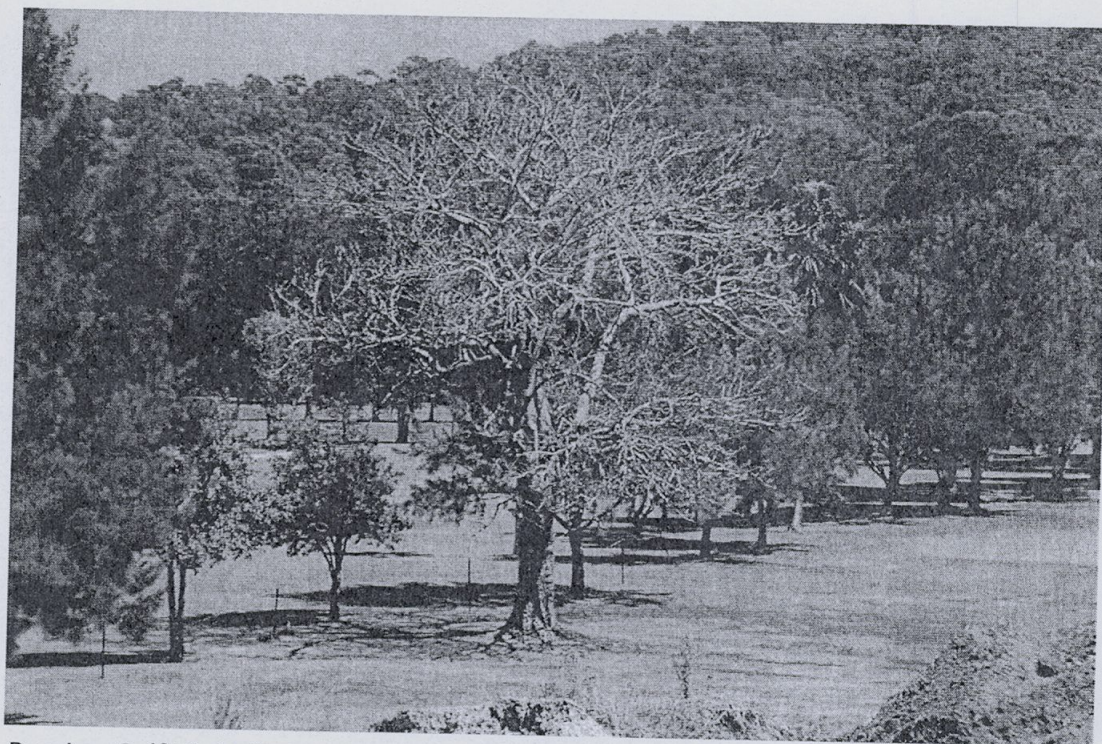
DSC_0060.JPG

Bayview Golf Club. Facing north-west to the golf course to the north-west of the site of the new club house. Noting the dead tree between the fairways.

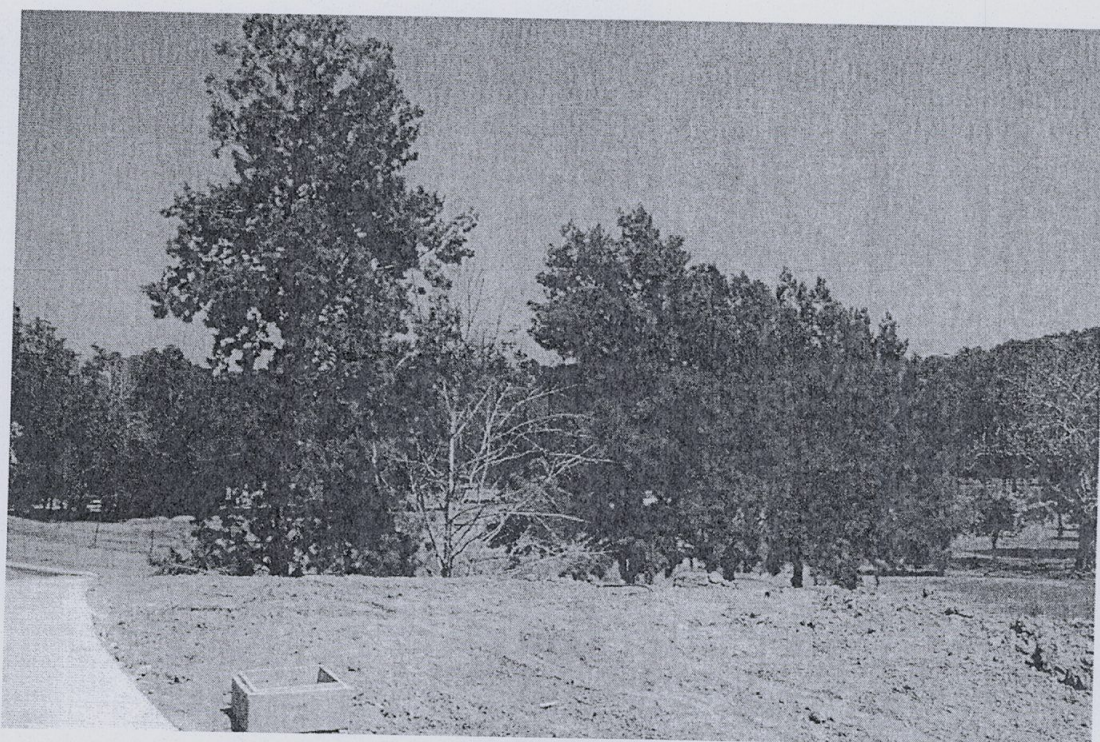
DSC_0061.JPG

Bayview Golf Club. Facing west to the golf course to the north-west of the site of the new club house. Noting the dead tree between the fairways.

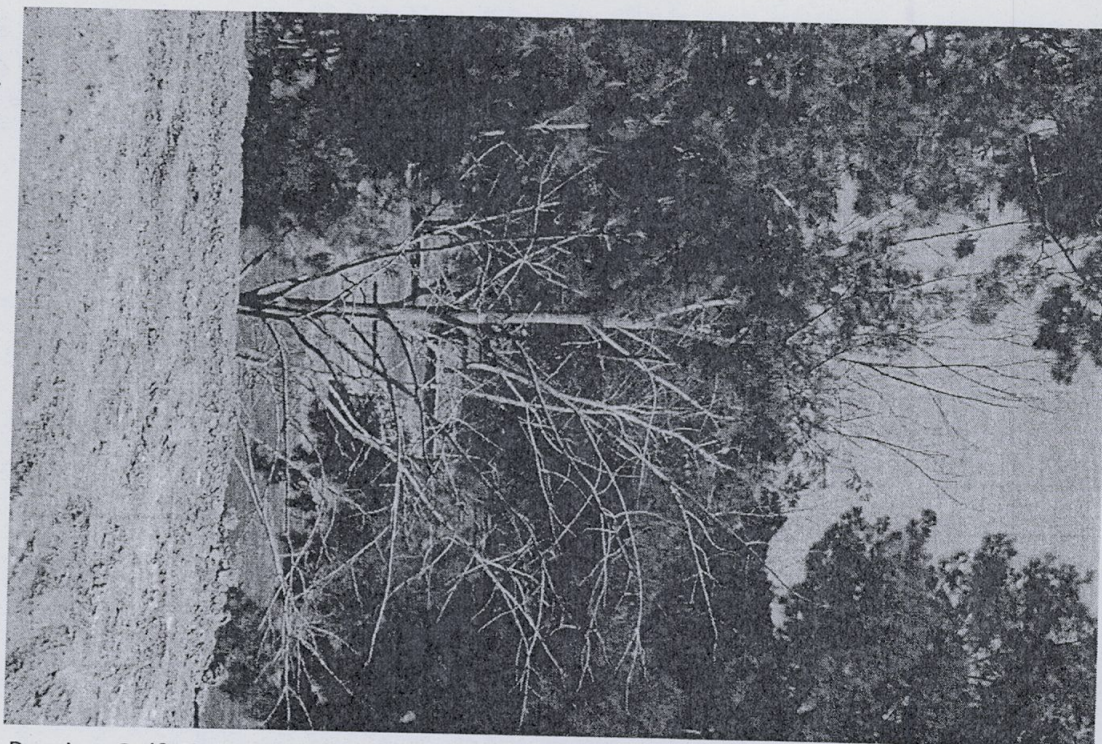
DSC_0062.JPG

Bayview Golf Club. Facing north-east to the golf course to the north-west of the site of the new club house. Noting the dead tree between the fairways. Detail of the area seen in photo DSC_0061. —>

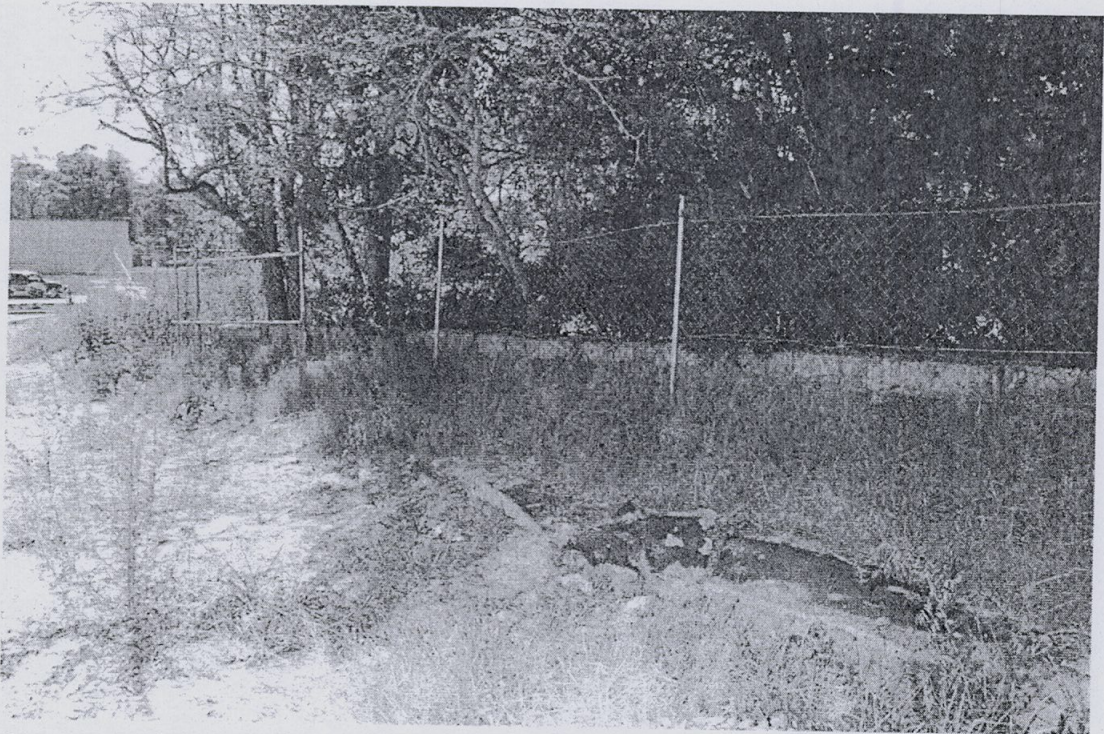
DSC_0065.JPG

Bayview Golf Club. Facing south-east along the bank to the south of the new club house. Area of the sandstone wall (seen behind the temporary fencing).

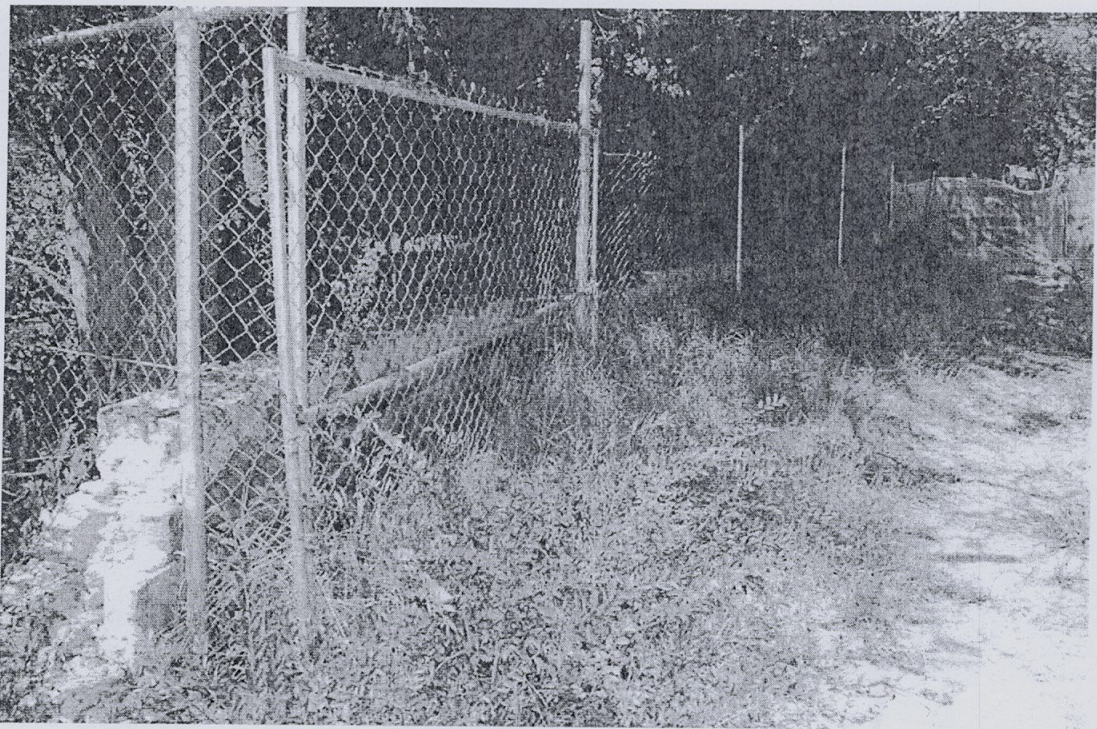
DSC_0066.JPG

Bayview Golf Club. Facing south-west along the bank to the south of the new club house. Area of the sandstone wall (seen behind the temporary fencing).

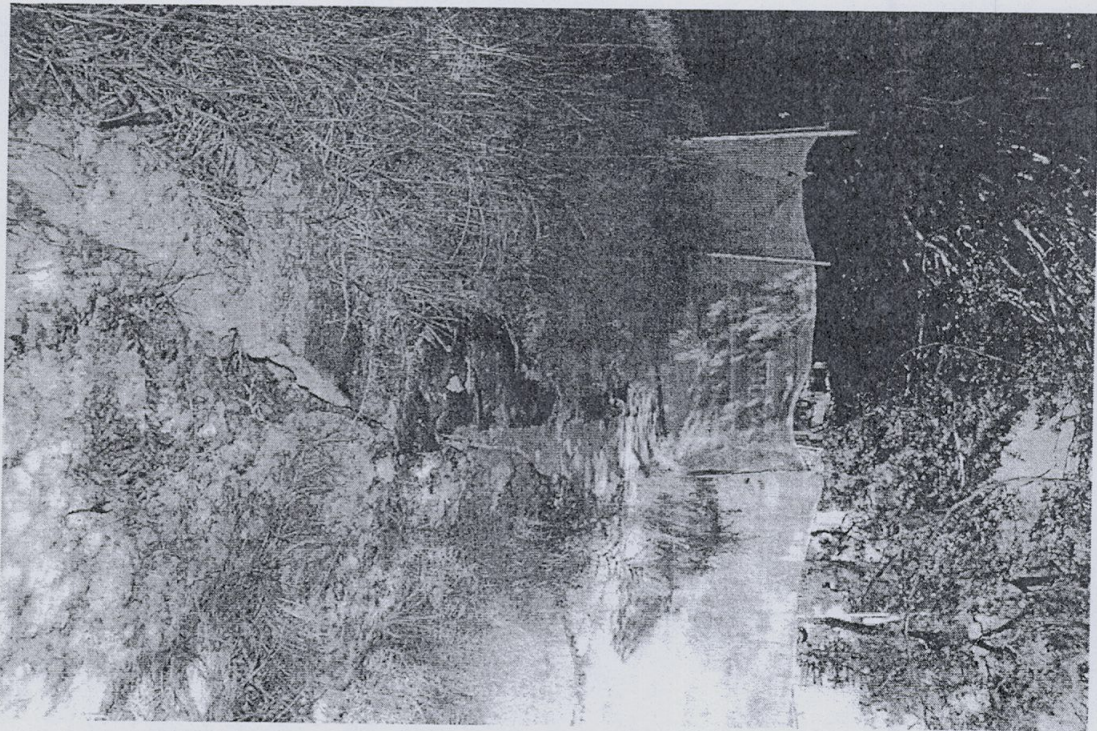
DSC_0067.JPG

Bayview Golf Club. Facing south-west along the bank to the south of the new club house. Remnants on the concrete path to the north of the sandstone wall (seen behind the temporary fencing). —>

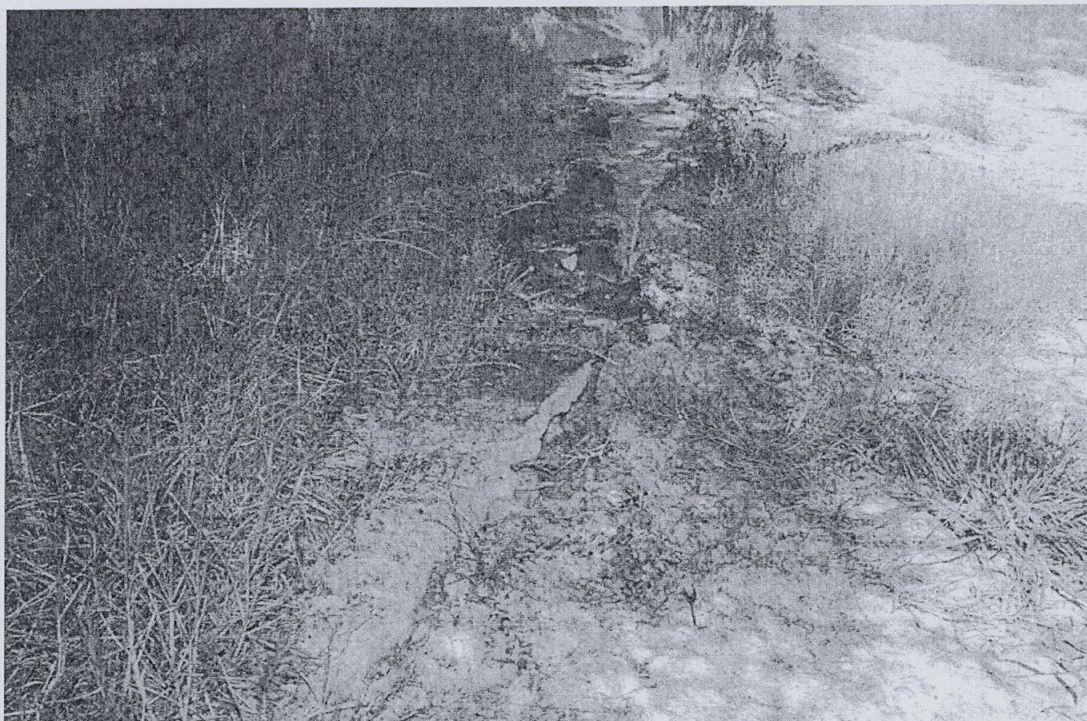
DSC_0068.JPG

Bayview Golf Club. Facing south-west along the bank to the south of the new club house. Remnants on the concrete path to the north of the sandstone wall (seen behind the temporary fencing). Detail of the area seen in photo DSC_0067.
