REPORT

316 Hudson Parade, Clareville Upgraded Boatshed Works Coastal and Marine Damages Assessment

Client: Mr Tony Walls Reference: PA1959MARP1901310938 Status: P02.01/Final

Date: 31 January 2019

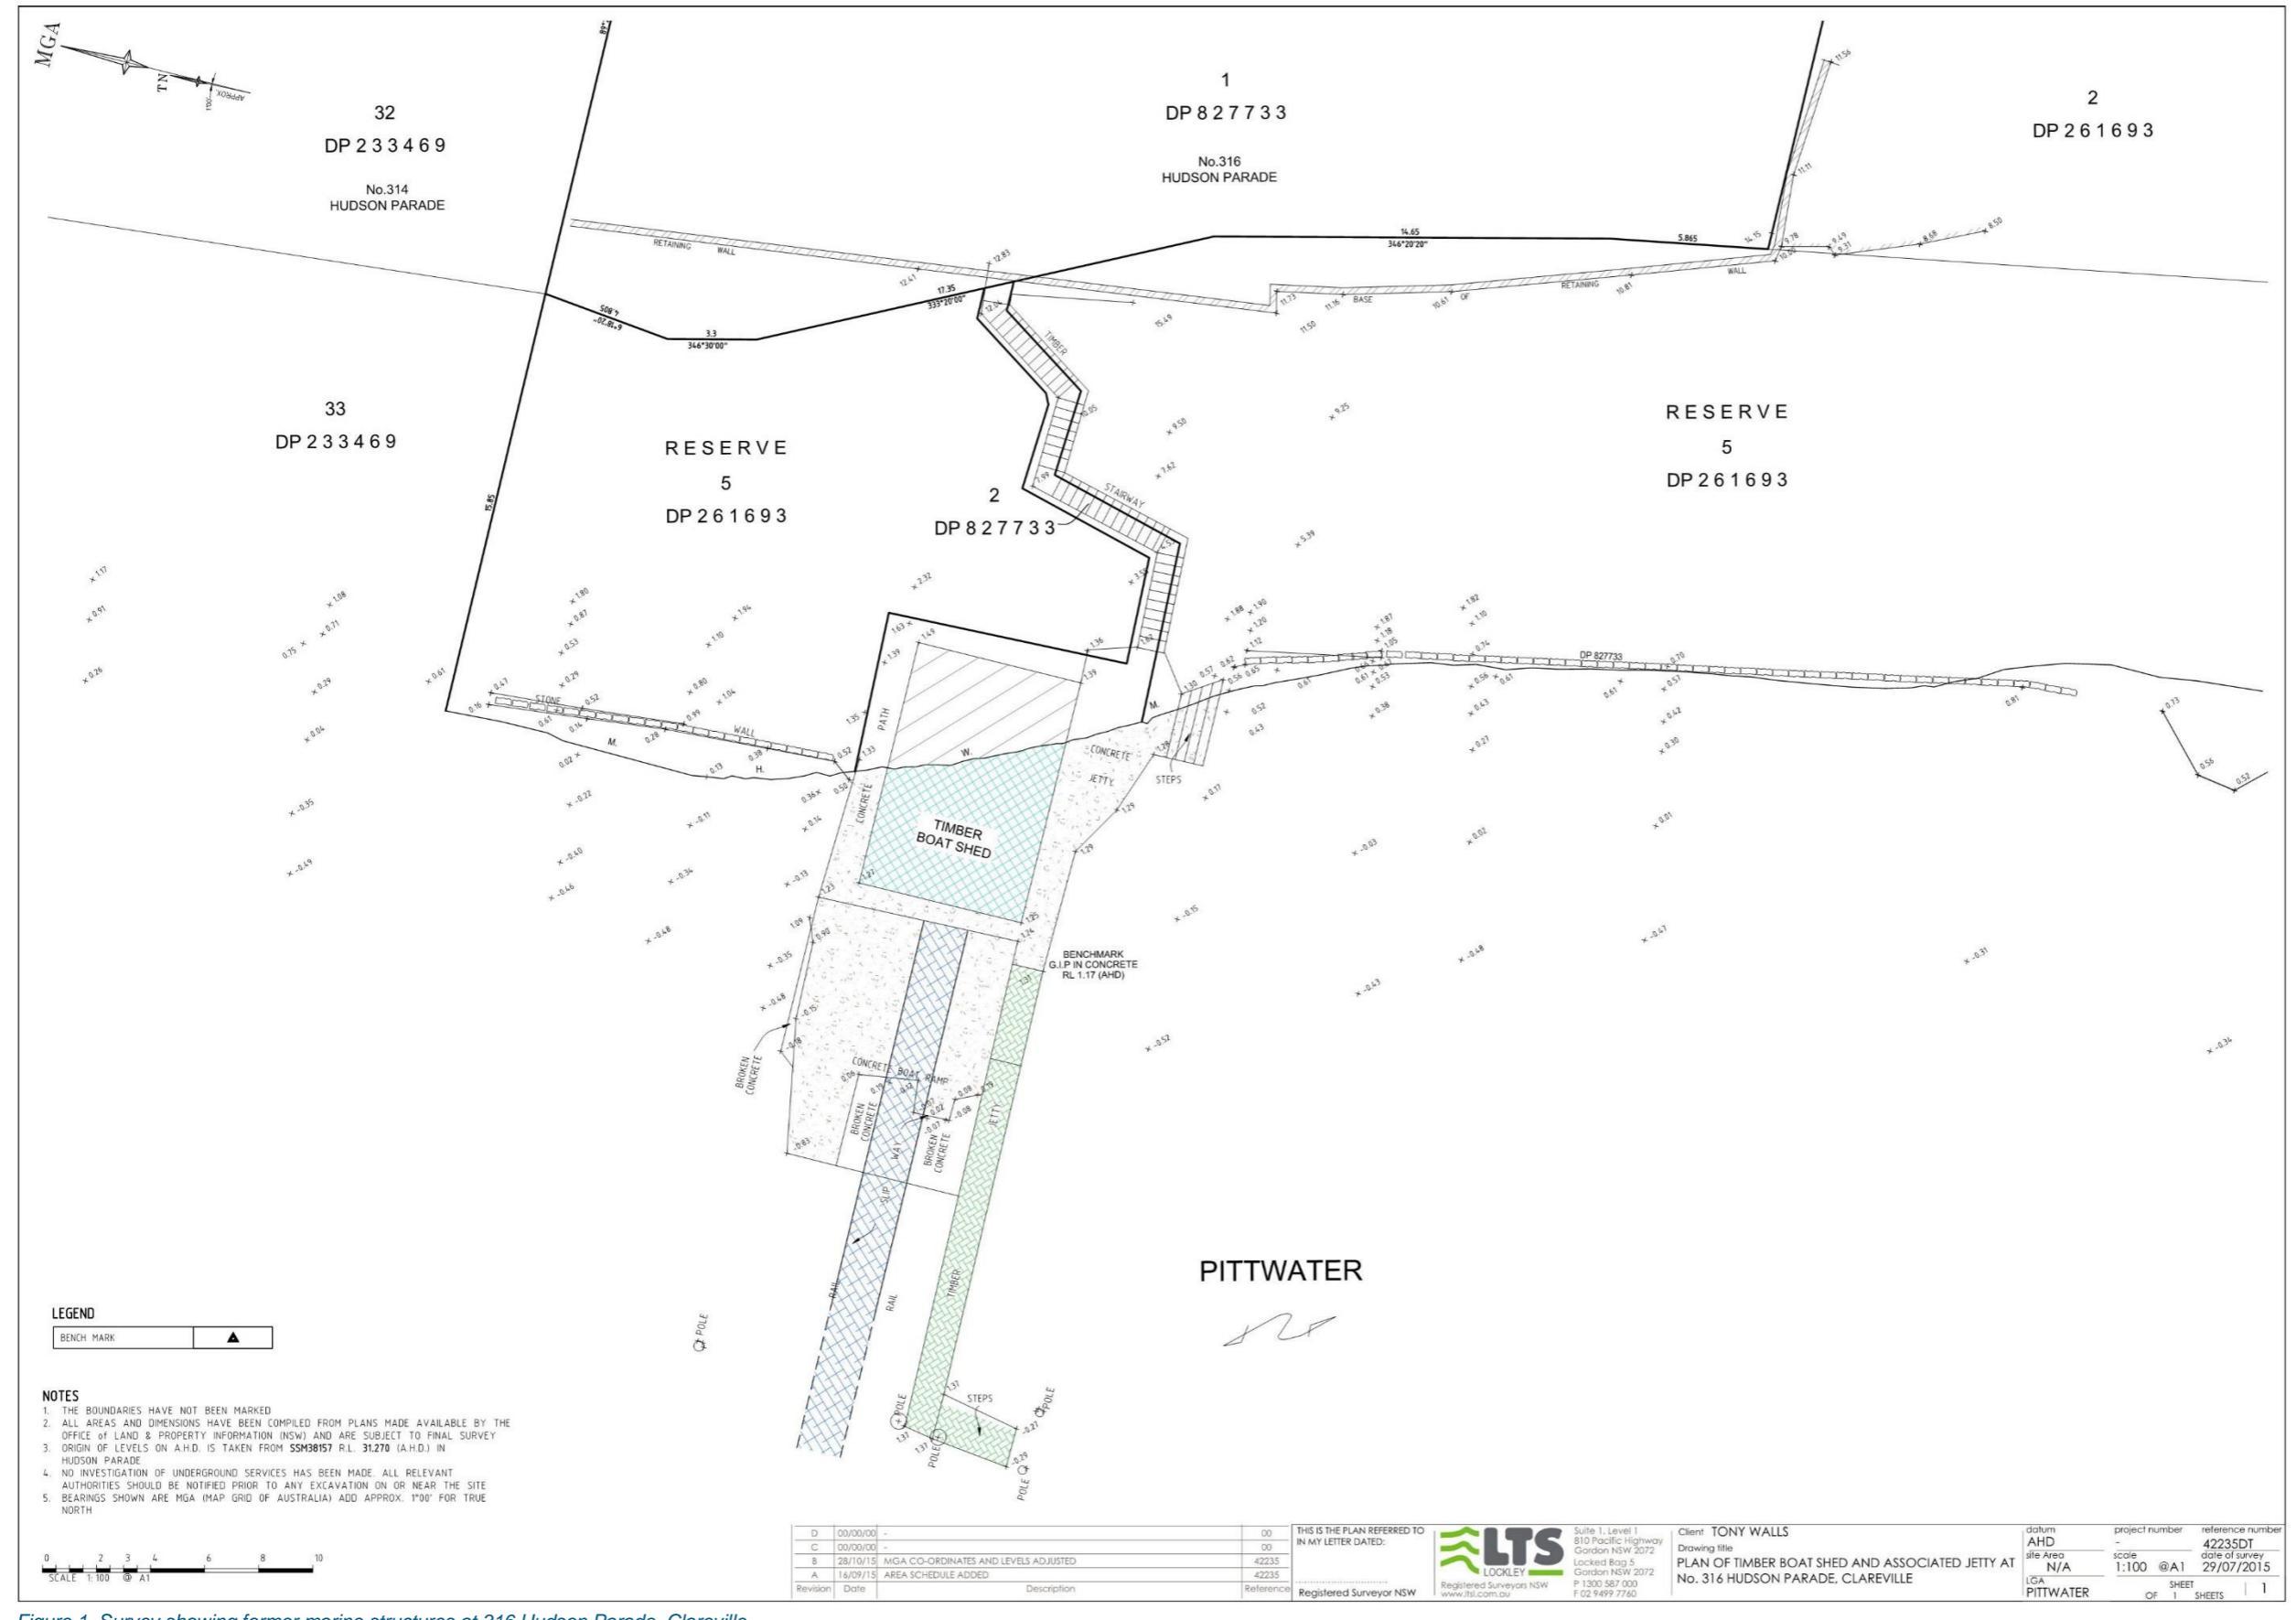
Figure 1 Survey showing former marine structures at 316 Hudson Parade, Clareville

In November 2016 a Complying Development Certificate (CDC) was issued by Anthony Protas Consulting Pty Ltd for *"Repairs and restoration of existing marine structures"* at 316 Hudson Parade, Clareville. The works relate to the reconstruction of a boatshed, concrete jetty, ramp, slipway, timber jetty, piles and timber steps. DPI Crown Lands had previously provided Land Owners Consent to make the CDC. A modified CDC was subsequently issued to cover a varied roof form at the boatshed. Works have recently commenced on the site including demolition of former marine structures, and construction of foundation walls surrounding the former boatshed. A survey by LTS Lockley Registered Surveyors dated 29/7/15 showing the former marine structures is presented in **Figure 1**, the approved CDC dated 24/5/17 is shown in **Figure 2**.
