Report Title: Geotechnical Report 155 Pacific Road, Palm Beach
Report Date: 26/11/21

GEOTECHNICAL INVESTIGATION:

Alterations and Additions and New Pool and Studio at **155 Pacific Road, Palm Beach**

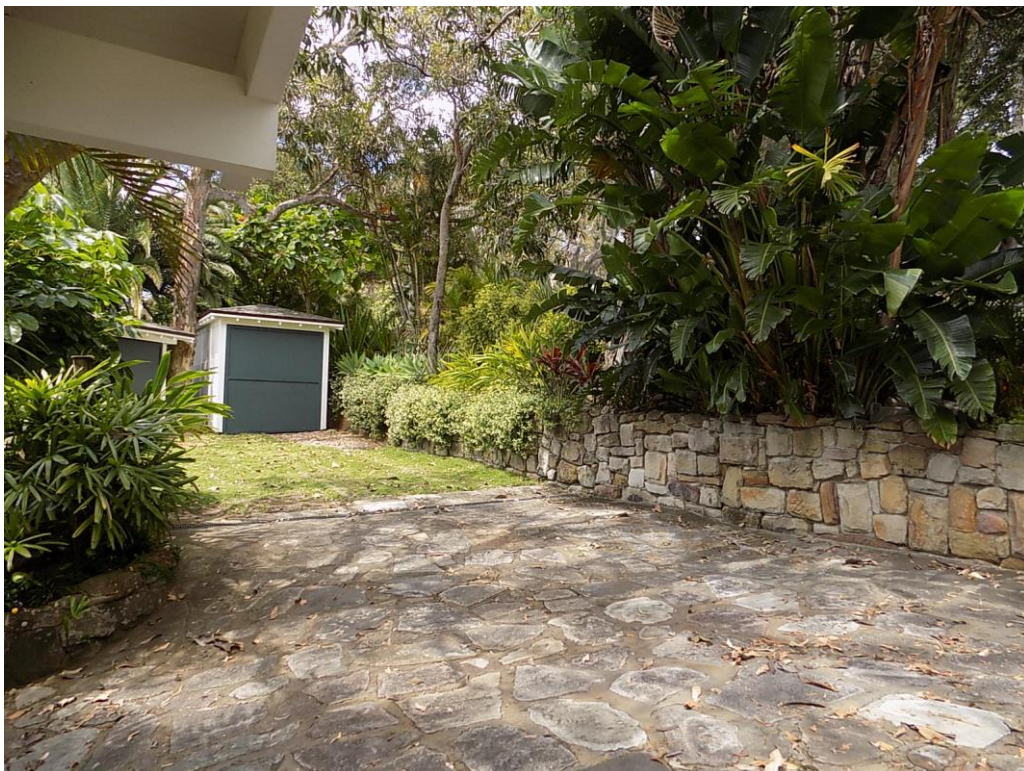
Photo 1

2.3 At the road frontage to Pacific Road, a concrete driveway runs down the slope to a carport and continues to two garages in the SW corner of the property (Photo 1). Between the road frontage and the house is a stable, $\sim 1.0\text{m}$ high sandstone block retaining wall that supports a cut to create a level lawn area (Photo 2). The cut has been partially made through outcropping competent Medium Strength Sandstone. A stable, $\sim 0.5\text{m}$ high sandstone block retaining wall supports the fill for the level lawn area above (Photo 3). The part three-storey timber clad house is supported on brick walls and brick piers. The external brick walls show no significant signs of movement. One of internal brick piers on the downhill side of the house appear to be askew to the bearer (Photo 4). Some of the walls and piers of the house were observed to be supported directly off outcropping Competent Medium Strength Sandstone (Photo 5). An inclined lift runs down the NW side of the property. A series of sandstone block retaining walls of varying heights between $\sim 0.3\text{m}$ and $\sim 1.8\text{m}$ terrace the slope immediately below the house to the NE common boundary. One of the sandstone block retaining walls has started to separate at the mortar due to root action of the palm tree above (Photo 6 & 7). See **Section 16** for advice regarding this wall. Competent Medium Strength Sandstone can be seen outcropping in various places and some of the walls are supported directly on this ground material. On the E corner of the property is a timber shed. The cut for the shed is supported by a concrete block and sandstone block retaining wall reaching up to $\sim 1.7\text{m}$ high. The shed and retaining wall are to be demolished as part of the proposed works. A $\sim 3.0\text{m}$ high sandstone rockface that falls to the neighbouring property on the NE common boundary is undercut to $\sim 1.0\text{m}$ (Photo 8 & 9). Given the thickness of the supporting cantilever arms with no visible defects, the undercut rock is considered to be stable. A moderately to
