# GEOTECHNICAL INVESTIGATION REPORT PROPOSED POOL HOUSE, SWIMMING POOL AND TERRACE 90 CABBAGE TREE ROAD, BAYVIEW, NEW SOUTH WALES MR ALEX JENKINS

MMGEO2021AJ\_AA REVISION A
AUGUST 2021

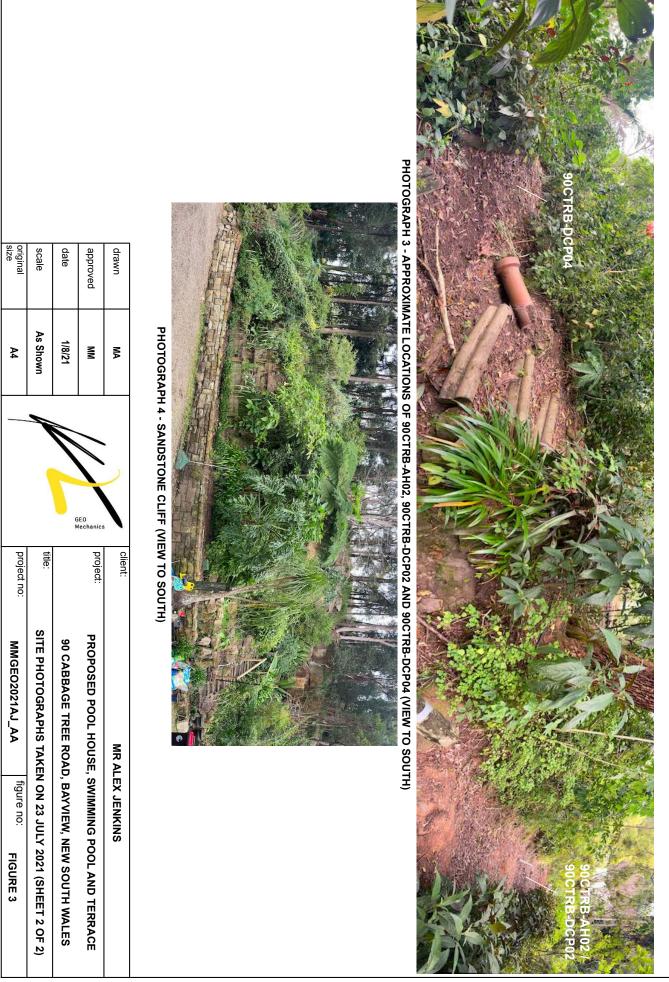
The approximate locations of the geotechnical tests are shown in Figures 2, 3 and 4. The site photographs are presented in Figures 3 and 4, and should be read in conjunction with the photograph view angles and orientations shown in Figure 2.
