**REPORT ON GEOTECHNICAL ASSESSMENT**

**PROPOSED ALTERATIONS AND ADDITIONS**

**325 WHALE BEACH ROAD, WHALE BEACH**

**Project No.: 2025-055**

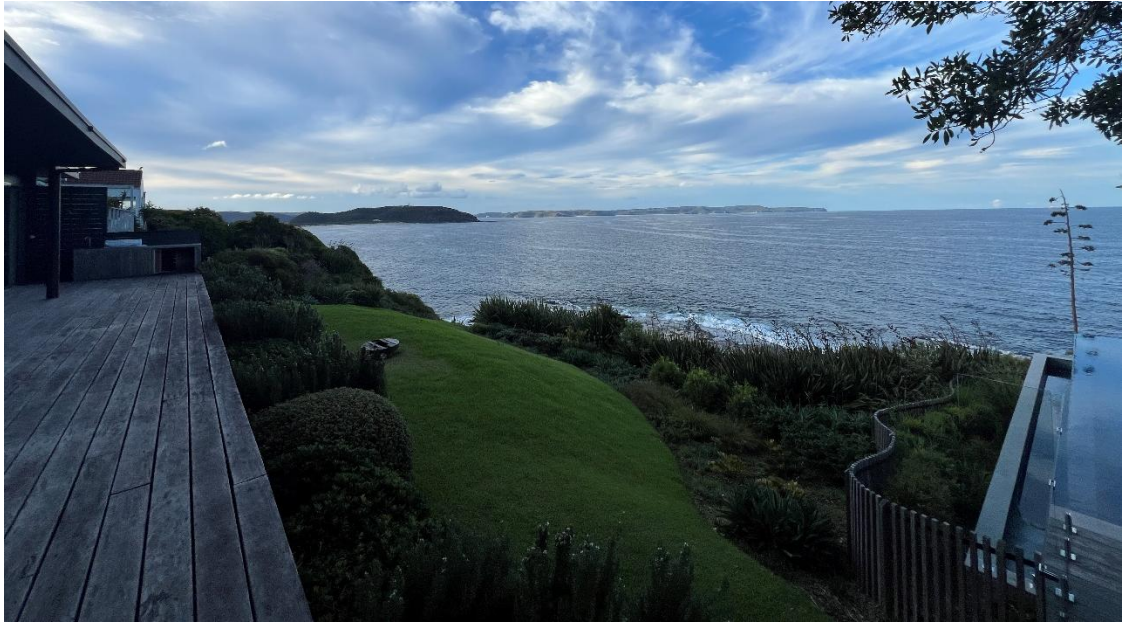
**Figure 4-1 View from existing house**

The site was visited by WRL's Principal Coastal Engineer James Carley on Wednesday, 26 March 2025. Photos from the site visit are shown in Figure 4-1 to Figure 4-4. As stated above, a site survey was provided to WRL from CMS Surveyors.

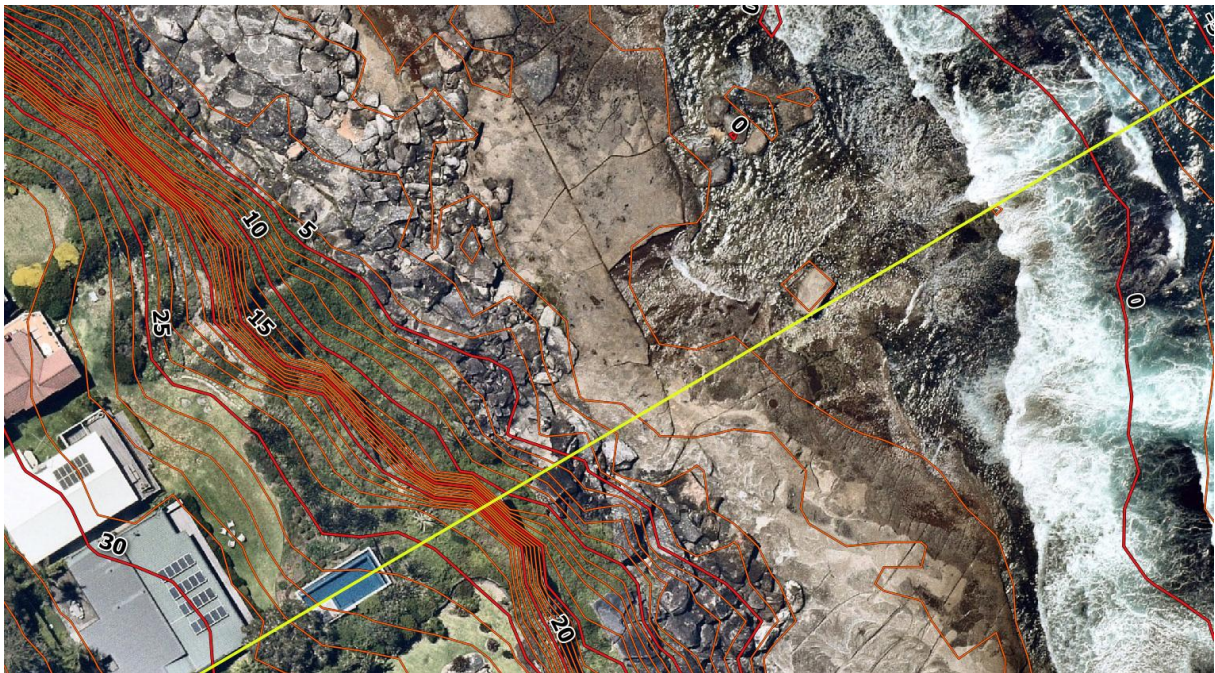
**Figure 4-5 Transect and NSW marine LiDAR bathymetry and topography data 2018**

The site's topography features a cliff face, rock platform and nearshore slope. The transect line (Figure 4-5) and transect section (Figure 4-6) taken from the widest part of the property and shows a near vertical steep cliff from 23 m AHD to 0 m AHD, with an approximately 70 m wide rock platform located at 0 m AHD (excluding toe rock boulders) continuing with a 1V:5H slope from to -10 m AHD and a 1V:30H slope further seaward.

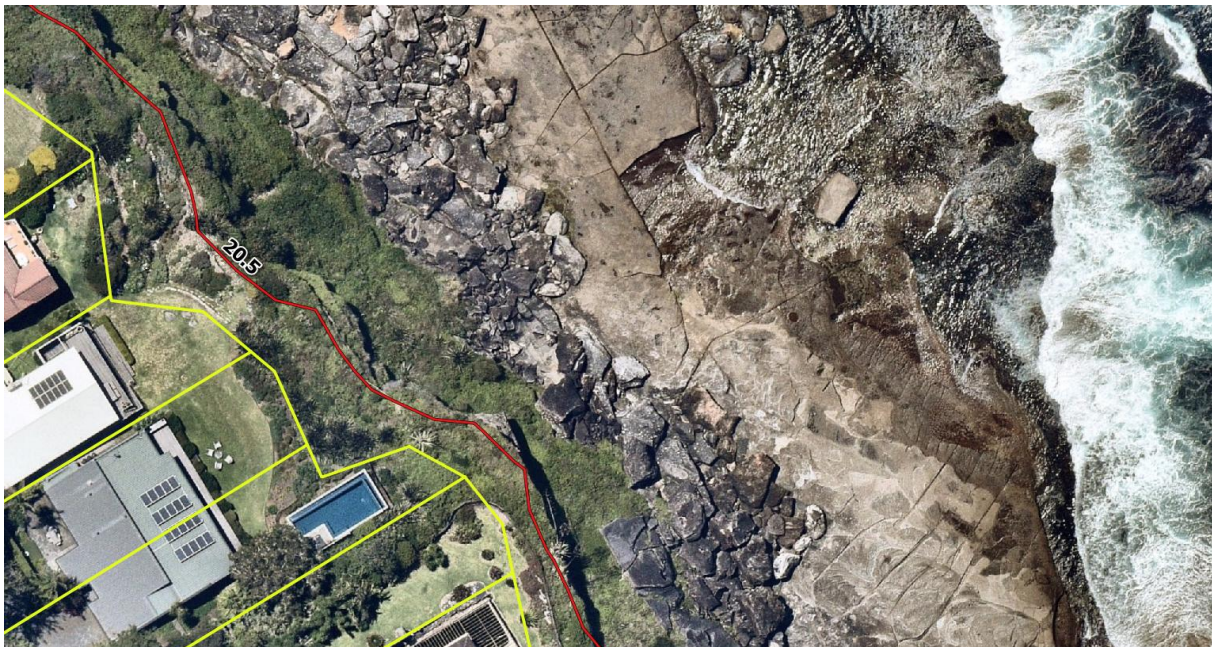
**Figure 7-1 R2% 2085 wave runup extents**

A visual representation of the EurOtop, 2018 runup extents are shown in Figure 7-1. The wave run up analysis show that even during extreme 100 ARI events the R2% wave runup is more than 4 m below the lowest point of the property and 9 m below the lowest floor level of the house, noting that splash, spray and some individual waves may exceed this design runup level – particularly during strong onshore winds
