Report Title: Geotechnical Report 53 Samuel Street, Mona Vale
Report Date: 25/11/20
Author: BEN WHITE
Author's Company/Organisation: WHITE GEOTECHNICAL GROUP PTY LTD

GEOTECHNICAL INVESTIGATION:

Alterations and Additions at 53 Samuel Street, Mona Vale

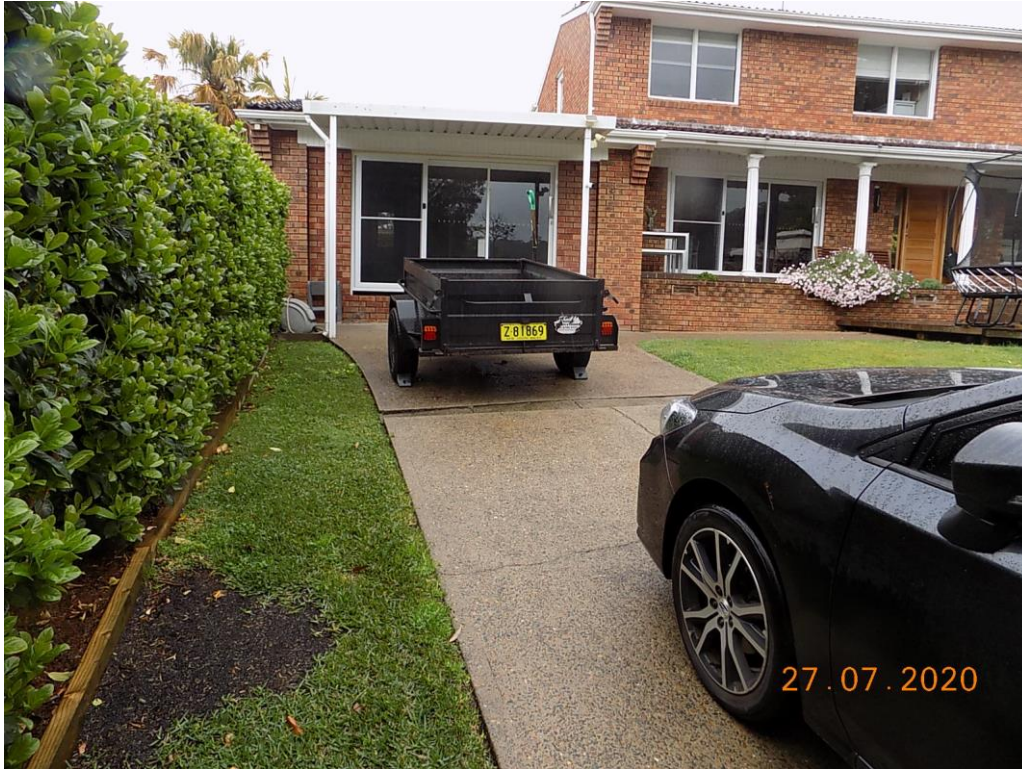
Photo 2

2.3 At the road frontage, a concrete driveway runs up the slope to a carport on the downhill side of the property and to a parking area on the downhill side of the house (Photos 1 to 3). The carport will be demolished as part of the proposed works. A pool has been cut into the slope between the carport and the house (Photo 4). The pool will also be demolished as part of the proposed works. The area around the pool has been filled. The fill is supported by a stack rock retaining wall that will be demolished as part of the proposed works (Photo 5). Between the pool and the house is a gently sloping lawn. The part two-storey house is supported on brick walls and brick piers (Photo 6). No significant signs of movement were observed in the supporting walls and the supporting piers stand vertical. A gently sloping lawn and tile-paved patio area extends off the uphill side of the house to the upper common boundary (Photo 7).
