Report Title: Geotechnical Report 4 Elwyn Close, Mona Vale
Report Date: 25/7/22

GEOTECHNICAL INVESTIGATION:

New Pool at 4 Elwyn Close, Mona Vale

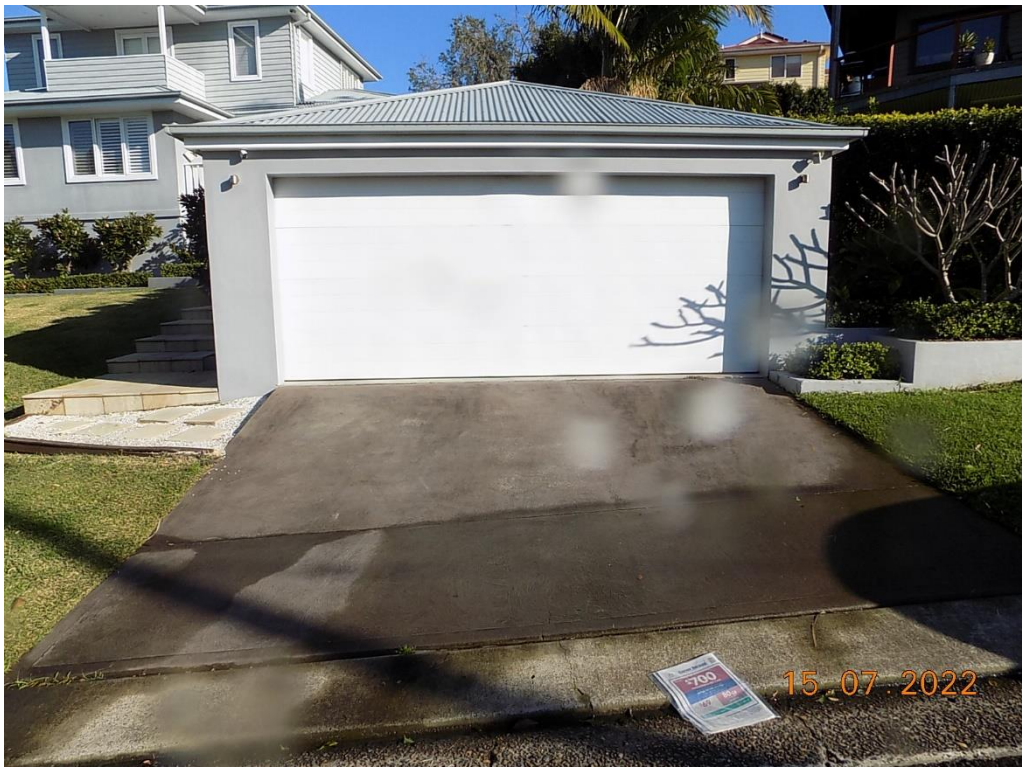
Photo 1

- 2.1** The site was inspected on the 15th July, 2022.
- 2.2** This residential property is on the high side of the road and has a SE aspect. It is located on the gentle to moderately graded upper middle reaches of a hillslope. The natural slope rises across the property at an average angle of ~9°. The land surface above and below the property continues at gradually decreasing angles.
- 2.3** At the road frontage, a concrete driveway runs to a stable rendered masonry garage (Photo 1). Between the road frontage and the house is a gently sloping lawn

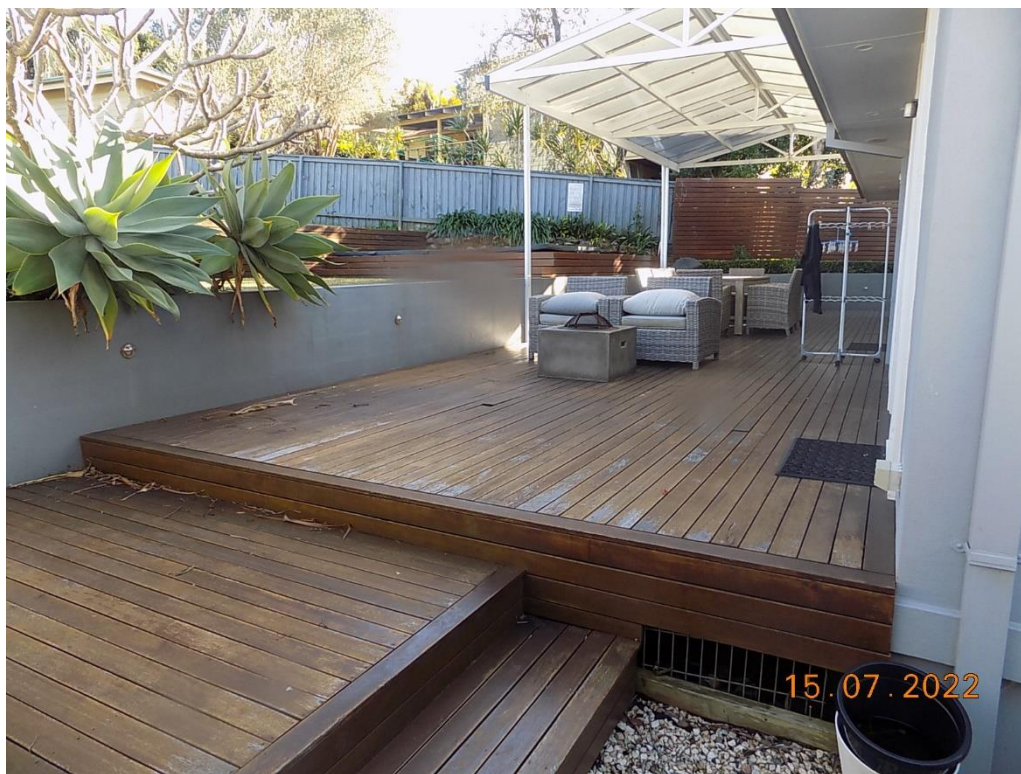
Photo 4

surrounded by garden beds (Photo 2). The part two-storey house is supported on rendered brick walls and brick piers (Photo 3). No significant signs of movement were observed in the supporting walls of the house and the visible supporting brick piers stand vertical. A timber deck extends off the uphill side of the house. The cut for the deck is supported by a rendered concrete block retaining wall ~1.0m high that will be demolished as part of the proposed works (Photo 4). The slope above the deck has been terraced with a timber retaining wall dressed in timber planks ~1.0m high that will also be demolished as part of the proposed works (Photo 5). The lawn-covered terraces extend to the upper common boundary. A fill on the upper neighbouring property is supported by a concrete block retaining wall reaching ~1.2m high (Photo 6). This wall was observed to be cracked and tilting downslope at a maximum angle of ~14°. The owner informed us that the upper neighbour is aware of the tilting wall and is gathering quotes to have it replaced. We recommend this wall be replaced within 1 year of the date of this report.

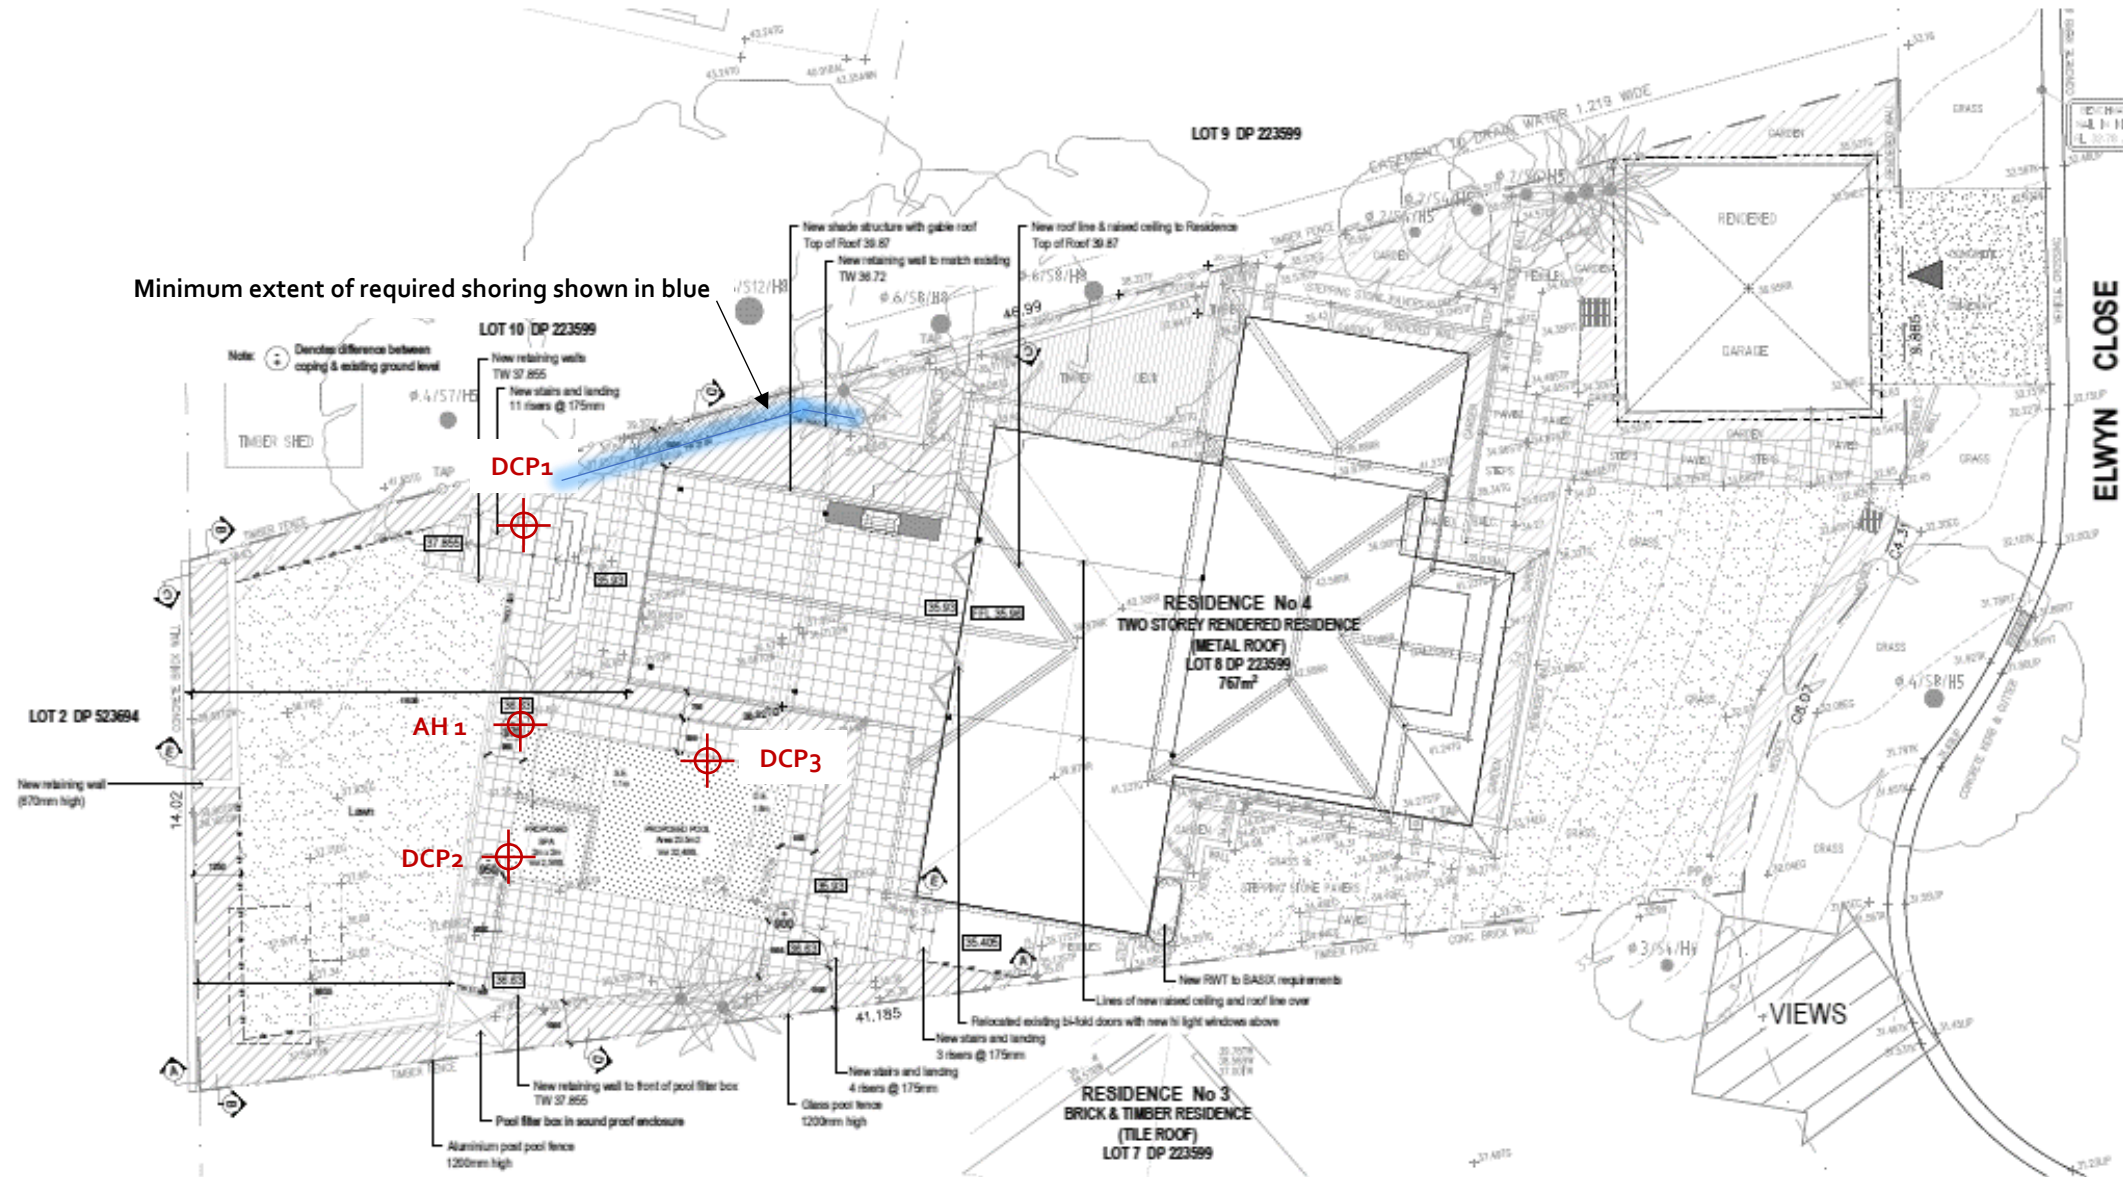
Minimum extent of required shoring shown in blue
