Report Title: Geotechnical Report 12 Corniche Road, Church Point  
Report Date: 21/9/21

## **GEOTECHNICAL INVESTIGATION:**

Alterations and Additions at **12 Corniche Road, Church Point**

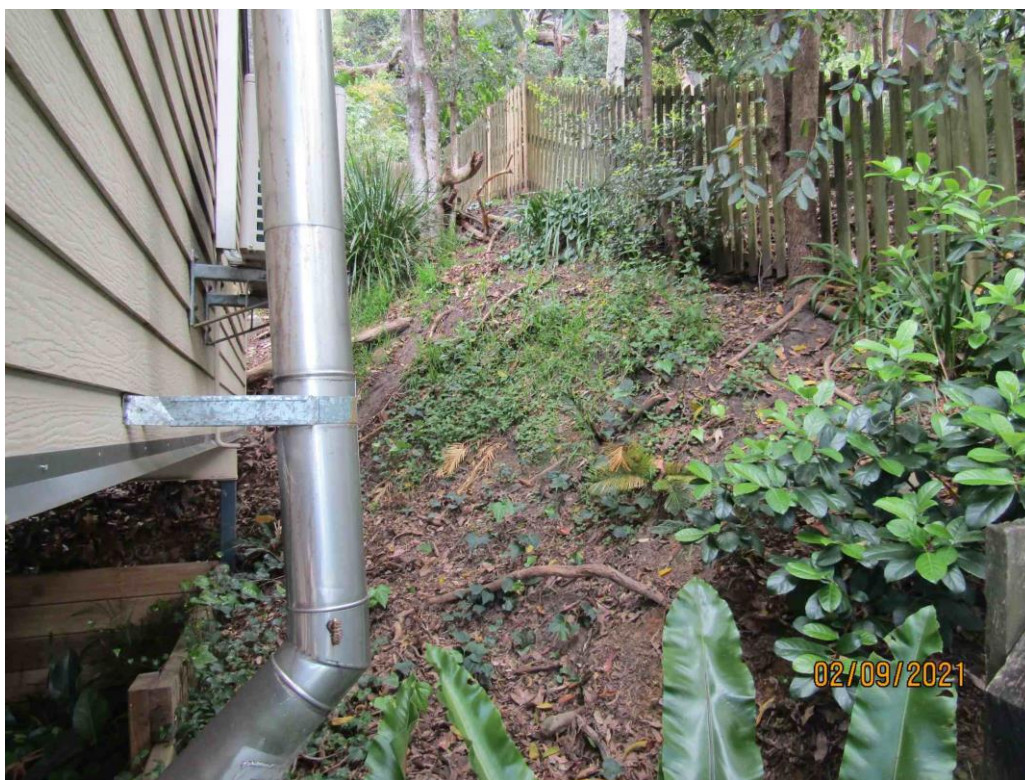
Photo 10

A timber deck extends off the uphill side of the house (Photo 8). The cut for the deck is supported by terraced low timber retaining walls (Photo 9). A steep bank is located above the cut (Photo 10). An intermittent watercourse runs down the property near the SE common boundary (Photo 11). The creek has been lined with rocks on the uphill side of the property. The creek runs under the SE side of the house. A concrete-lined channel runs under the house where this occurs (Photo 12). Sandstone joint blocks are embedded in stable positions in the slope on the uphill side of the house (Photo 13). The steep slope near the uphill property boundary is thickly vegetated
