## **Geotechnical Assessment**

**Project:** Alterations and Additions  
65 Marine Parade, Avalon Beach NSW

**REF: AG 19229**  
23<sup>rd</sup> January, 2020

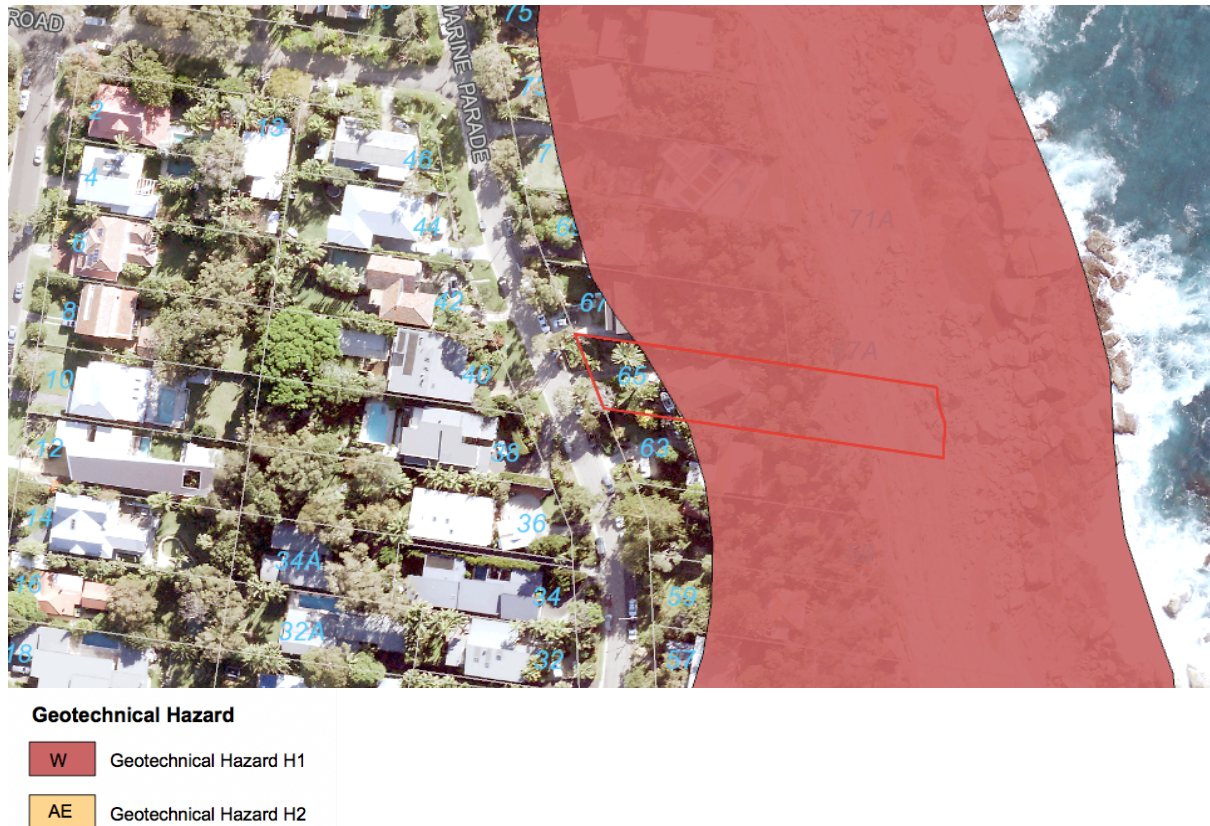
- The property is classified '**Geotechnical Hazard H1**' in Northern Beaches Council PLEP Geotechnical Hazard Map (PLEP Geotechnical Hazard Map **Image 2** below).

**Image 2:** 65 Marine Parade, Avalon Beach NSW – **Geotechnical Hazard H1**– Red polygon (PLEP 2014)
