ACCESS CONSULTANTS ADVICE

RE: Harvey Norman Balgowlah

REF: Harvey Norman Balgowlah – Dedicated Accessible Car Spaces

PERFORMANCE SOLUTION REPORT

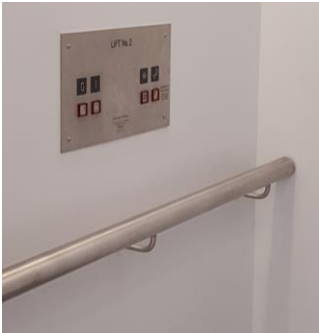
Distance from wall: 60 mm Diameter of handrail: 35 mm Top of handrail: 890 mm Support: below handrail

Comply
