GEOTECHNICAL INVESTIGATION:

New House, Pool, and Boatshed at 1744 Pittwater Road, Bayview

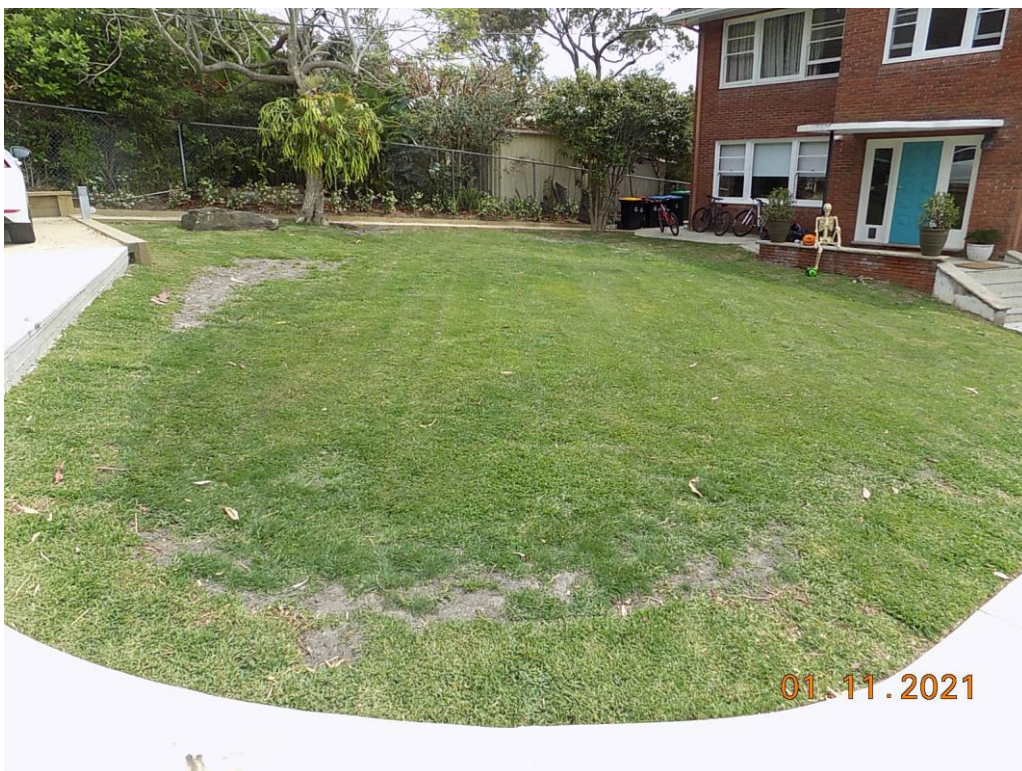
Photo 3

- 2.3** At the road frontage, a concrete driveway runs to a gravel parking area on the uphill side of the property and to a brick garage attached to the SE side of the house (Photos 1 & 2). Between the road frontage and the house is a gently sloping lawn (Photo 3). The part three-storey brick house is supported on stable brick walls and will be demolished as part of the proposed works (Photo 4). Another gently sloping lawn extends off the downhill side of the house to top of the steep bank that rises from the

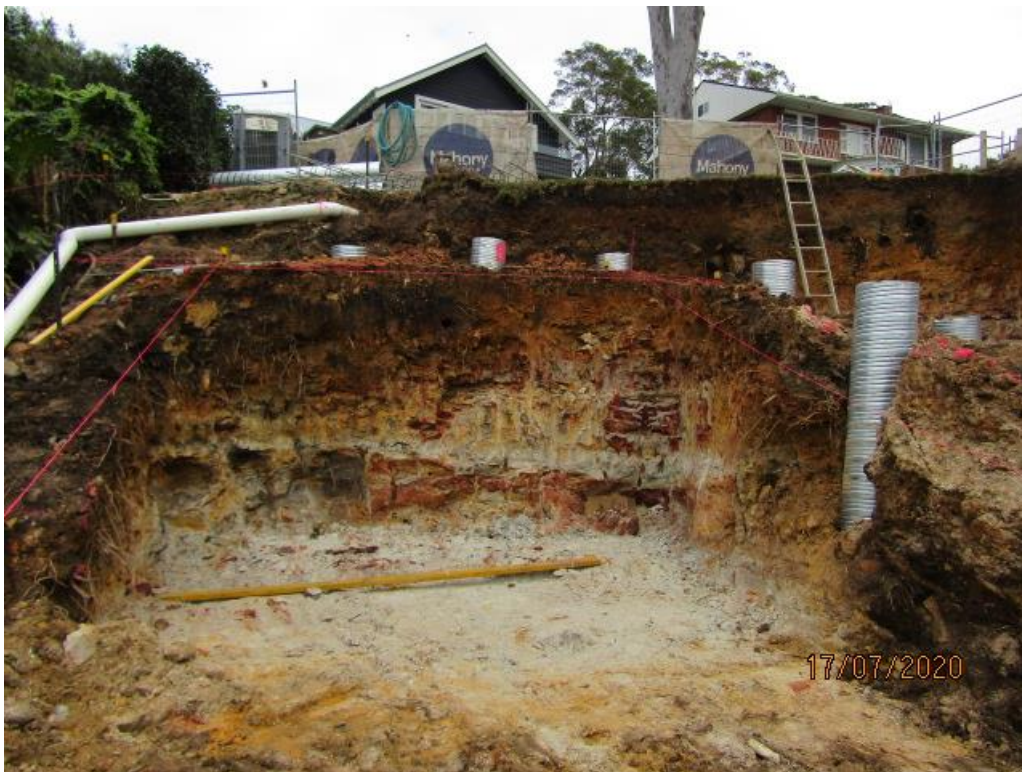
Photo 9

The slope materials are colluvial at the near surface and residual at depth. In the test locations, the ground materials consist of a thin topsoil over firm to hard clays. The clays merge into the underlying weathered rock at depths of between 0.9 to 1.8m below the current surface. The weathered zone is interpreted to be Extremely Low to Very Low Strength Shale. Thin bands of Low to Medium Strength Sandstone are present through the shale. These bands were observed by this firm during the excavation works on the SE neighbouring property (Photo 9). See Type Section attached for a diagrammatical representation of the expected ground materials.
