Proposed New Residence Lot 12, 4 Lincoln Avenue, Collaroy NSW

Geotechnical Investigation

Our ref: 6200-G1
11 September 2020

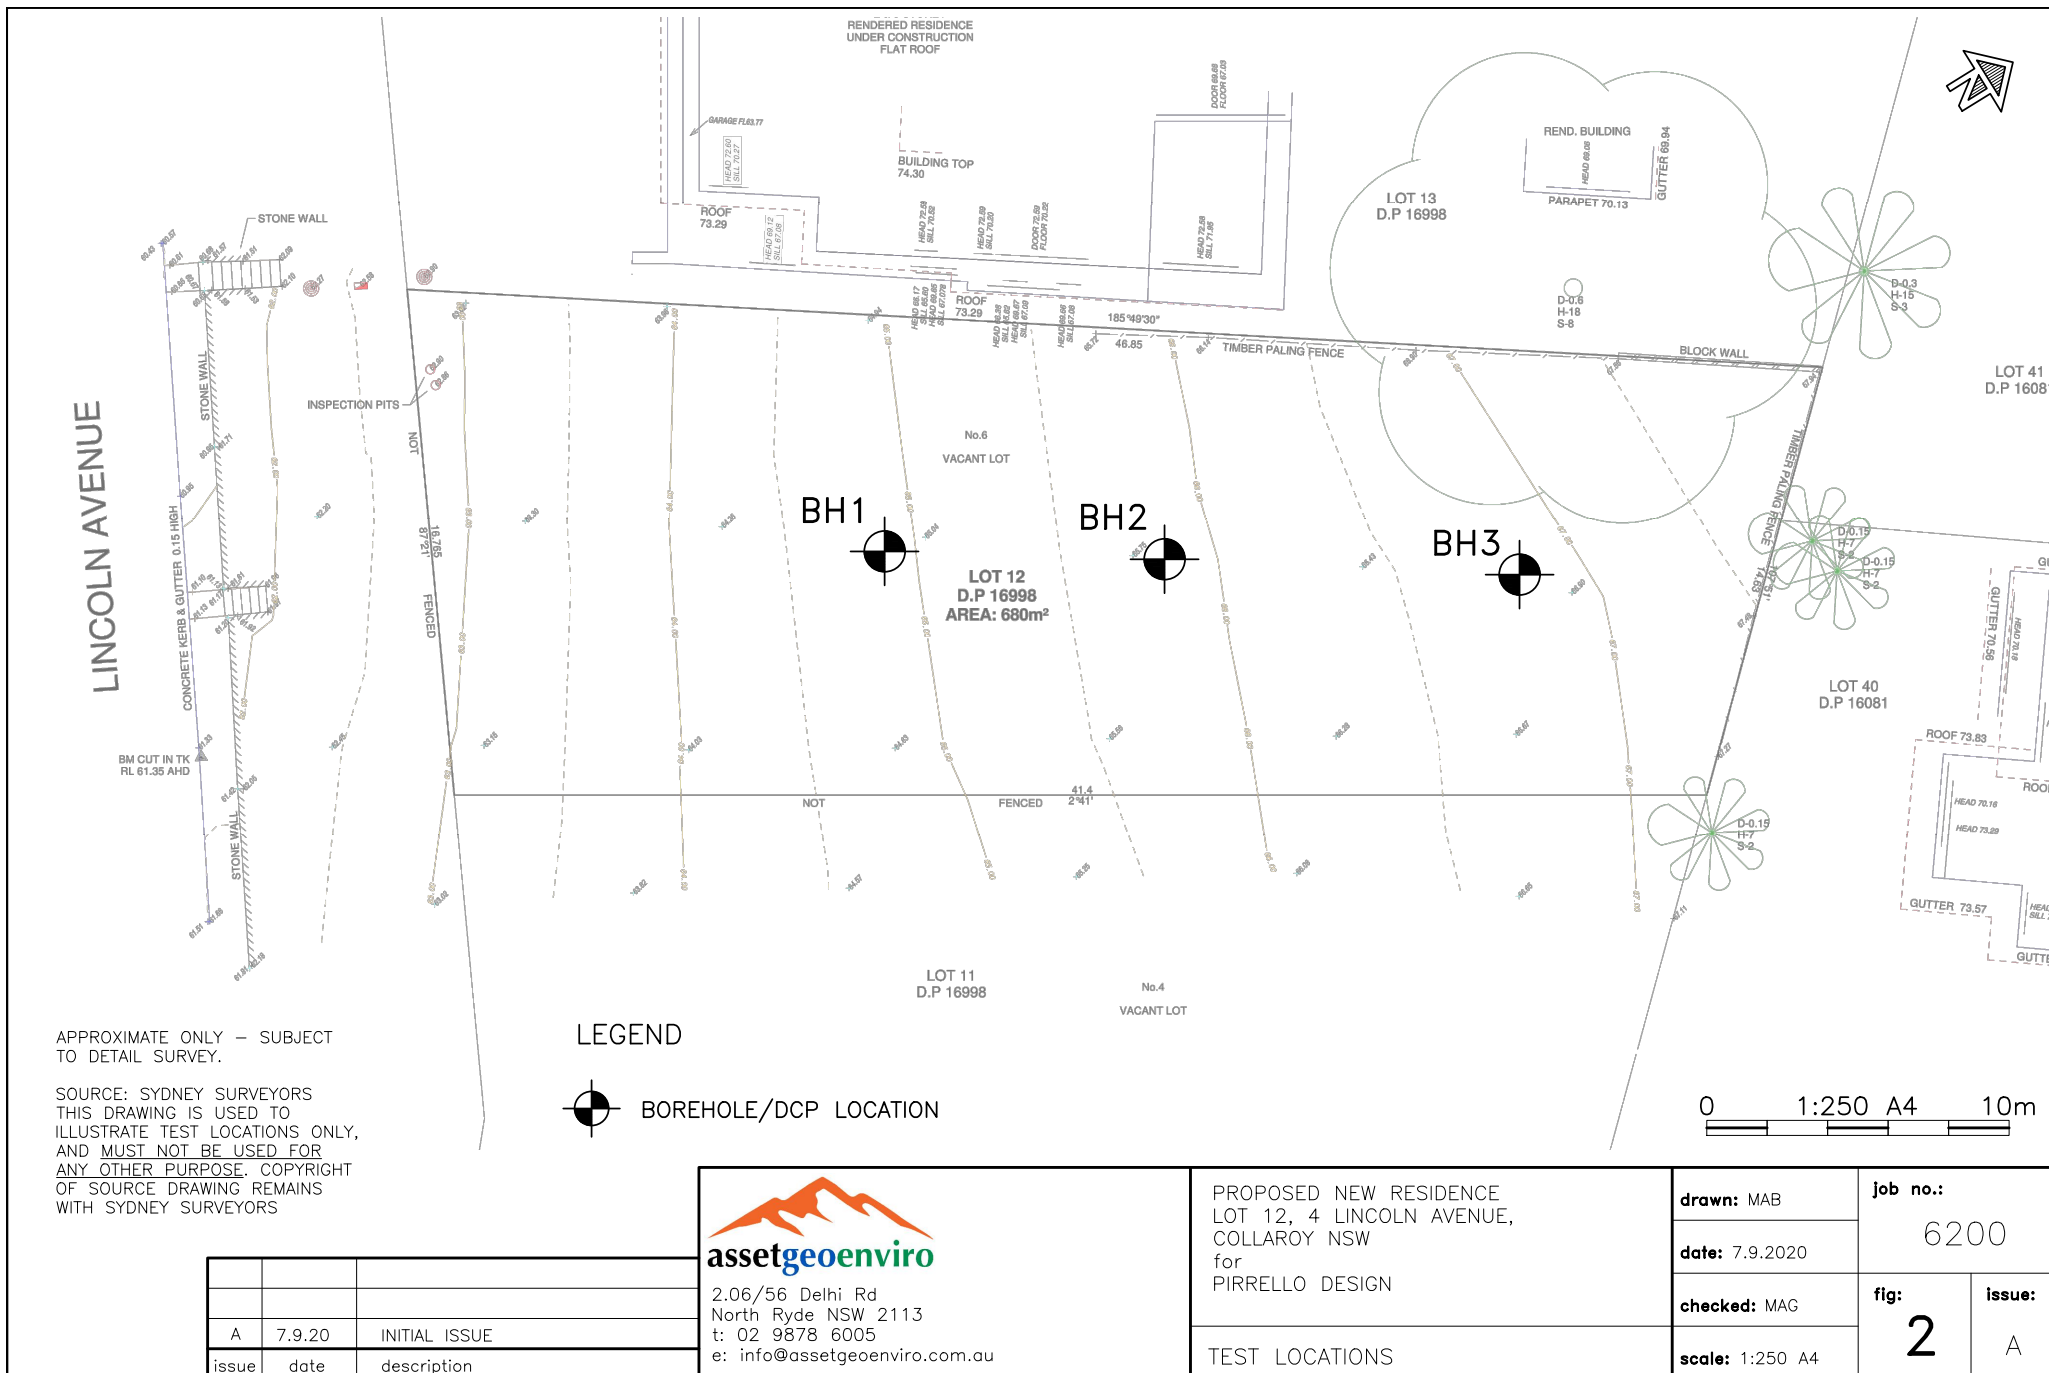
PROPOSED NEW RESIDENCE LOT 12, 4 LINCOLN AVENUE, COLLAROY NSW for PIRRELLO DESIGN	drawn: MAB	job no.: 6200	
	date: 7.9.2020		
	checked: MAG	fig: 2	issue: A
TEST LOCATIONS	scale: 1:250 A4

The test locations are shown in the attached Figure 2 and were set out by our Geotechnical Engineer by measurements relative to existing site features. Surface levels at the test locations were estimated by interpolation from levels shown on the survey plan provided (prepared by Sydney Surveyors; ref: 17085/1A; dated: 7/9/20).
