**GEOTECHNICAL RISK MANAGEMENT POLICY FOR PITTWATER**  
**FORM NO. 1 – To be submitted with Development Application**

Report Title: Geotechnical Report 15 Hudson Parade, Avalon  
Report Date: 12/06/20  
Author: BEN WHITE  
Author's Company/Organisation: WHITE GEOTECHNICAL GROUP PTY LTD

## **GEOTECHNICAL INVESTIGATION:**

Alterations and Additions at **15 Hudson Parade, Avalon.**

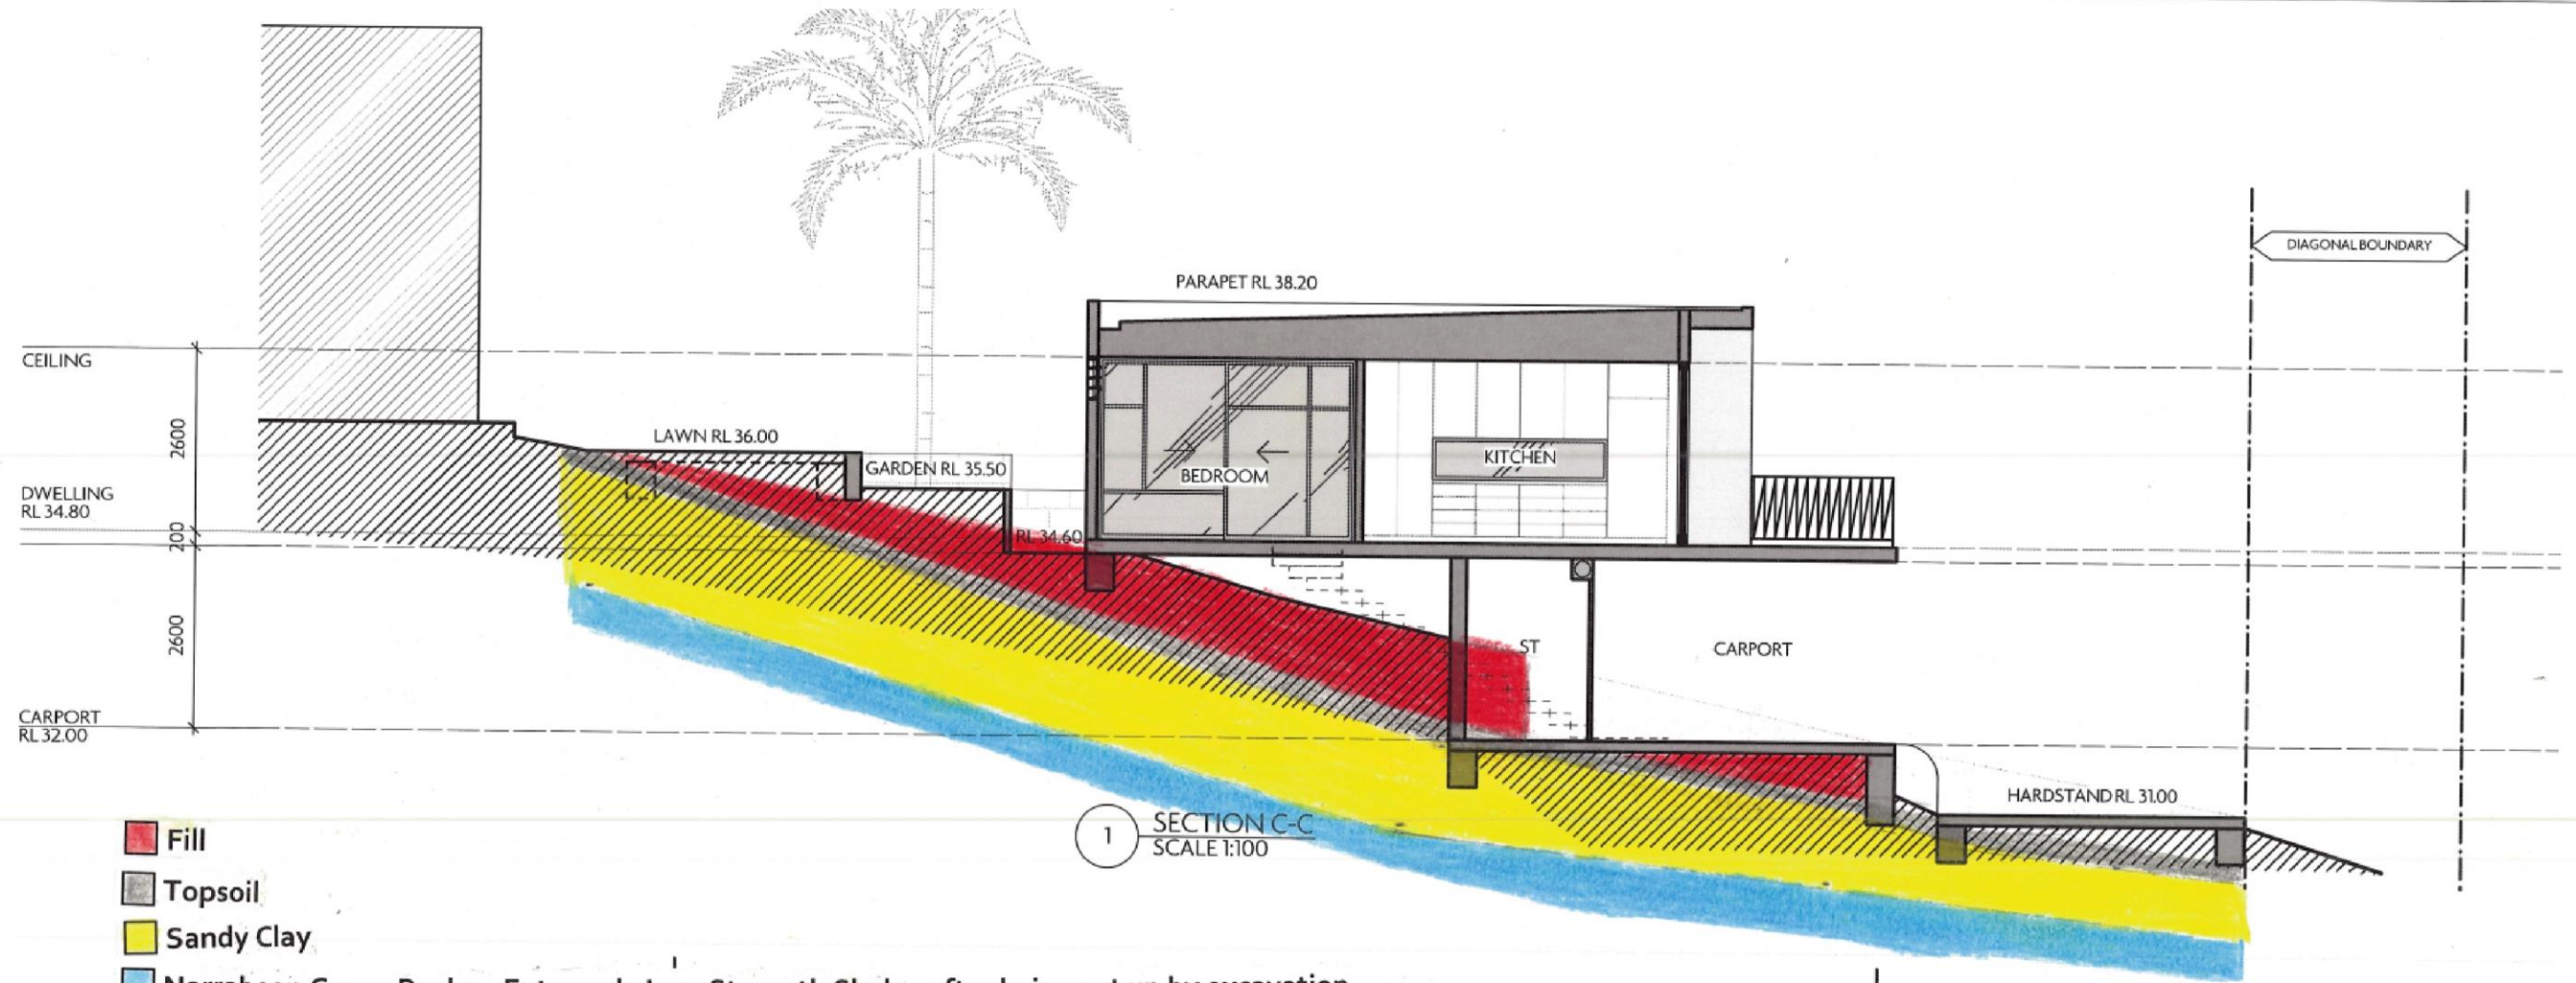
# TYPE SECTION – Diagrammatical Interpretation of expected Ground Materials

- Fill
- Topsoil
- Sandy Clay
- Narrabeen Group Rocks – Extremely Low Strength Shale - after being cut up by excavation equipment can resemble a stiff to hard clay.
