**re: GEOTECHNICAL ASSESSMENT / LANDSLIDE RISK APPRAISAL
PROPOSED INDEPENDENT LIVING DEVELOPMENT
PENINSULA GARDENS RETIREMENT VILLAGE, 79 CABBAGE TREE RD BAYVIEW NSW**

**REPORT ON
GEOTECHNICAL ASSESSMENT / LANDSLIDE RISK APPRAISAL**

**PROPOSED INDEPENDENT LIVING DEVELOPMENT
PENINSULA GARDENS RETIREMENT VILLAGE
No.79 CABBAGE TREE RD BAYVIEW NSW**

report ref: R/17-049.A

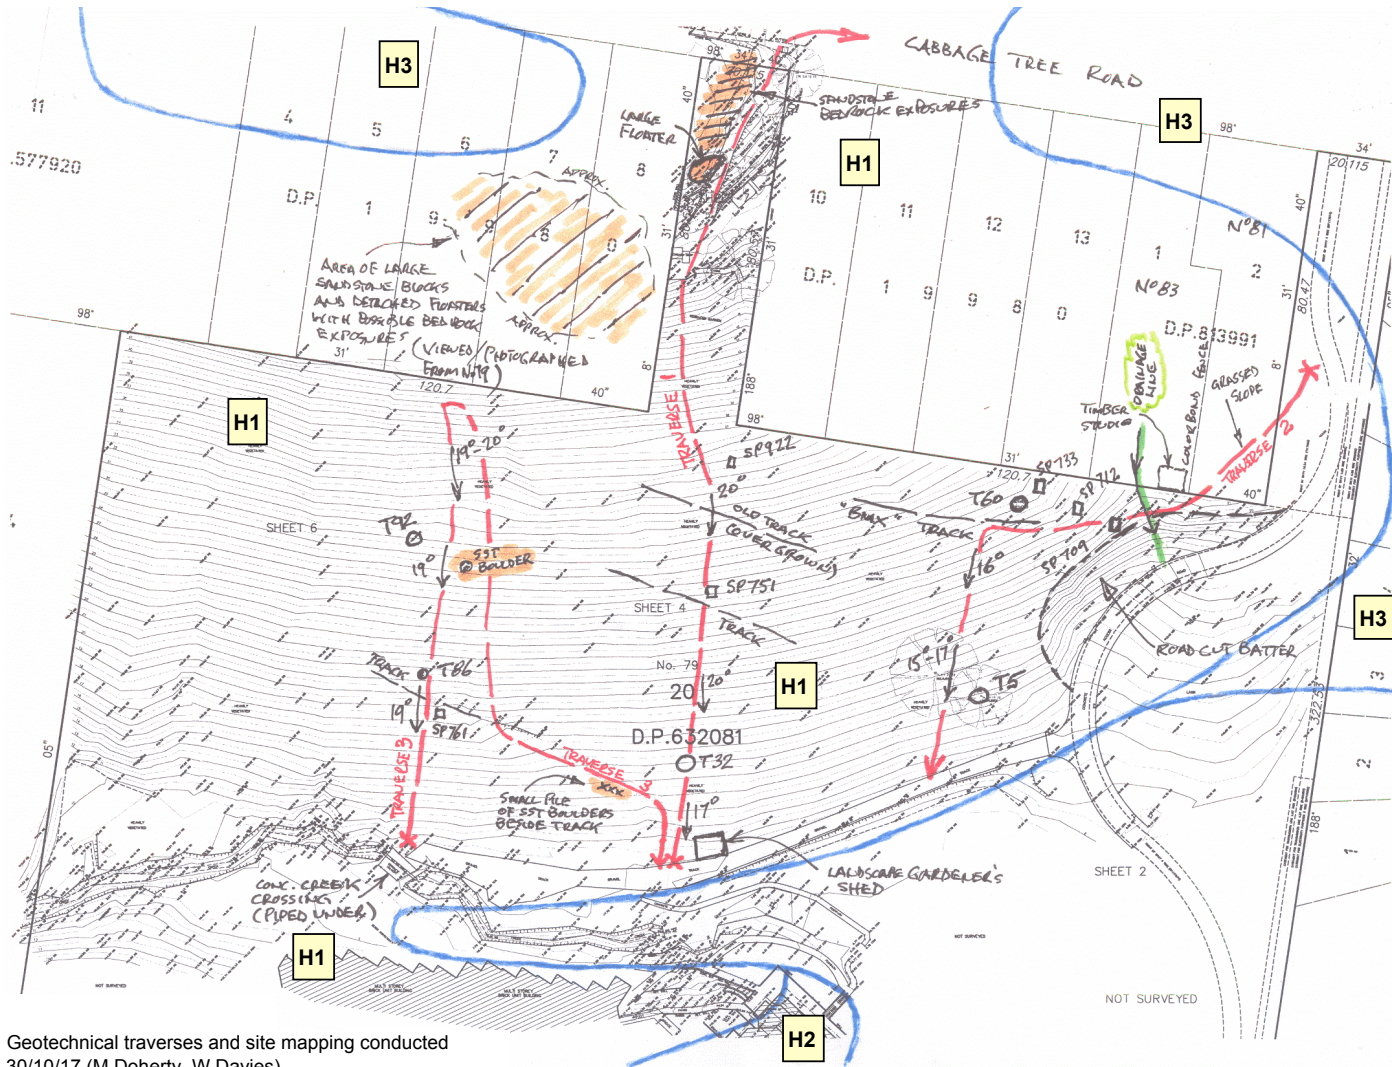
The landform of the development site comprises a relatively uniform slope of the south-facing valley hillside. Typical slope angles calculated from the site survey plan are 15° to 20° degrees. Measured slope angles from our walk-over of the site are within this range and are indicated on the attached plan in Figure 3 and the slope sections presented as Figures 4A – 4C.

The features described above from our geotechnical mapping and general observations are marked up on the survey plan presented as Figure 3 and on the geotechnical slope sections provided in Figures 4A – 4D.

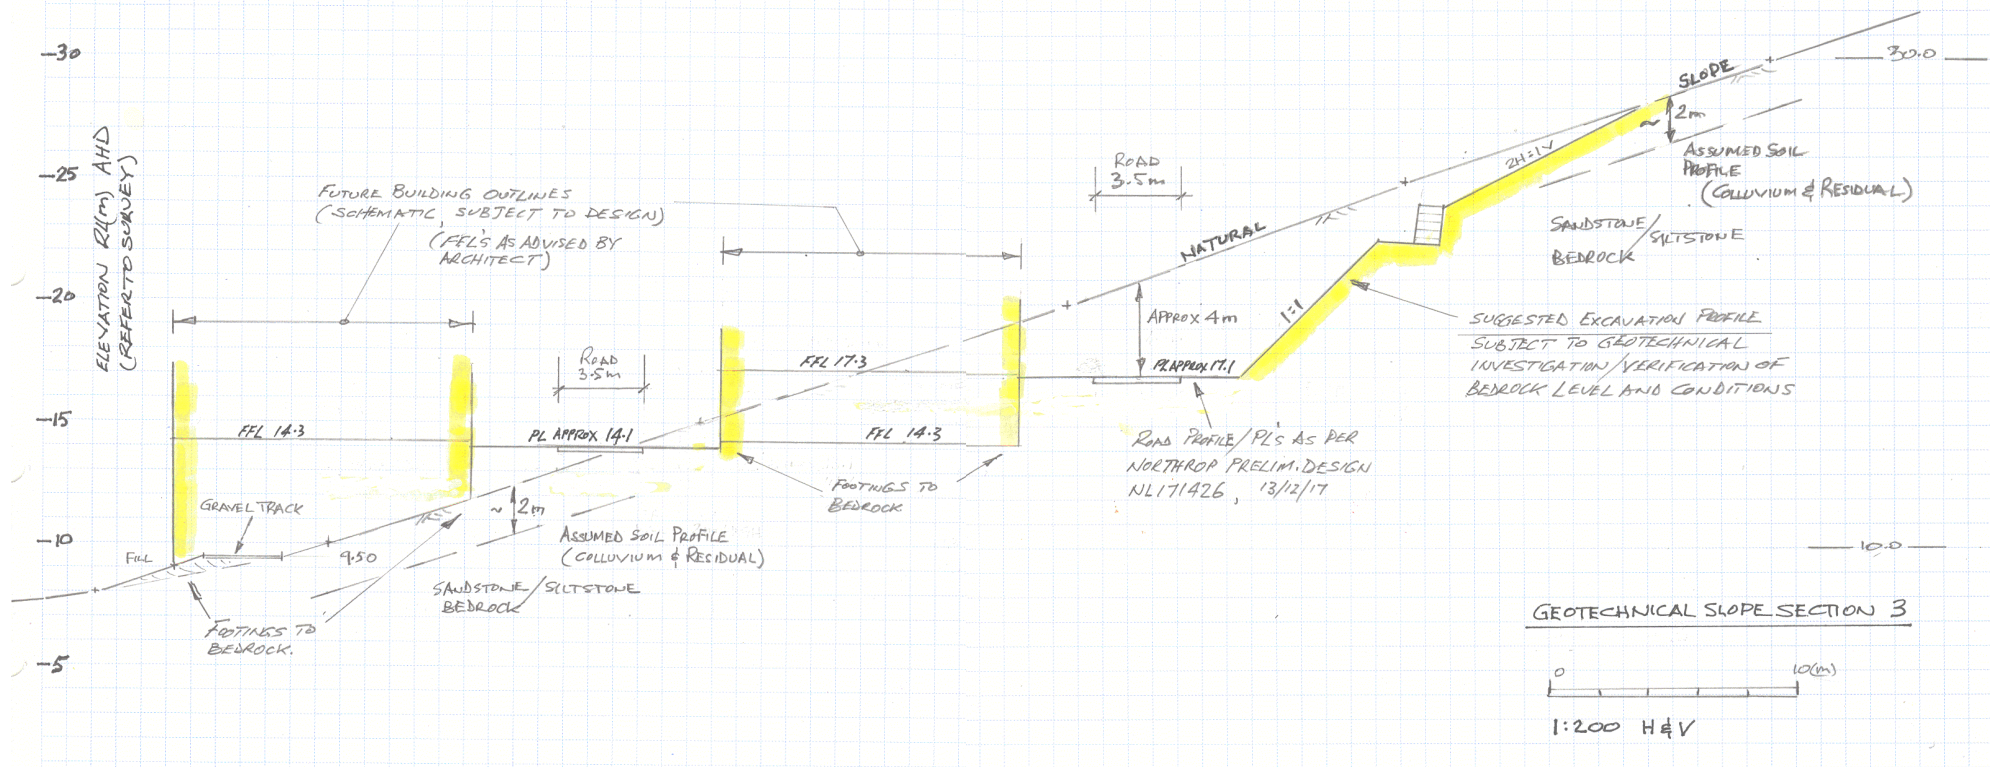
The current design (alignment, level and grades) prepared by Northrop Consulting Engineers for the proposed western loop road requires a continuous excavation of some 4m depth on centreline along the upslope portion of the road, and approximately at grade (only minor excavation or fill) for the downslope portion. The design is illustrated in the plan provided as Figure 7, and details from the design are used for developing part of Section 3 (Figure 4B).

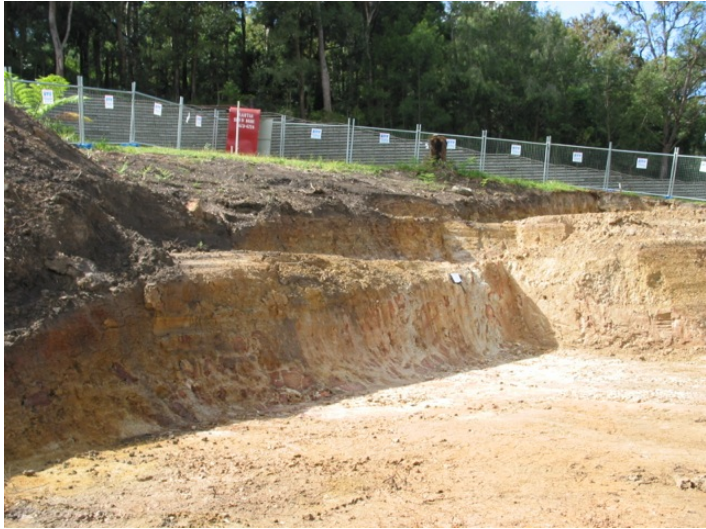
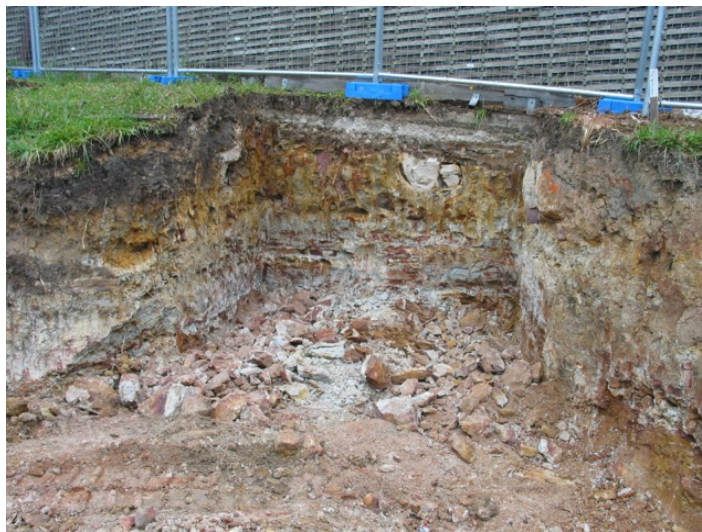
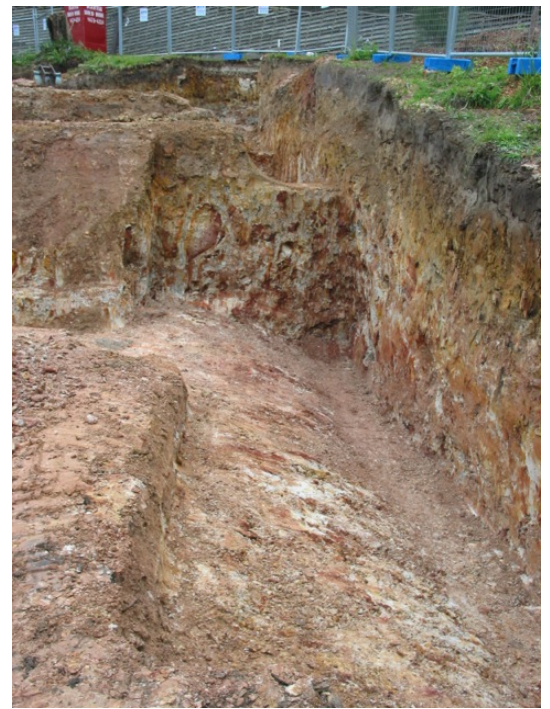
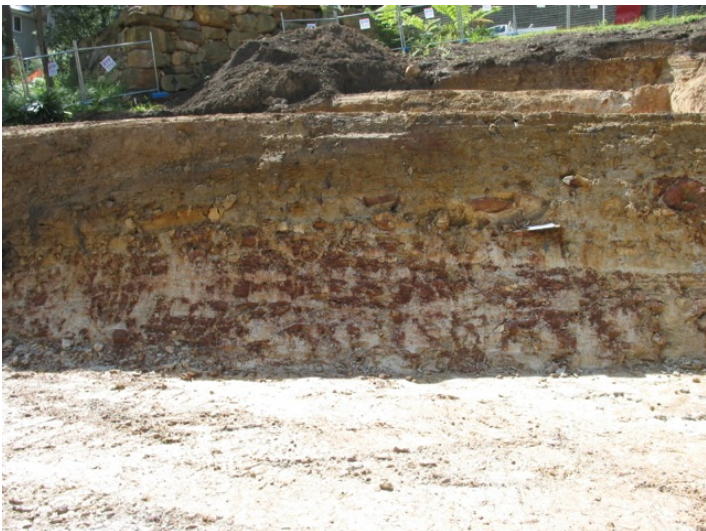
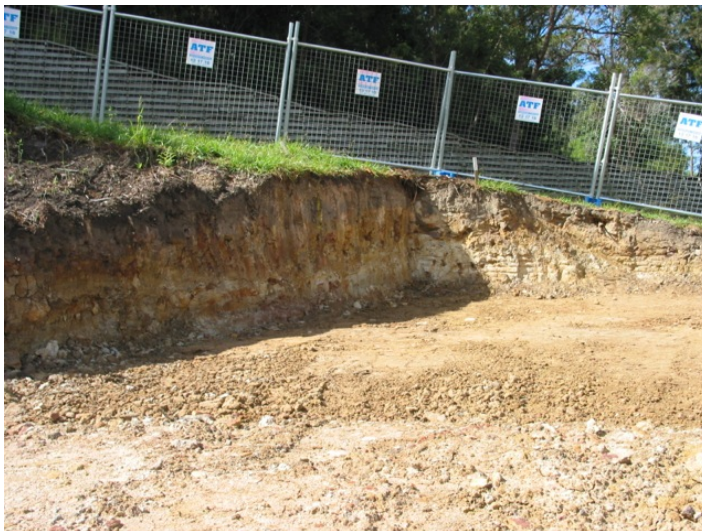
Figure 6A

Figures 6A and 6B illustrate the observed subsurface conditions at these two sites, comprising:-

- ❑ Photos by Davies Geotechnical Pty Ltd, Barkala Rd Bayview, April - July 2008.
- ❑ Subsurface conditions for Newport Formation sandstone stratigraphy, RL range 22m - 32m AHD.

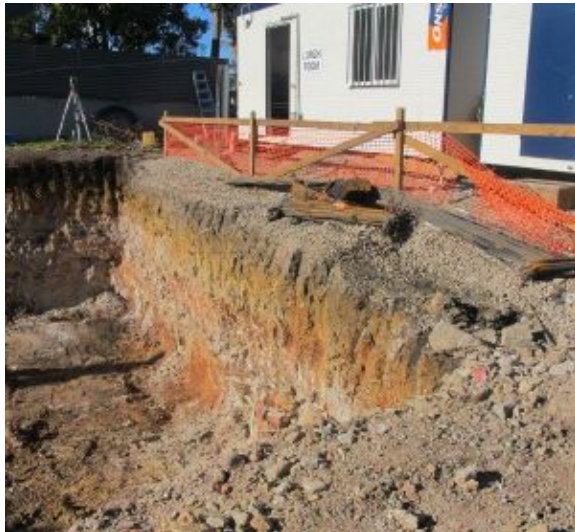
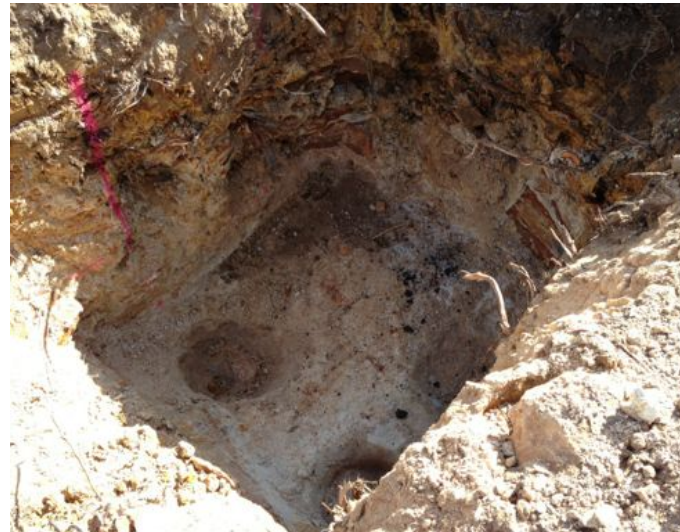
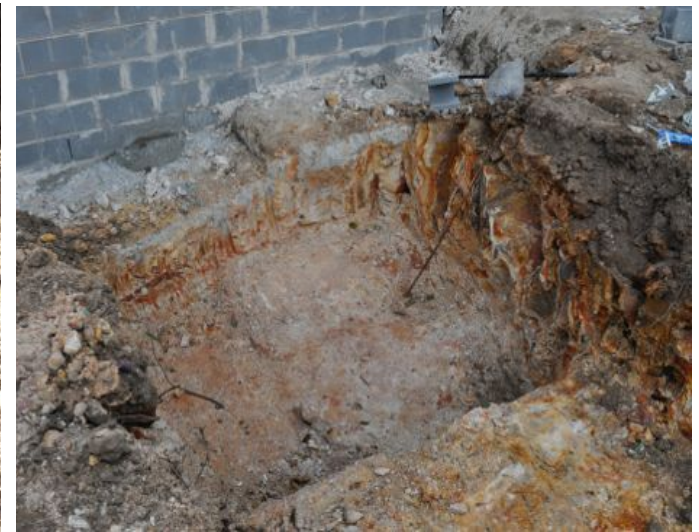
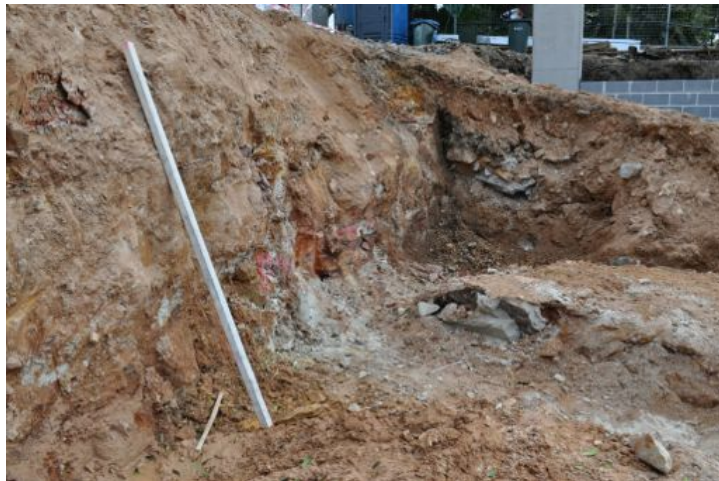
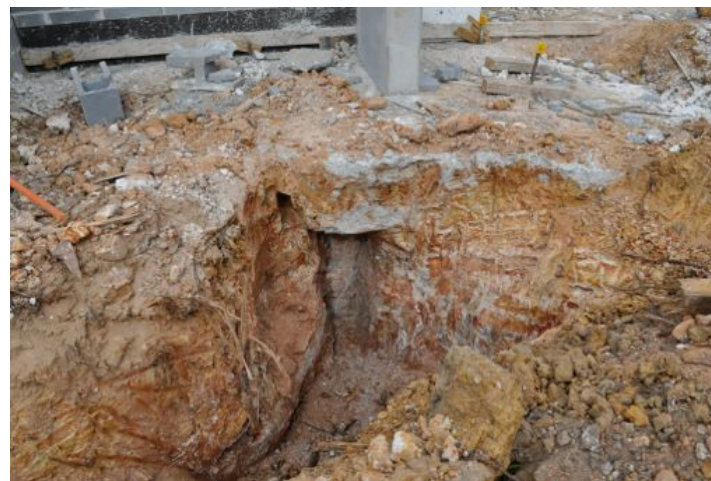
Figure 6B

- ❑ Photos by Davies Geotechnical Pty Ltd, Park St Mona Vale, August 2012.
- ❑ Subsurface conditions for Newport Formation sandstone stratigraphy, RL range 18m - 22m AHD.
