MT 31477

26th November, 2018

RISK ANALYSIS & MANAGEMENT FOR PROPOSED ALTERATIONS & ADDITIONS AT 10 TALGARA PLACE BEACON HILL

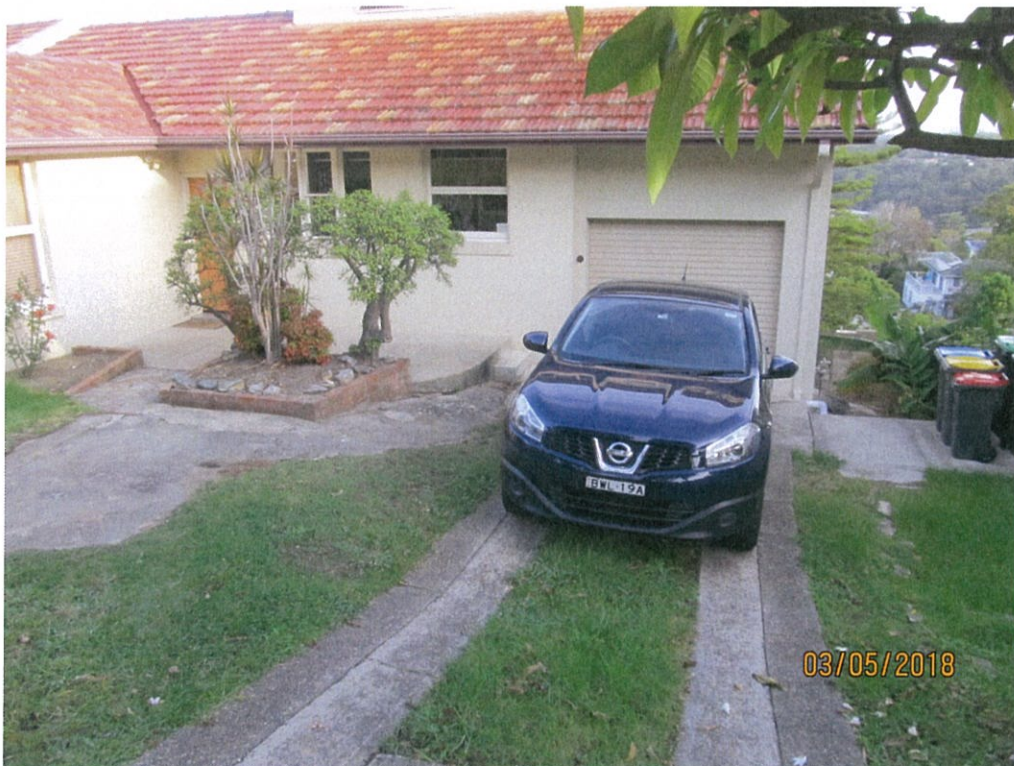
Photo 1

3.3 Vehicle access to the property is via a strip concrete driveway that leads to a single car garage on the north western corner of the existing residence, Photo 1. Pedestrian access is also via the driveway and a pathway to the main entrance. Exposed sandstone bedrock was visible at the front to the property, Photo 2. Access to the rear of the property is via a pathway on the western side of the existing residence where sandstone bedrock was also visible, Photo 3. Access is also possible to the rear yard on the eastern side of the existing residence but is not a formalised pathway, Photo 4. An existing deck area is over a terrace created by a concrete blockwork wall near the top of the rock escarpment, Photo 5. No access to the area below the rock escarpment was available at the time of inspection with access via the neighbouring property to the north. The approximately 6.0 metre high stepped escarpment runs along the subject and neighbouring properties, Photo 6. A Council stormwater pipe runs along the subject properties western boundary with the exposed pipe visible in Photo 6. At the base of the rock escarpment the lower slope is littered with displaced joint blocks (Rock Floaters) of various sizes, Photo 7. A large Norfolk pine dominates the south western corner of the site directly next to the Council pipeline, Photo 8.
