GEOTECHNICAL INVESTIGATION REPORT

PROPOSED SUBDIVISION

49 BLACKBUTTS ROAD, FRENCHS FOREST

Project No.: 2023-107

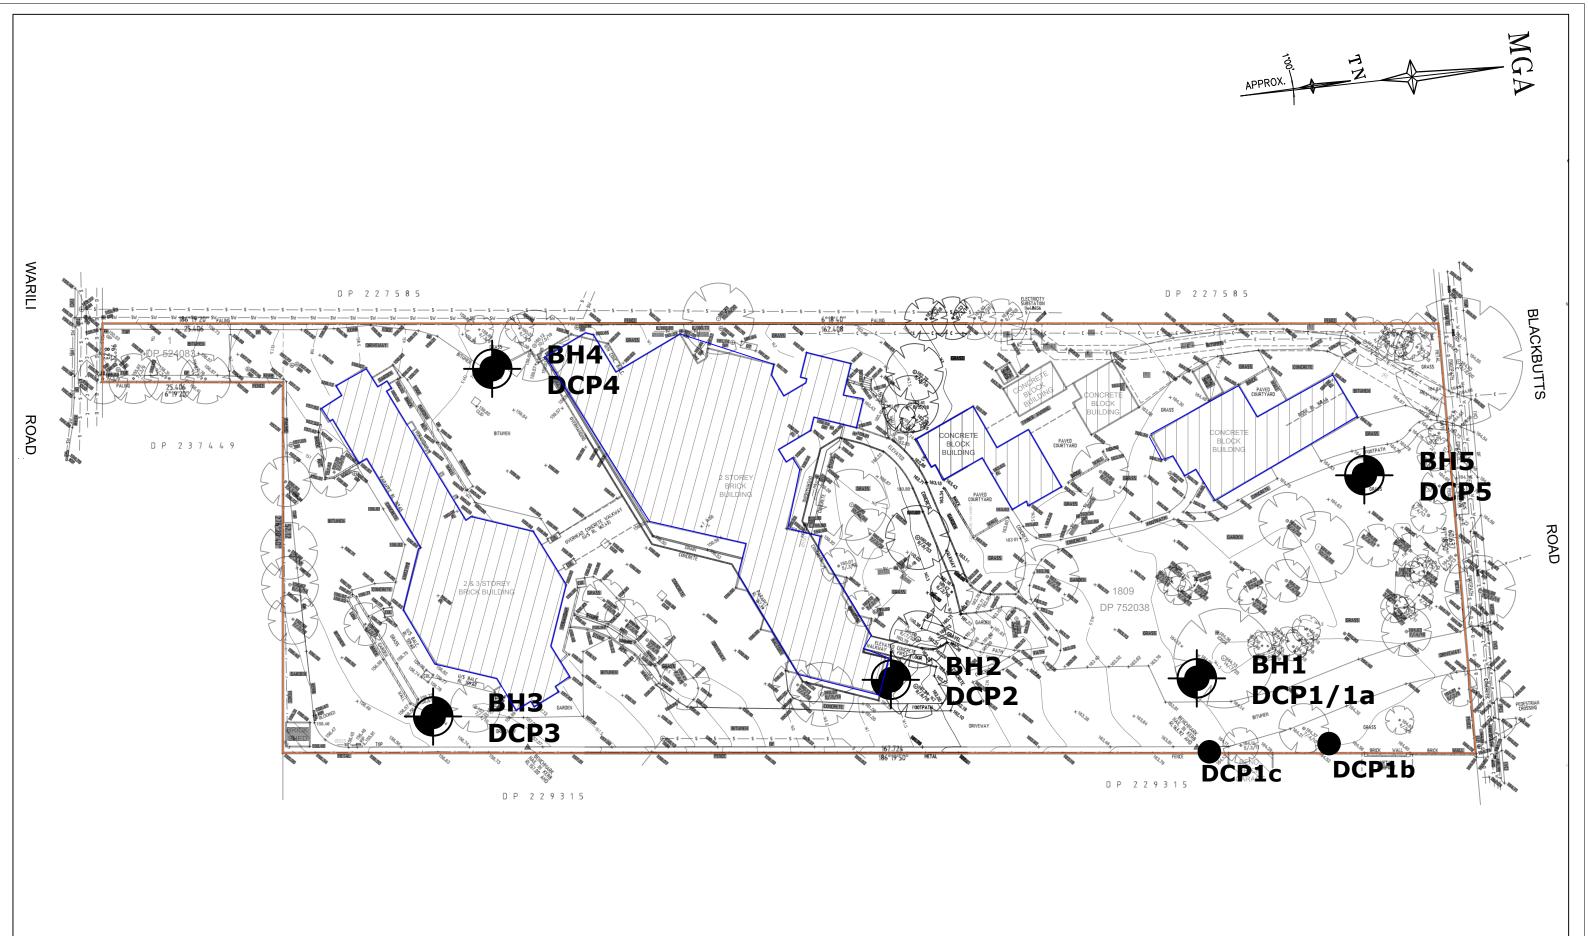
FIGURE 1.

Explanatory notes are included in Appendix: 1. Mapping information are shown on Figure: 1, along with detailed Borehole Log Report and Dynamic Penetrometer Test Sheet in Appendix: 2.
