## **GEOTECHNICAL INVESTIGATION:**

New Semi-Detached Houses and Pools at 103 Ocean Street, Narrabeen

# **INFILTRATION TESTING:**

#### For Proposed Infiltration Trench at 103 Ocean Street, Narrabeen

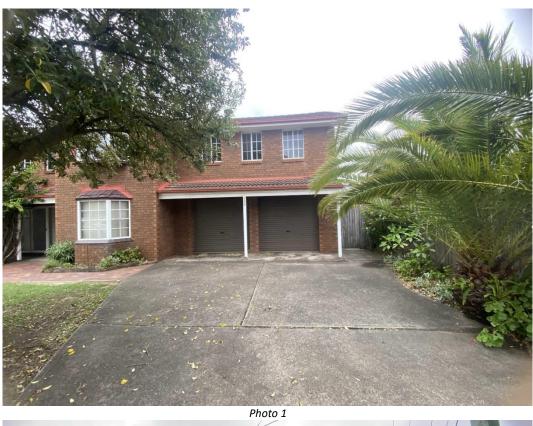
Photo 2

**2.3** At the road frontage, a paved driveway runs to a garage on the ground-floor of the house (Photo 1). In between the road frontage and the house is a near level lawn area (Photos 2). The two-storey brick house is supported on brick walls. The external brick walls show no significant signs of movement (Photo 3). The house is to be demolished as part of the proposed works. A near level lawn area extends off the E side of the house to the E common boundary. (Photo 4).

#### AUGER HOLE 2 (~RL9.3) – AH2 (Photo 2)
