# ARBORICULTURAL IMPACT ASSESSMENT REPORT

relating to construction of a new dwelling (House D) and driveway at

# 64 POWDERWORKS ROAD NORTH NARRABEEN NSW 2101

Prepared for Somers Isles Pty Ltd 6 December 2023

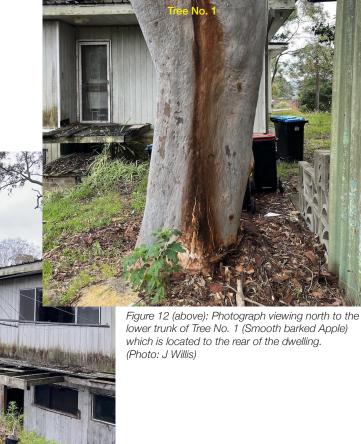
Figure 10 (above): Photograph viewing south to the carport and Tree No. 1 (Smooth barked Apple) which is located to the rear of the dwelling and adjacent to the existing carport. (Photo: J Willis)

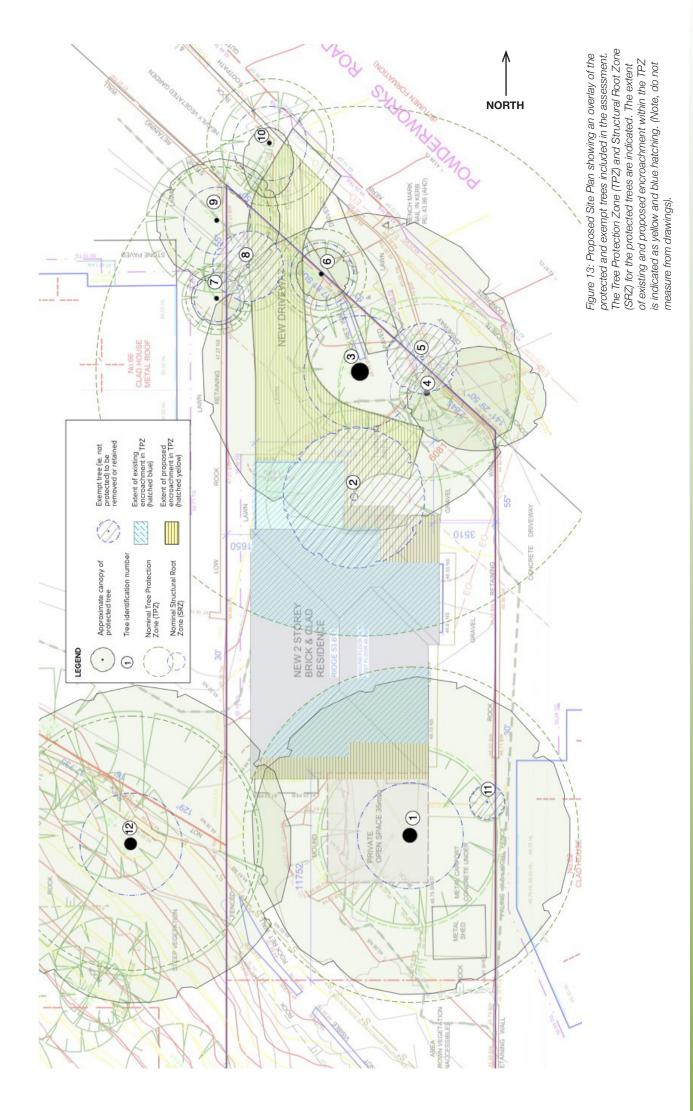
#### i) Tree No. 3 (Smooth-barked Apple)

The proposed driveway area and crossover represent an encroachment in the TPZ and SRZ of 12%. With consideration to the new dwelling located in the TPZ of the tree, the combined encroachment of both dwelling and driveway totals 24%. The tree is considered to have a high retention value on the basis of its crown volume, ecological significance and a long estimated life expectancy. The owner is seeking permission from Council to remove the tree. The repositioning of the driveway and crossover to the northern side of the tree and the associated excavation works required will potentially result in a moderate to high level of impact upon the tree. If the tree is retained as part of the future works, details relating to the finished driveway levels would need addressed to ensure excavation within the TPZ is kept to a minimum and therefore mitigate any potential impact upon the tree.
