GEOTECHNICAL INVESTIGATION:

New Pool and Decks at 135 Seaforth Crescent, Seaforth

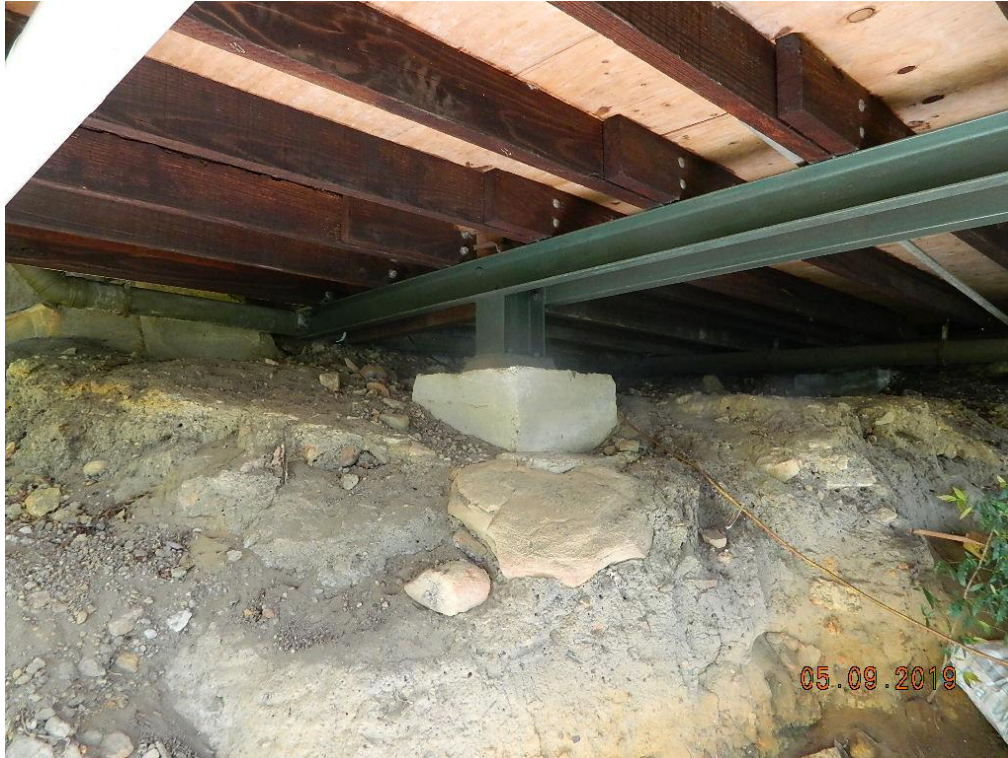
Photo 2

- 2.3** At the road frontage, a concrete driveway runs to a suspended carport on the uphill side of the property (Photo 1). A timber and steel stair case runs downslope from the carport to the house (Photo 2). Outcropping sandstone was observed across the entire site. The three storey timber framed and clad house continues downslope. The house is partially suspended and is supported by steel beams and concrete footings on sandstone (Photo 3). All visible footings showed no signs of movement and are considered stable. An inclined lift runs along the S boundary and rough sandstone block set of stairs along the E side of the property (Photo 4). A $\sim 3.0\text{m}$ high sloped and jointed sandstone rock face extends downslope of the house (Photo 5). The rock face is considered stable. The footprint of the suspended pool will fall over this portion of the slope. A timber stair case has been cut into the sandstone rock face
