11 July 2024  
Our Ref: 220643

## REVIEW OF ACCESSIBILITY MATTERS PILU RESTAURANT, 80 UNDERCLIFF ROAD, FRESHWATER NSW

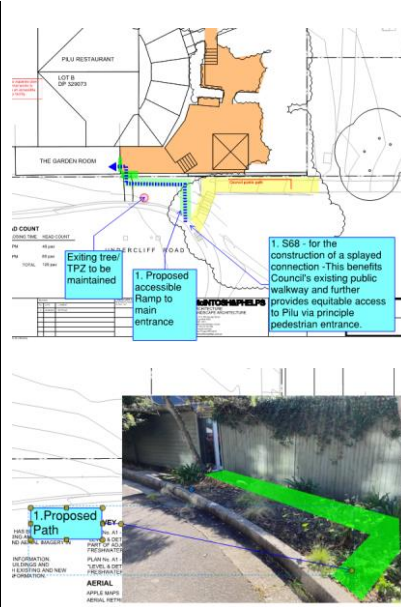
In summary, it is considered that there are potentially two (2) viable access upgrade options that could be implemented however, it would be appropriate to engage with the heritage consultant and the applicant to ascertain if there are any limitations which may prevent one option or another.
