REPORT ON GEOTECHNICAL INVESTIGATION AND RISK ASSESSMENT

PROPOSED NEW RESIDENTIAL BUILDING

5 LAUDERDALE AVENUE, FAIRLIGHT, NSW

Project No.: 2024-109

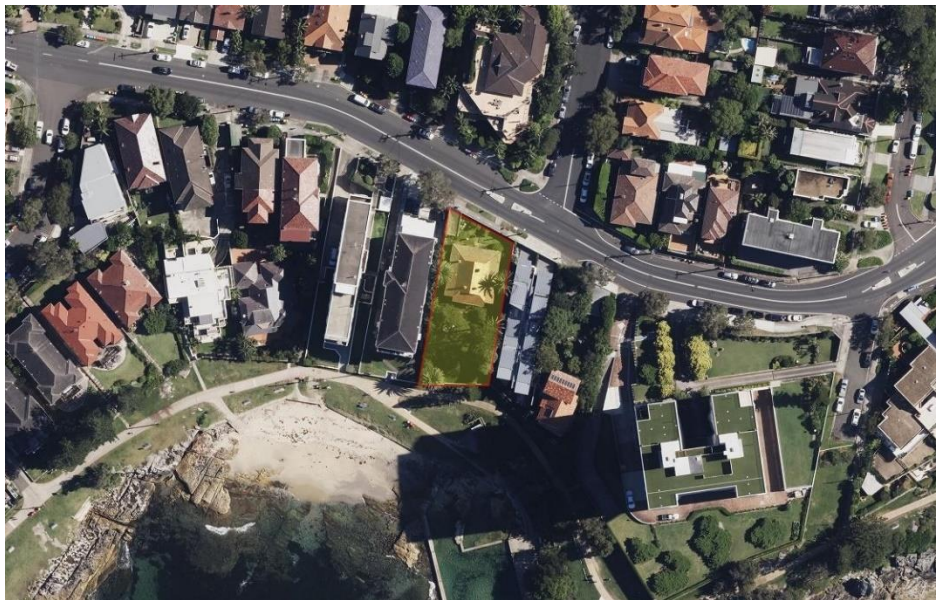
Based on the orientation in the outcrops, the bay to the south probably indicates a local drainage gully.

Photograph-1: Aerial photo of site and surrounds (source: SIX Maps, access 21/6/2024)

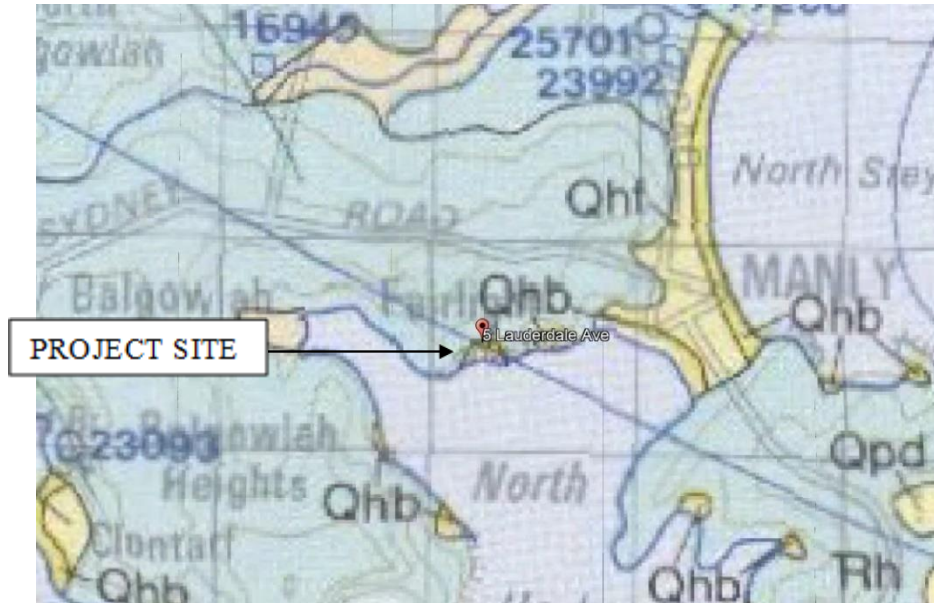
Reference to the Sydney 1: 100,000 Geological Series sheet (9130) indicates that the site is located near the boundary between Hawkesbury Sandstone (Rh) and Coarse quartz Sand (Qhb). The Hawkesbury Sandstone (Rh) typically comprises medium to coarse-grained quartz sandstone with minor lenses of shale and laminate.

The Coarse Quartz Sand (Qhb) typically comprises coarse-grained sand with varying amounts of shell fragments and is deposited over the bedrock within the adjacent foreshore beach environment.

Extract-1 of Sydney: 1:100 000 – Geology underlying the site

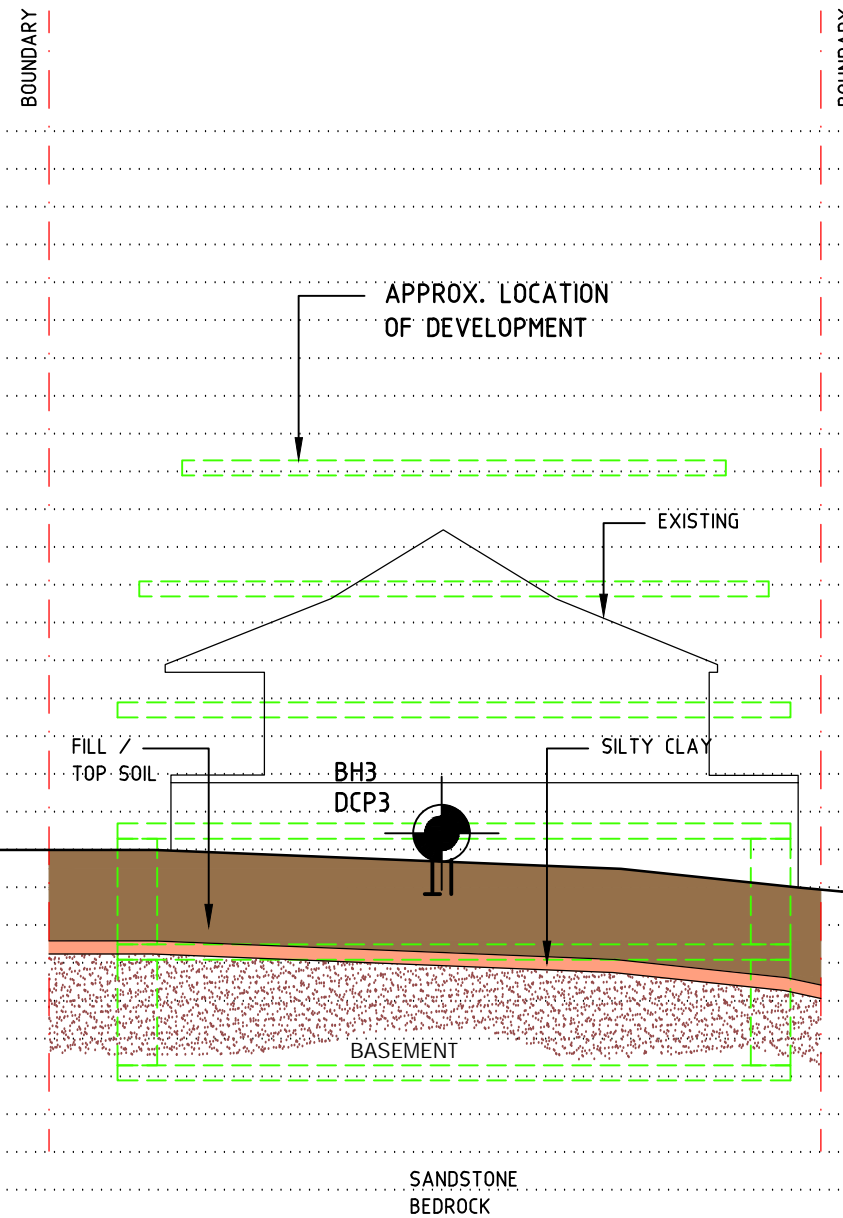
FIGURE 3

GEOLOGICAL MODEL
