SEASONED TREE CONSULTING

ARBORICULTURAL IMPACT ASSESSMENT REPORT

Site Address-
**129 Upper Clontarf Street
Seaforth NSW 2092**

| <u>Date</u> | 15 November 2019 |

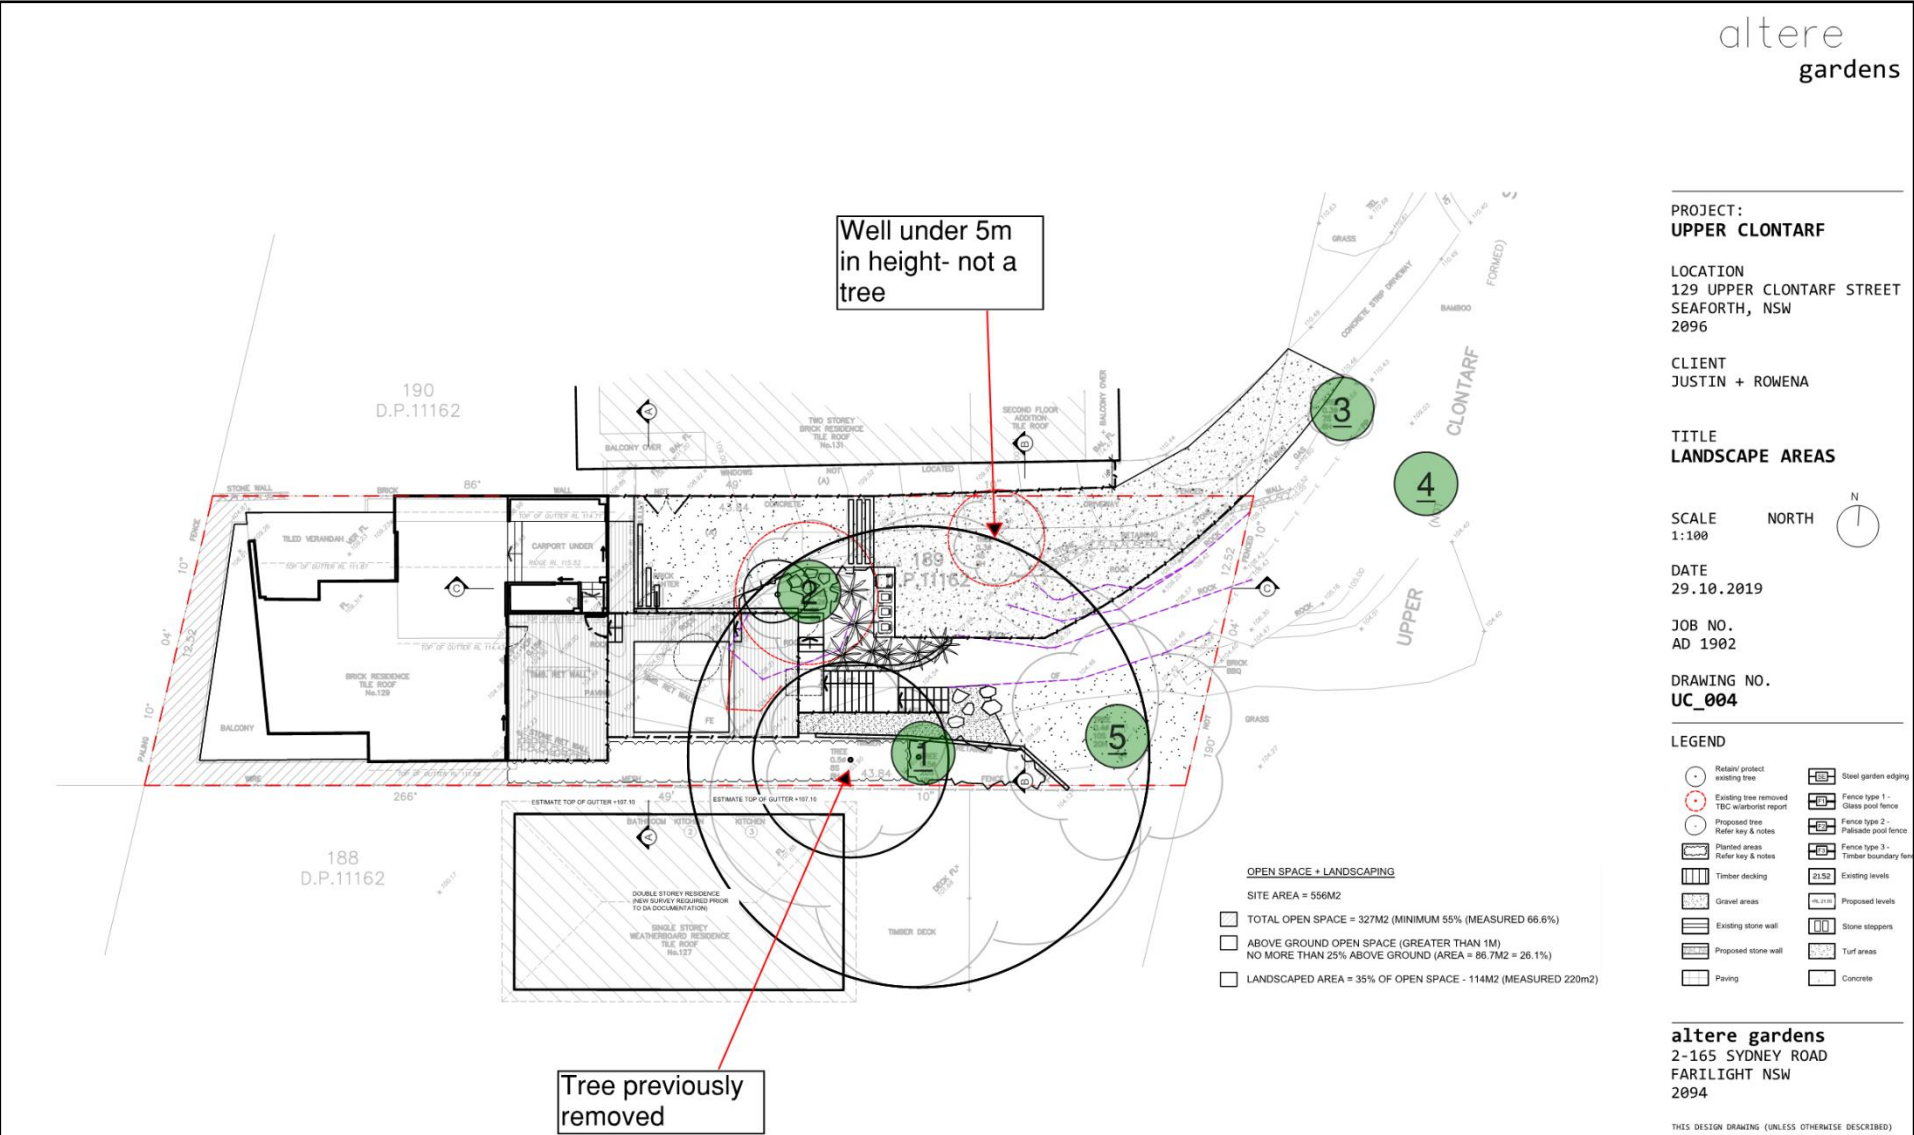
APPENDIX B - Tree location Plan

Trees identified are assessed in Appendix A and tree numbers are noted on a Tree location Plan in Appendix B.
