Report Title: Geotechnical Report 103 Narrabeen Park Parade, Mona Vale

Report Date: 29/7/20

GEOTECHNICAL INVESTIGATION:

New Garage, Storeroom and Lift at **103 Narrabeen Park Parade, Mona Vale**

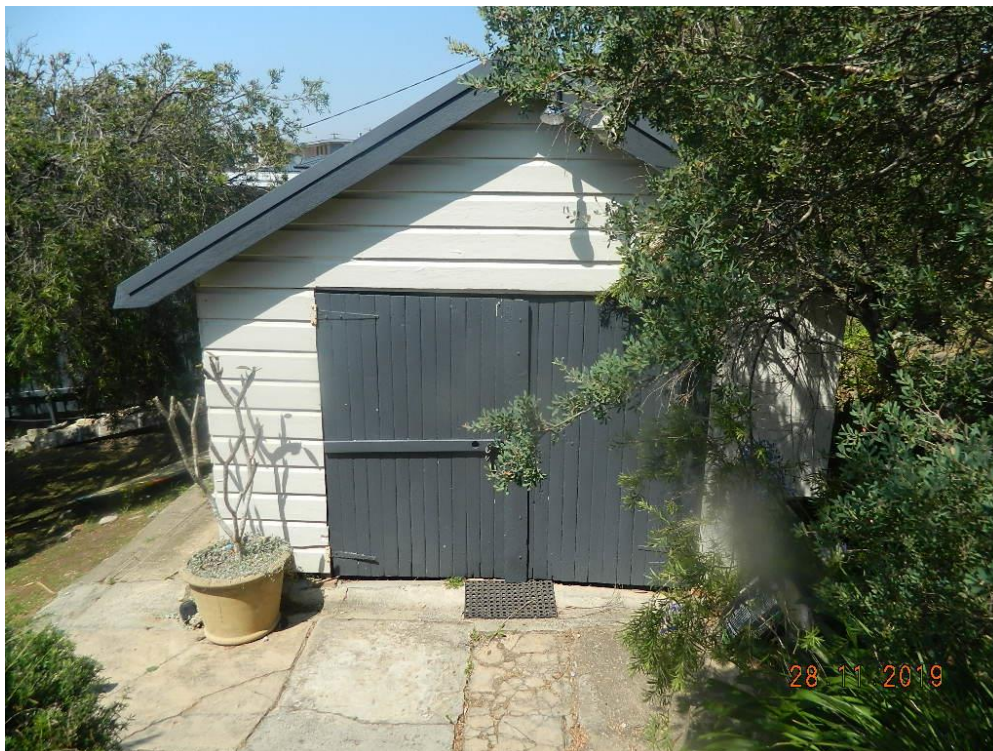
Photo 5

natural slope. In a small section adjacent to the stairs it is lined with bricks (Photo 4). The timber and weatherboard clad garage is supported on a concrete slab which shows some cracking but no movement related to slope instability (Photo 5). Between the driveway and house are garden beds and a lawn (Photos 6 & 7). An excavation has been made in the slope to provide a level platform for the house. The cut below the garden is supported by a stable stack rock retaining wall ~1.0m high (Photo 8). The cut below the lawn is supported by a stable sandstone retaining wall ~1.0m high (Photo 9).

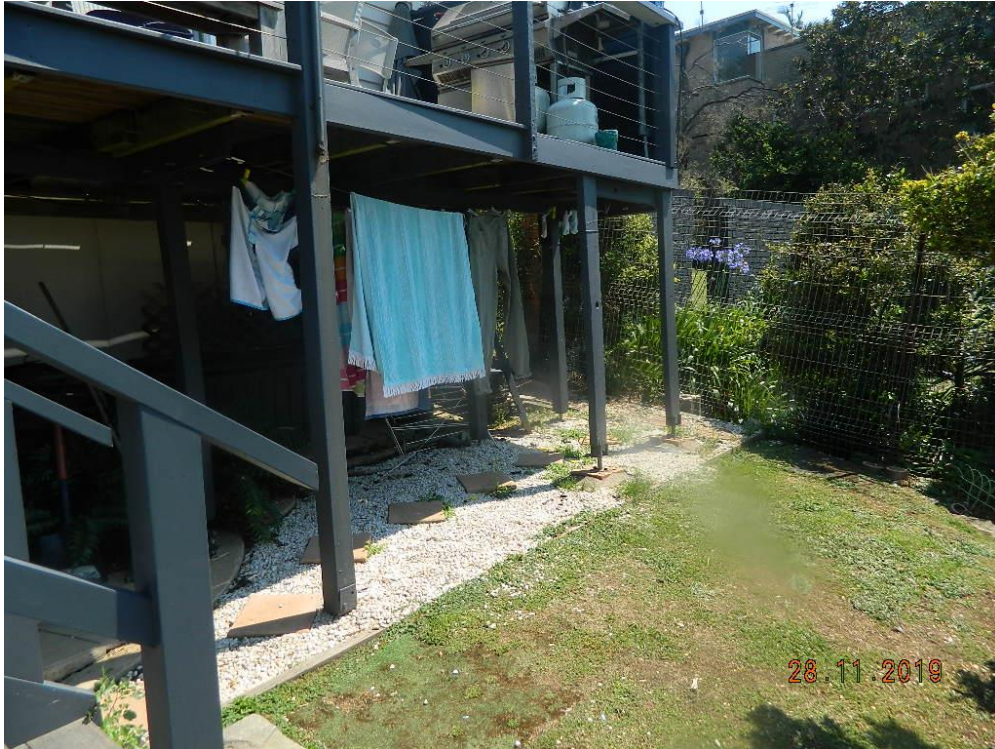
Photo 15

The two storey timber and weatherboard clad house is supported on brick walls, brick piers and concrete piers (Photos 10 to 14). The supporting walls and piers show no significant signs of movement. A stable timber retaining wall supports a cut batter located underneath the downhill side of the house (Photo 13). A suspended timber deck supported on timber posts extends off the downhill side of the house. (Photo 15). A fill that provides a level platform for a stone pavement is supported by a stable timber retaining wall (Photos 12, 16 & 17). A moderately sloping lawn descends downhill to the SE boundary of the property (Photo 18). Below the boundary the surface is covered in coastal shrub and continues to Warriewood Beach (Photos 19 & 20).
