Address of site 28 Pacific Road, Palm Beach

Report Title: RISK ANALYSIS & MANAGEMENT FOR PROPOSED ALTERATIONS AND ADDITIONS AND SWIMMING POOL AT 28 PACIFIC ROAD, PALM BEACH- QY 00170

Report Date: 25th January, 2021

**RISK ANALYSIS & MANAGEMENT
FOR
PROPOSED ALTERATIONS AND ADDITIONS
AND SWIMMING POOL
AT
28 PACIFIC ROAD, PALM BEACH**

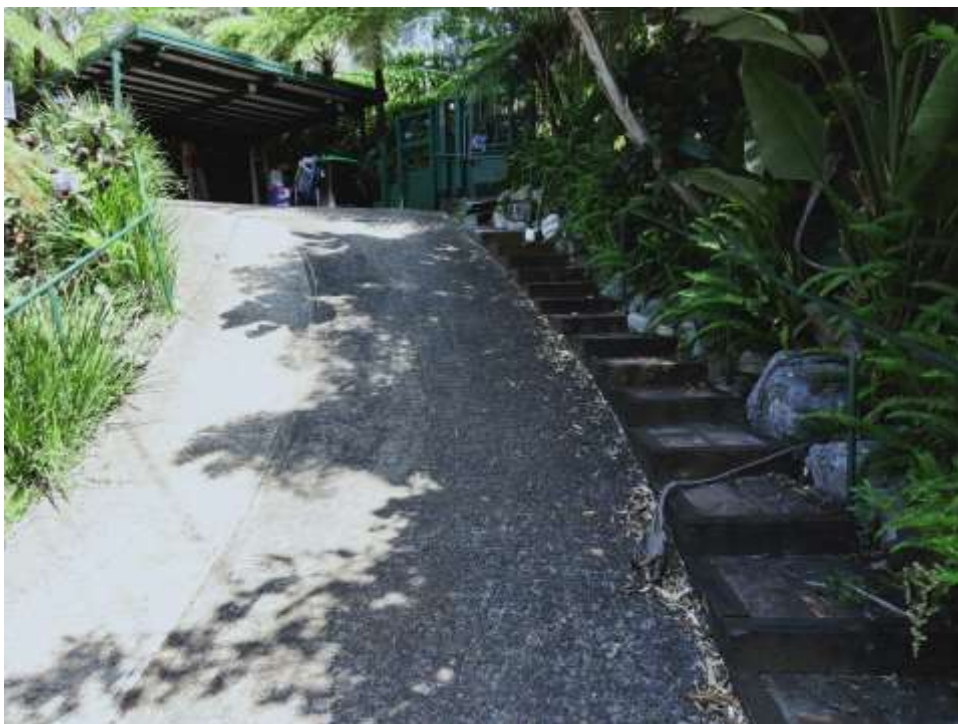
Photo 2

3.3 Vehicular access is from Pacific Road via the concrete crossing and paved driveway, Photo 1. A set of stairs on the western side of the driveway provides pedestrian access to the landscaped path and stairs which leads to the main entrance of the residence, Photo 2. The carport is at the top of the driveway where the exposed Hawkesbury Sandstone can be seen on the uphill side of the carport, Photo 3. An inclinometer runs adjacent the western boundary toward the main entrance of the existing residence, Photo 4. The front yard is a sloped lawn and garden area with some smaller landscaping retaining walls, Photo 5. Access to the rear of the existing residence is via landscaped stairs of the western side of the residence, Photo 6. The rear yard is a lawn and garden area sloping up to be level with the first of the existing residence, Photo 7. The natural slope is evident on the eastern side of the existing residence, Photo 8. Some cracking in the masonry was observed near the south eastern rear corner of the existing residence, Photo 9. Evidence of water flowing under the existing residence was observed which has also been previously controlled by a series of dish drains, Photos 10 to 11.
