Report Title: Geotechnical Report 60 Palm Beach Road, Palm Beach

Report Date: 2/9/19

## **GEOTECHNICAL INVESTIGATION:**

New pool at **60 Palm Beach Road, Palm Beach**

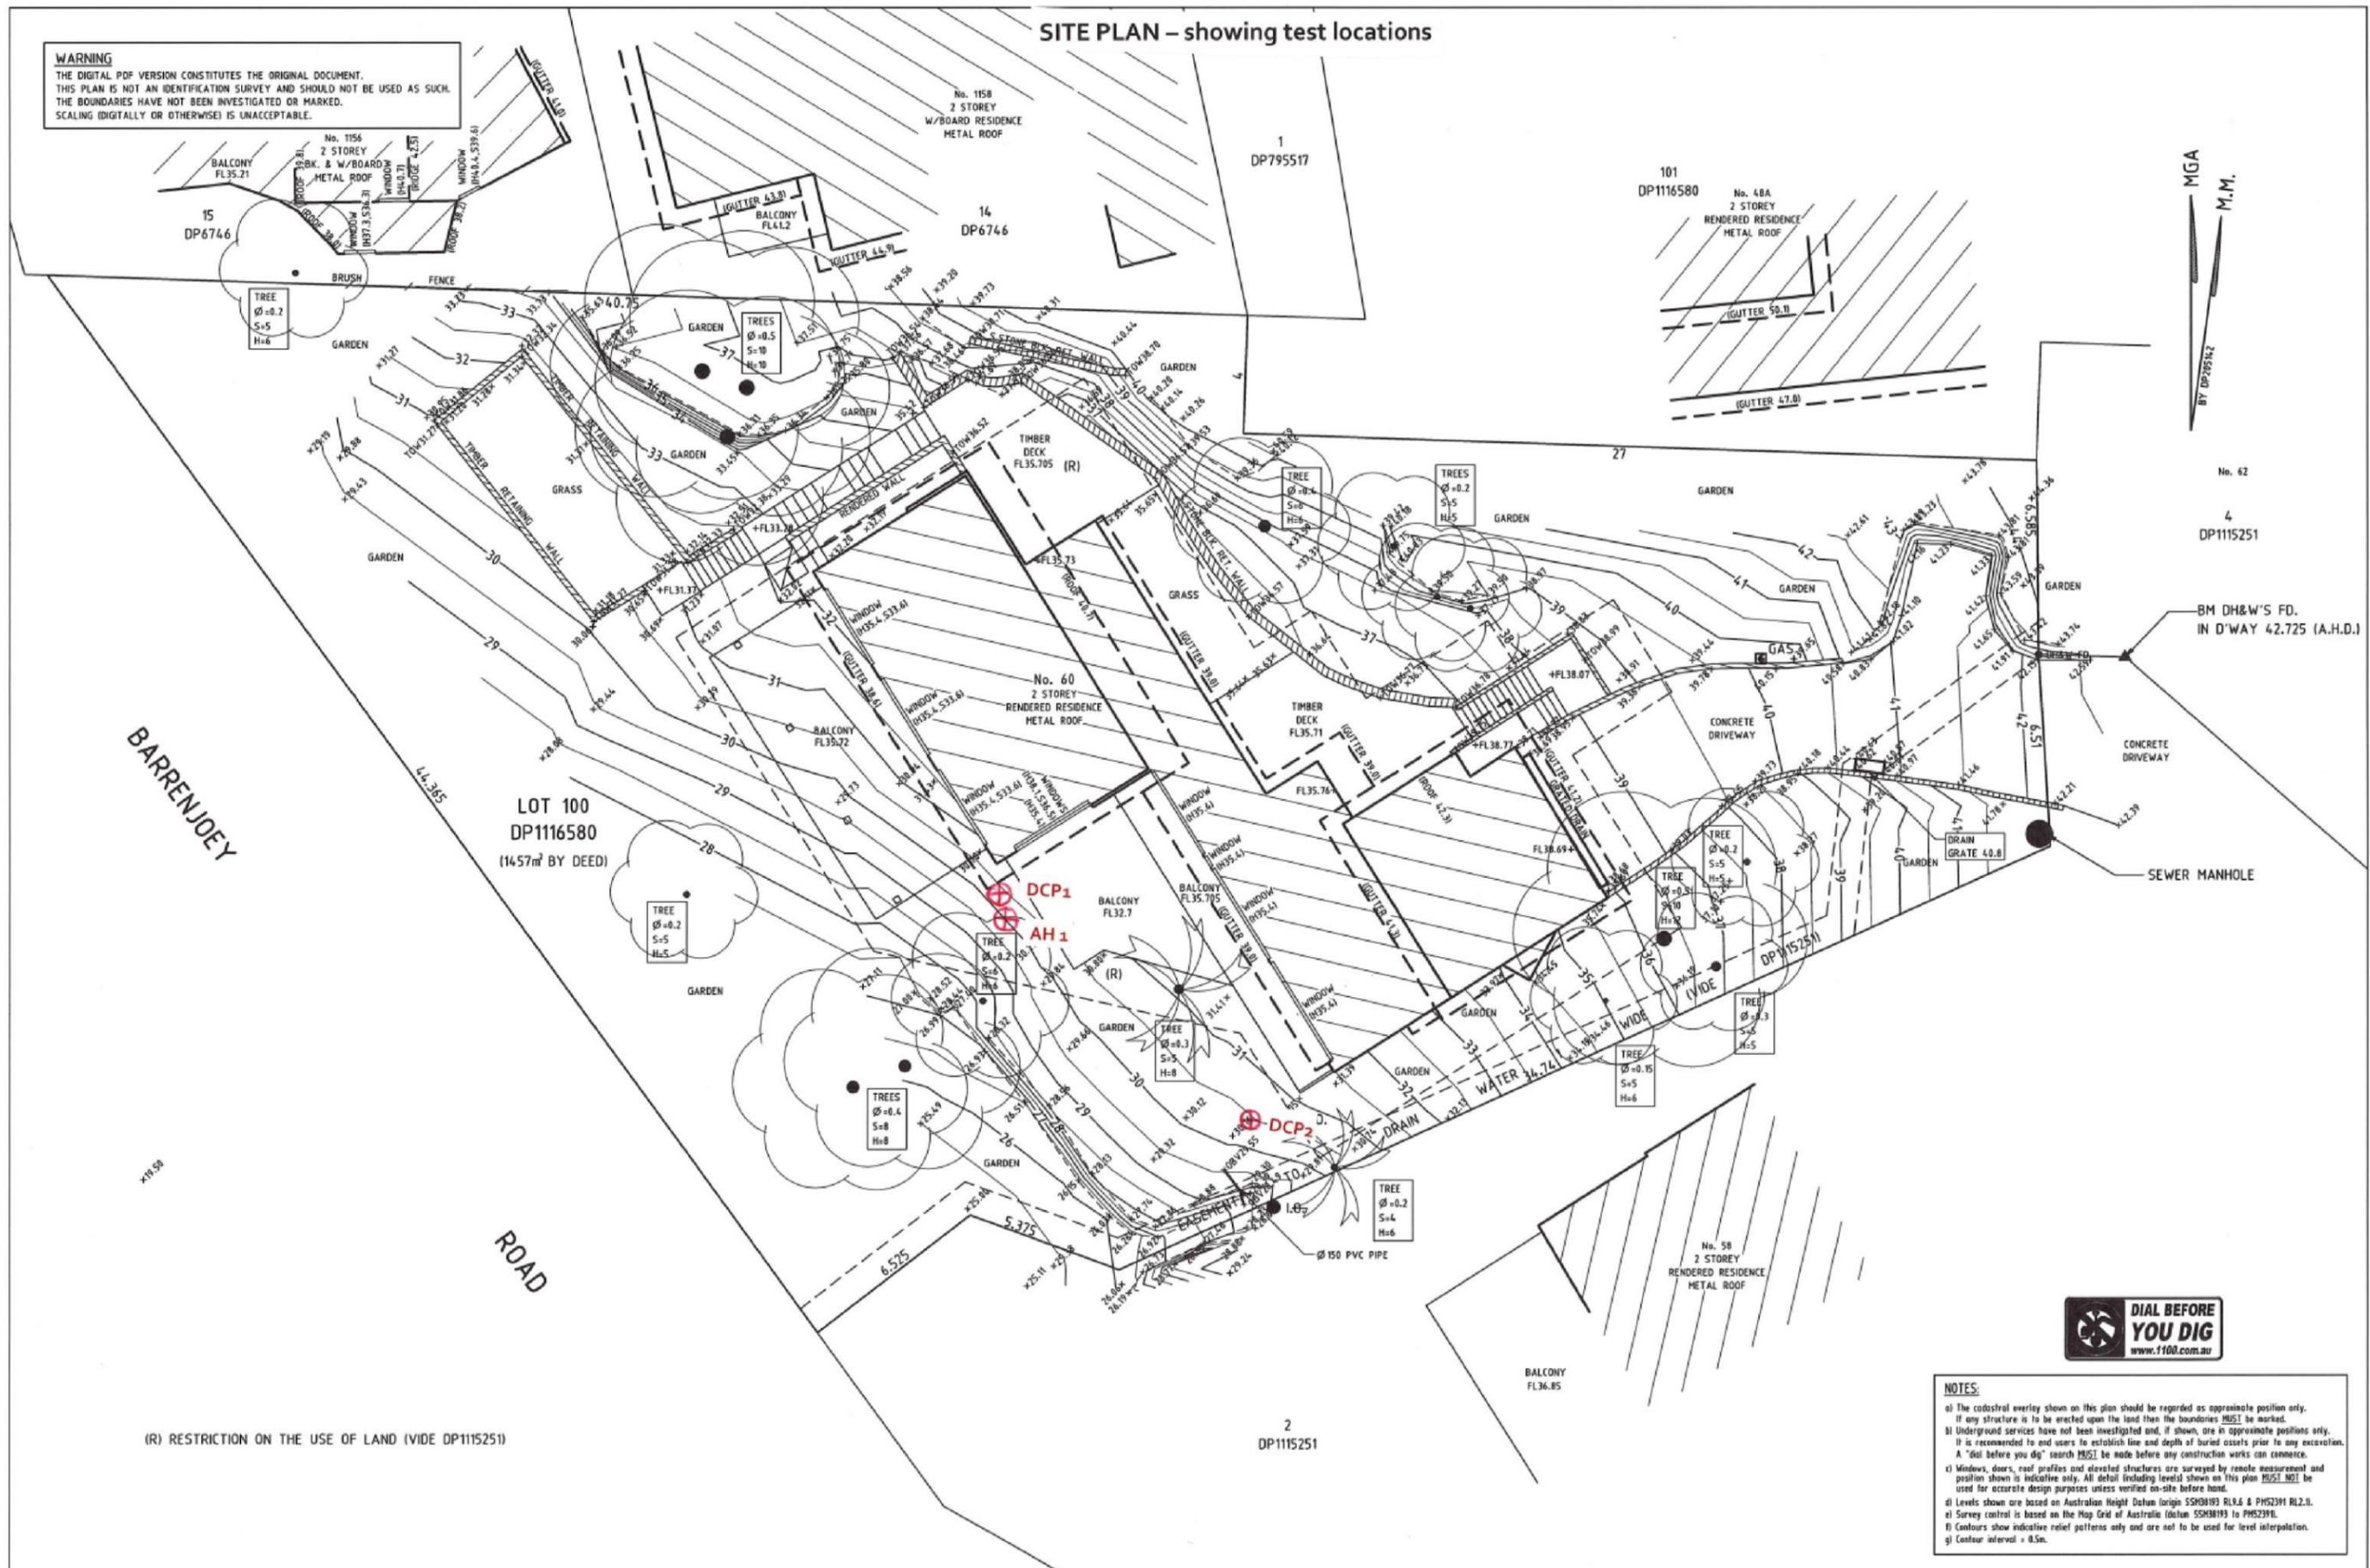
**SITE PLAN – showing test locations**

One auger hole was put down to identify the soil materials. Two DCP (Dynamic Cone Penetrometer) tests were carried out to determine the relative density of the overlying soil and the depth to bedrock. The locations of the tests are shown on the site plan. It should be noted that a level of caution should be applied when interpreting DCP test results. The test will not pass through hard buried objects so in some instances it can be difficult to determine whether refusal has occurred on an obstruction in the profile or on the natural rock surface. This is not expected to be an issue for the testing on this site and the results are as follows:
