Report Title: Geotechnical Report 30 Narrabeen Park Parade, Warriewood

Report Date: 26/6/19

## **GEOTECHNICAL INVESTIGATION:**

### **New Secondary Dwelling at 30 Narrabeen Park Parade, Warriewood**

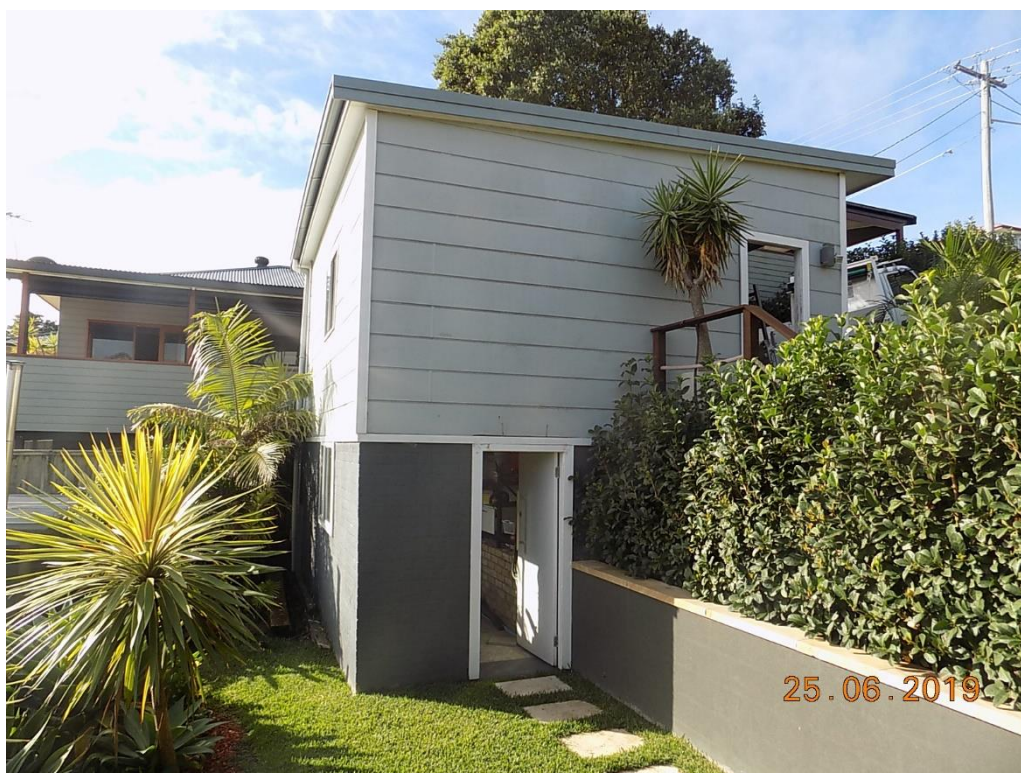
Photo 1

- 2.3** Low to Medium Strength Sandstone was observed to be outcropping on the opposite side of the road to the subject property (Photo 1). At the road frontage, a concrete driveway runs down the slope to a stable brick and clad garage on the uphill side of the property (Photo 2). The slope between the road frontage and the house is terraced with a series of stable brick, stack rock, and rendered masonry retaining walls (Photos 3 & 4). Some of these walls will be demolished as part of the proposed works. The single-storey brick house is supported on brick walls and brick piers (Photo 5). A near-level lawn-covered fill extends off the downhill side of the house to the lower

Sandstone bedrock outcrops on the opposite side of the road to the subject property (Photo 1) and the owner of the N neighbouring property informed us that he encountered sandstone during excavation works on the uphill side of his property. We interpret this to be a thick sandstone bed within the Narrabeen Group of rocks. The rock is overlain by a thin sandy soil and sandy clays. In the test locations, rock was encountered at depths of between 0.5 to 1.3m due to the terraced land surface and stepped nature of the rock. The sandstone that outcrops on the opposite side of the road is estimated to be low to medium strength and similar strength rock is expected to underlie the proposed works. See Type Section attached for a diagrammatical representation of the expected ground materials.
