GEOTECHNICAL RISK MANAGEMENT POLICY FOR PITTWATER

RISK ANALYSIS & MANAGEMENT FOR PROPOSED GARAGE & ALTERATIONS AND ADDITIONS AT 3 BEACONSFIELD STREET, NEWPORT

The work is to be carried out in accordance with the Risk Management Report PX 00005 dated 1st July, 2019.

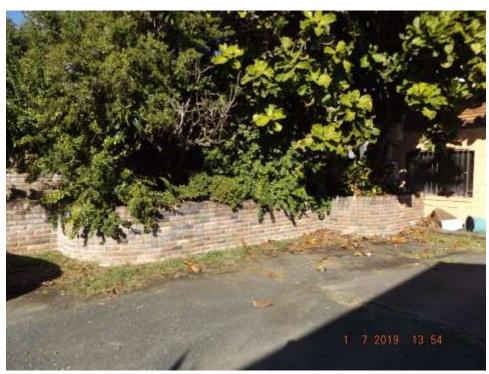
Photo 1

- 3.3 Access to the property is via the gravel driveway which starts from the edge of the Beaconsfield Street adjacent north western corner of the property, Photo 1. A terraced masonry retaining wall supports the cut on the eastern side of the driveway, Photo 2. A pathway from the side of the driveway provides pedestrian access to the main entrance, Photo 3. A level courtyard area is on the eastern side of the existing residence, Photo 4. On the western side of the existing residence the driveway continues to the south providing access to rear of the property changing into concrete, Photo 5. A series landscaping retaining walls are providing support at the south western corner of the property, Photo 6. These retaining walls are located on neighbouring properties and were observed to be in good condition with no signs of significant movement. A concrete block retaining wall supports the fill material at the north eastern corner of the property and was observed to be in good condition with no signs of significant movement, Photo 7.
