Report Title: Geotechnical Report 10 Grandview Drive, Newport

Report Date: 5/8/19

GEOTECHNICAL INVESTIGATION:

Alterations and Additions at 10 Grandview Drive, Newport

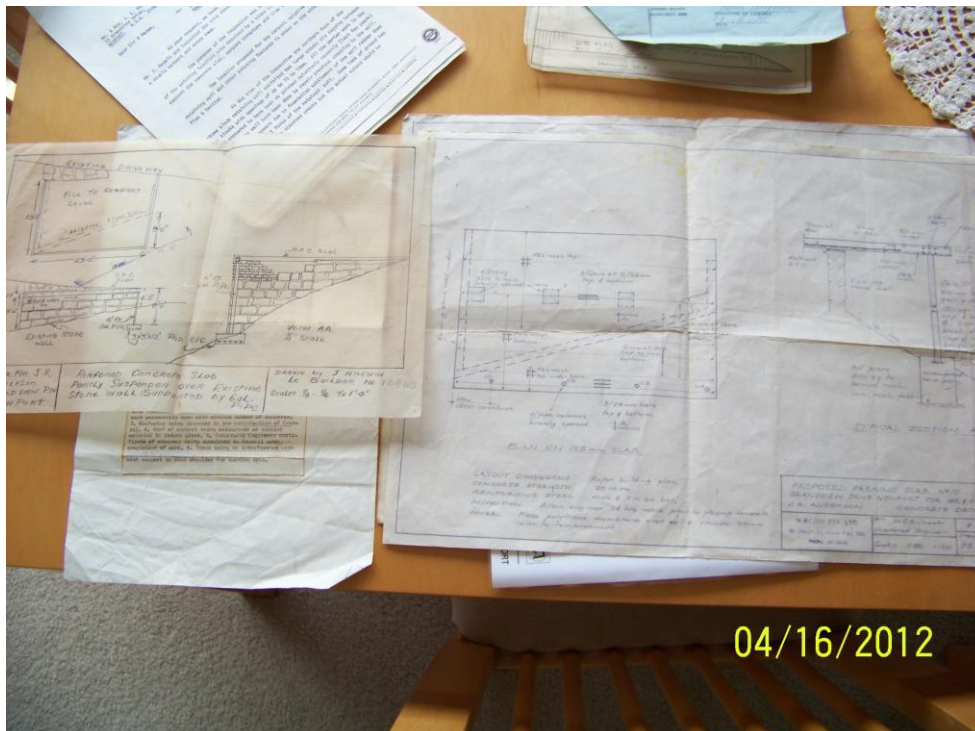
Photo 1

- 2.3** A right of carriageway runs from the road and provides access to a double garage near the upper boundary of the property. The garage can be seen to be supported on sandstone block walls and steel posts (Photo 1). The owner had the original plans available at the time of the inspection and these show the slab is also supported on three piers behind the wall (Photo 2). The sandstone block walls show cracks on the downhill face that rise from the base of the wall between the mortar and step up the face (Photo 3). The cracking appears to be from settlement and potentially tree roots. The wall shows little deflection and has shown no significant signs of movement from the last inspection in 2012, as such the wall is considered stable. Rough cut concrete steps run down the slope to a path and the main entrance
