J2328. 9<sup>th</sup> September, 2019. Page 1.

# **GEOTECHNICAL INVESTIGATION:**

Secondary Dwelling and double garage at 42 Elanora Road, Elanora Heights

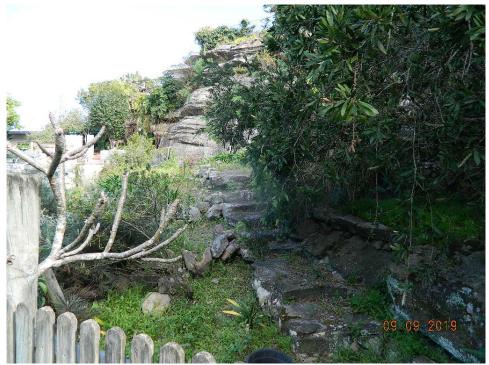
Photo 1

**2.3** From the road frontage two 0.4m high mortared sandstone block retaining walls on outcropping sandstone terrace the street frontage (Photo 1). These stable walls support garden beds. A rough sandstone block and cut stairway travels along the NE boundary granting access to the rear of the property (Photo 2). Where mortared sandstone blocks are not used to support the cut batters for the stairway it is cut into outcropping rock. Outcropping sandstone was visible across the site from the road frontage to the base of the house (Photo 3). A sandstone cliff some 7.5m high rises below the house. There is some minor undercutting around the upper bedding plane

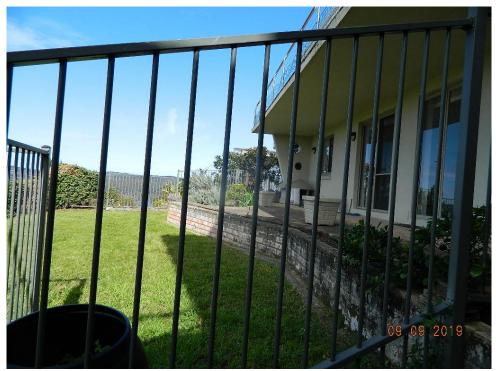
Photo 5

but no significant geological defects where observed in the rock that could impact of its stability. The rock making up the cliff is Medium Strength or better and the formation is considered stable (Photo 4). Above the face a level lawn and paved terrace extend to the foot of the house (Photo 5). The 2 storey brick house shows no signs of movement or any visible cracking in its external walls and is considered stable. A paved parking area extends uphill of the house to a garage. A concrete paved right of way carriageway (ROW) enters the property form Dewrang Ave to the N (Photo 6).
