INTERNATIONAL MOUNTAIN BICYCLING ASSOCIATION AUSTRALIA

Trail Audit Documentation

Manly Dam (Manly Warringah War Memorial Park)

- Warringah Council

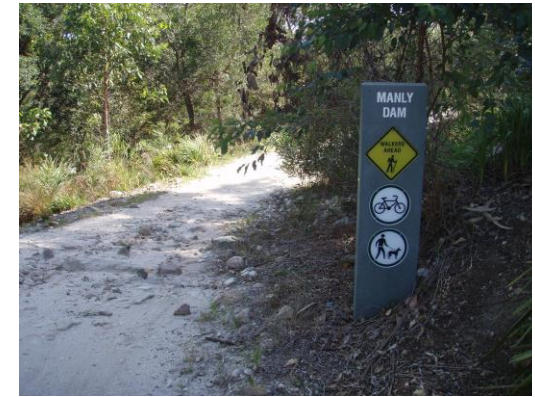
Some of the existing signage at Manly Dam, such as this example above, is very good. There is however a lack of consistency and some considerable gaps in provision.

12 locations have been identified as park entry/exit points where trail-head signage could be warranted. This is a substantial number and could be rationalised by prioritising say 5-6 locations as main trail-heads and installing totem style signage at the other 6-7 locations.

Approximately 50 locations have been identified where trail markers and/or cautionary signage is warranted. In most cases the cautionary signage could be done in a trail marker style; in a few cases where more detailed and specific information is required, the caution signage could be done in a totem-style.

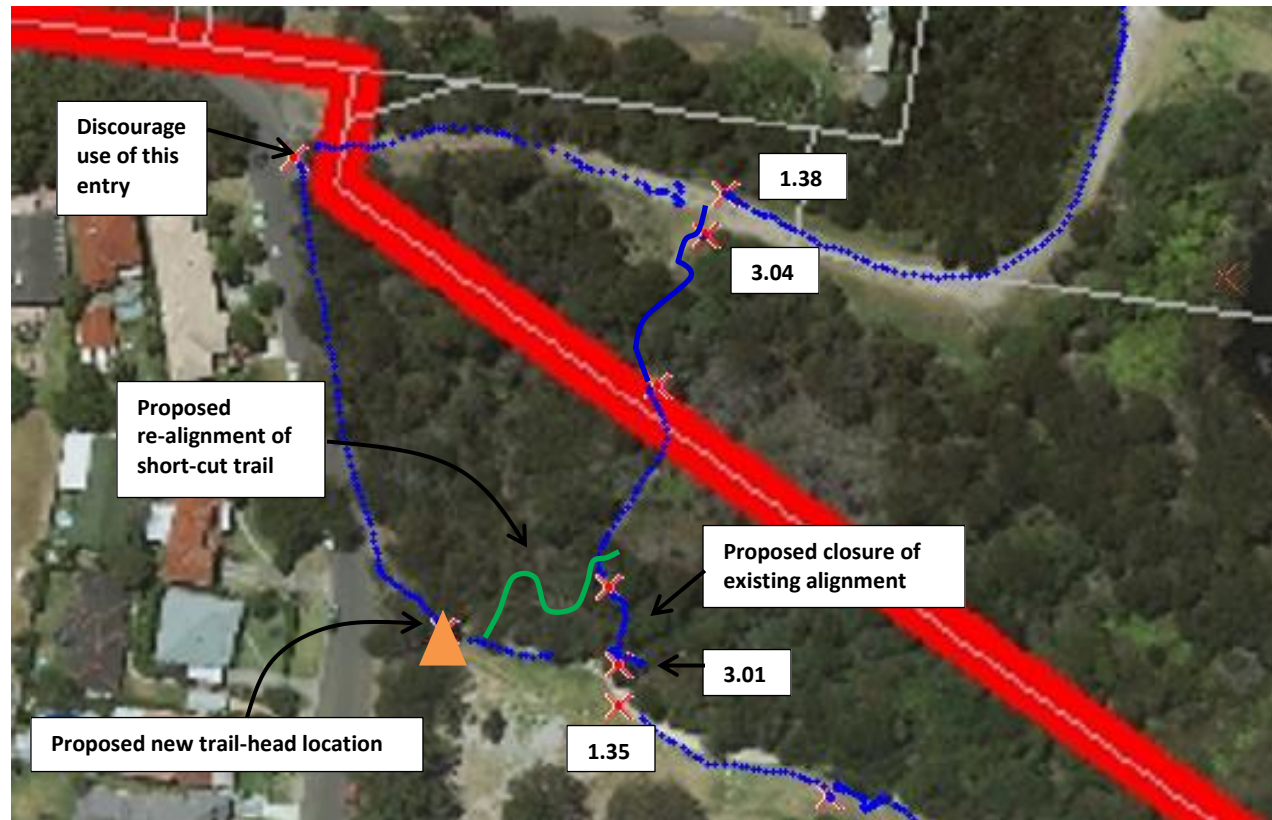
WP3.02 – This first section of the short cut trail has drainage problems, but a minor re-route is easily achieved and the rest of the trail is quite sound.

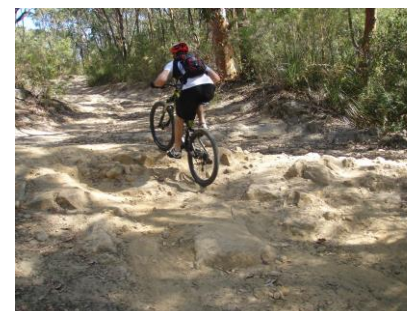
- Heartbreak Hill – the steep climb is degraded and most likely will continue to worsen. The erosion is resulting from both water and user-action, and users are seeking easier ride lines on the track edges and meandering within the corridor, so widening is occurring. It is (arguably) a fairly poor riding experience.

A typical view of the ascending management track section between WP4.14 & WP4.15, ‘Heartbreak Hill’.

2	Address degradation and poor riding experience on 'Heartbreak Hill' ascent.	OPTION 1: CREATE ALTERNATIVE SINGLE TRACK OPTION		
		Develop new single track trail for shared use (MTB ascent + foot traffic either direction). Proposed single track alignment is flagged to western side of management track at sustainable gradients relative to side slope (av. trail gradient = <5%). It is quite easily achievable and will require some minor stone armour work through sandstone outcrop sections. <ul style="list-style-type: none">• Total new trail length: 850m approx.• Allow for 20m x 1m stone armouring.• Length of management track bypassed: 100m approx.	Start point — new trail deviates with management track at WP9.01. End point — new trail meets management track at WP9.12.	<ul style="list-style-type: none">• Warringah Council to lead assessment, approvals & further trail planning• Trail contractor to construct.

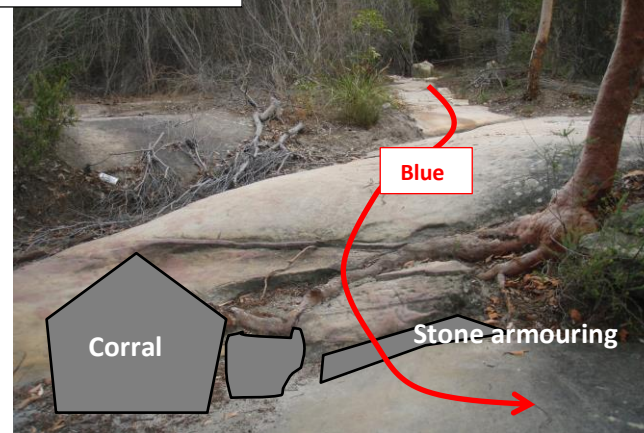
Blue-square line

(Left) – View looking up black-diamond line. Some minor stone armouring will enhance this line.

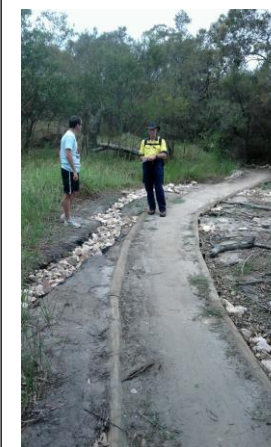
WP6.17 – A well-constructed raised tread section. This technique is very effective. Stone is recommended rather than timber and this feature may need regular maintenance to prevent drain blockages.

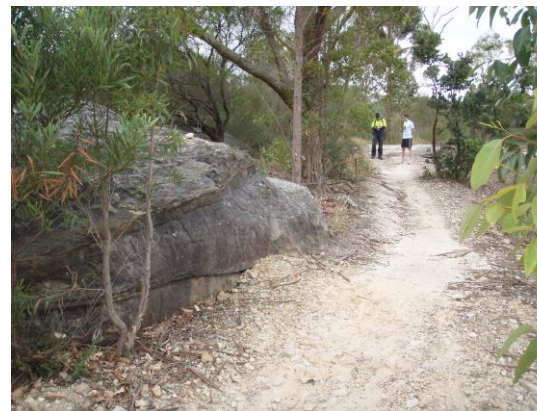
Sandstone outcrops are a distinguishing feature of the Manly Dam loop and entire North Shore Sydney region. There is scope to incorporate more of these natural outcrops into the trail loop to add interest to the trail as well as improve overall trail sustainability.

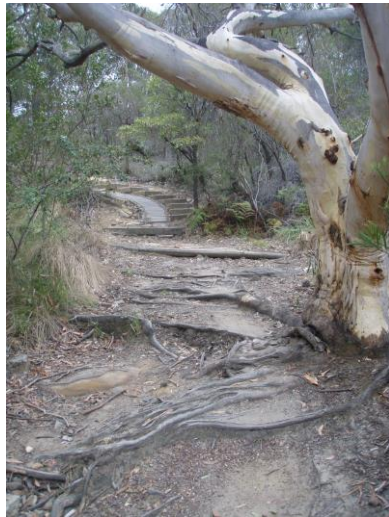
WP6.33 (right) – Some excellent work has been done in this area such as the Dutch ladder combined with steps (background). User-caused erosion and trail-widening are still problems though (foreground). Clarity around land tenure should be sought with Uni of NSW to establish best management approach for this section of the trail.

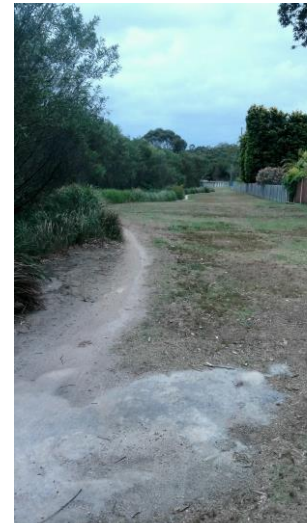
WP6.28 (above) – Rolling Grade Dips are required through this section to ensure adequate drainage. A lack of pruning has contributed to the emergence of a ride line on the left. Some 'wiggle' in this trail reinforced with corrals would improve its flow and help moderate user speed.
