# MANLY DAM WALKING TRACKS AUDIT

for  
**Northern Beaches Council**  
May, 2017

CONTROLLED DOCUMENT  
**“Manly Dam Walking Tracks Audit”**

**FINAL ISSUE**

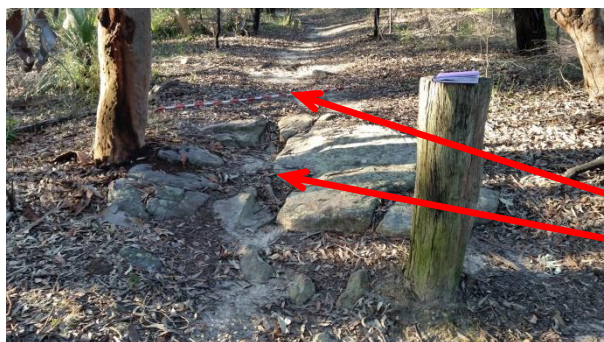
##### Site ID: MHT – 1(A)

**Location:** 338562 6260439 Embedded rock/outcrop (slightly angled) and smaller embedded rocks beside Angophora, gap between rocks with drainage down to S, 2 timber (log) posts

Fill narrow gap/drain with rock, and match to existing levels.

**(low)**

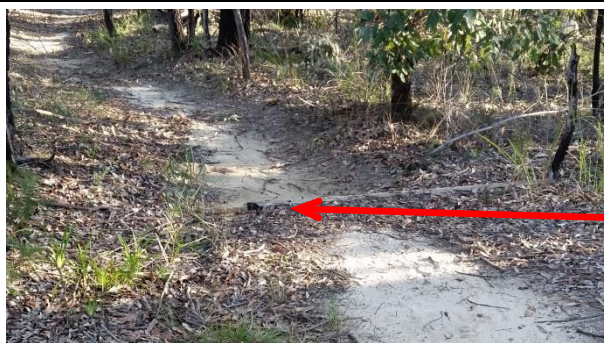
##### Site ID: MHT – 1(B)

**Location:** 338568 6260452 Waterbar with burnt end, full/failed and flows over/through gap.

Replace/repair waterbar and clean out.

**(low)**

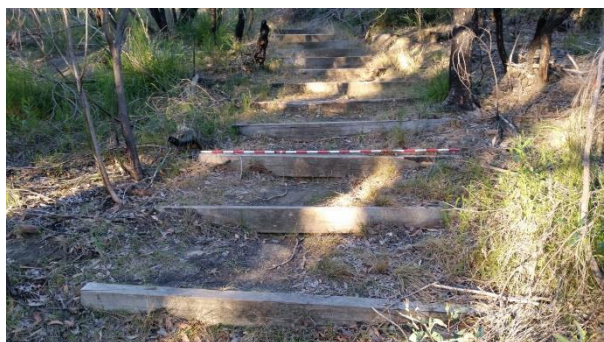
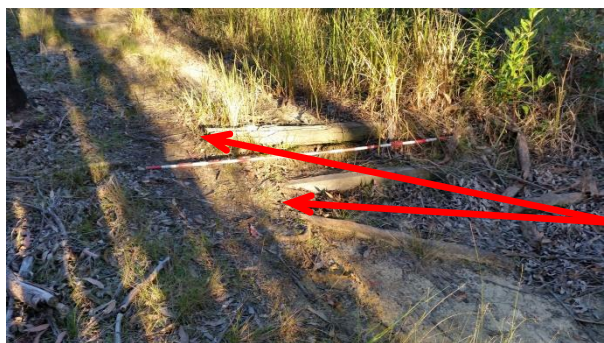
Run of 28 wide (2.4m) sleeper step-and-runs and occasional steps (some boxed a few with stone end blocks), 2 sleeper waterbars (1 with an old log step above, in lower third of site), most timbers are scorched or burnt but still serviceable, compacted sand with laterite gravel, lower 7-8 step-and-runs are full of loose sand, occasional roots, 5° on lower section 9.5° in middle 7° on shorter upper section, middle and upper treatments still have some freeboard but drainage over all treatments (but no problems/scour), main track 900-1600mm wide within wider step-and-runs.

Repair/replace 4 burnt timbers - or just cut and replace burnt ends (or box ends, or install end blocking stones).

Extend waterbar and replace old log step with new waterbar above (at old log step/waterbar in lower third).

**(low)**

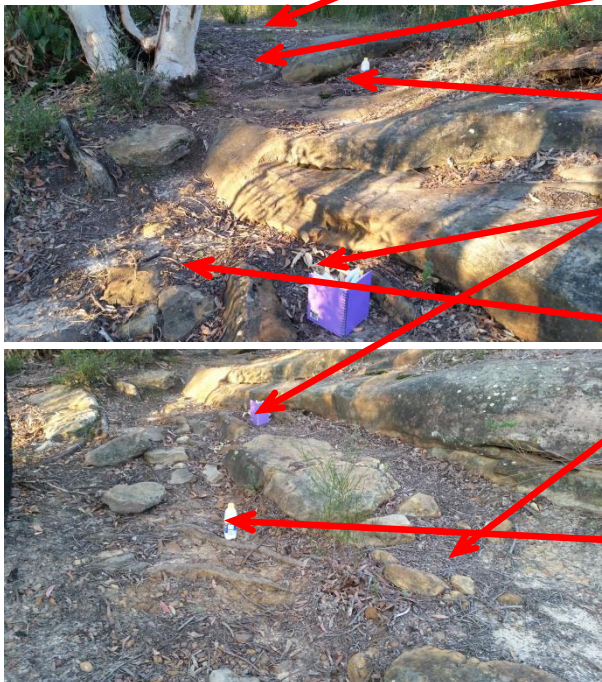
**Site ID: MHT – 2(B)**

**Location:** 338636 6260476 Rock shelf/ledge with embedded and broken rock, roots and gravel/stones below, 2 rock outcrops above with “natural” step in lower ledge, drainage down, track 800-1200mm wide (but indistinct over wide rock ledges angling across track) some track widening (especially in S).

Block/barrier (rock rubble) higher direct route to S/SW and embedded rock area to W to direct users onto flat rock outcrop along low side of rock shelf/ledge.

**(low)**

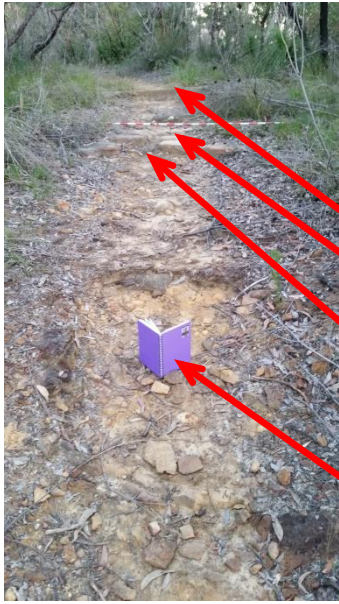
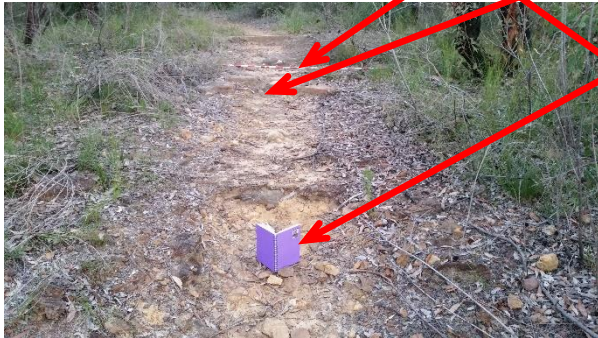
### Site ID: MHT – 3A

*Location:* 338678 6260486 Loose sandstone and laterite gravel on 6° slope, dished to 50-75mm BNSL with drainage flows, low laterite outcrop with lip in bottom third, embedded sandstone blocks as natural step but central gap with drainage flows through/down, low sandstone pavement/outcrop and sleeper waterbar (full/failed, with drainage flows over) at top.

Build waterbar/step to catch and divert drainage flows down track from “loop” on crest upslope, cut discharge channel or extended outlet through mound to N (if required).

**(low)**

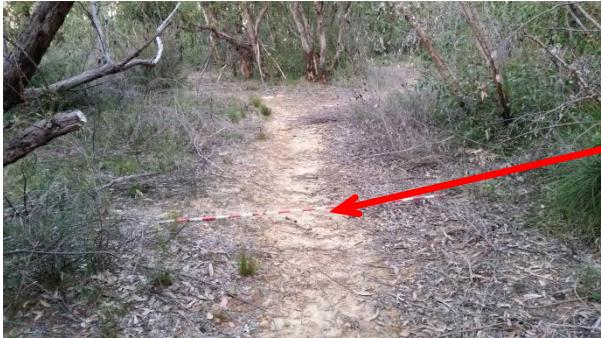
**Site ID: MHT – 3C**

*Location:* 338707 6260484 “Loop” track in crest around small copse of Eucalypts, 1-1.2m wide compacted sand and laterite gravels/stones, track to N side of tree is more heavily used, track to S of trees runs more directly up/down slope, sloped 4° down to W, “cubby-house” of sticks in centre of trees.

Close/block and disguise upper section of unmanaged track to N off “loop” (if not to be retained and managed as part of approved track network).

**(Medium – for environmental/sustainability and user orientation/safety issues)**

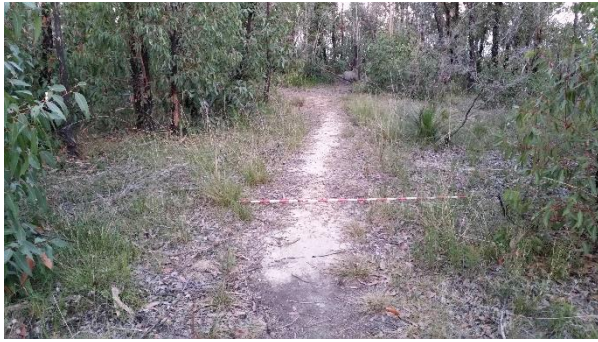
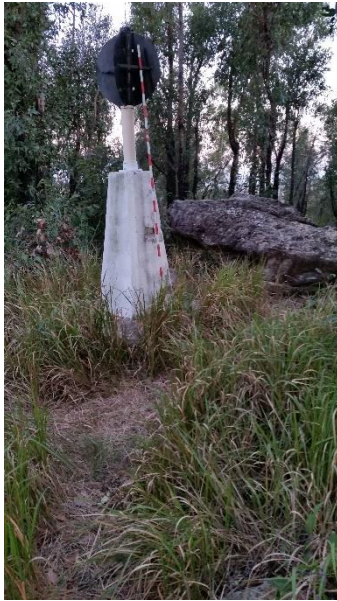
**Site ID: MHT – 3 (end) C**

*Location:* 338725 6260458 End of MHT at Trig Station, set in long grass and open spindly Eucalypts (fire regrowth) amongst sandstone boulders/outcrops. Track from “loop” (Site MHT-3(C)) of compacted and loose sand with laterite gravel, 600-700mm wide, up 1.5° slope. Multiple trample tracks away from Trig Station, with numerous clearings, “cubby-houses” and small fireplaces/fire-scars.

**(low)**

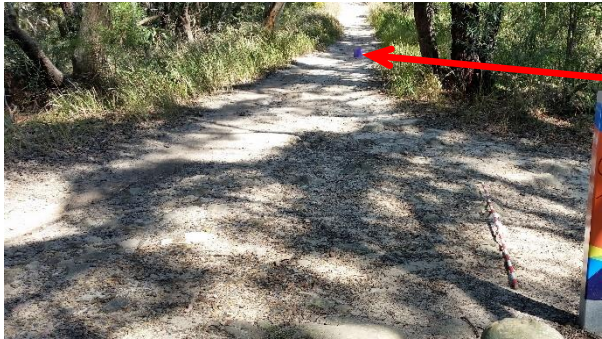
**Site ID: NTL – 1(A) (Note - on Perimeter Fire Trail 10M from top of NTL)**

**Location:** 338537 6260400 Located on the Perimeter Fire Trail 10m SW of junction (top) of NTL. Management trail.

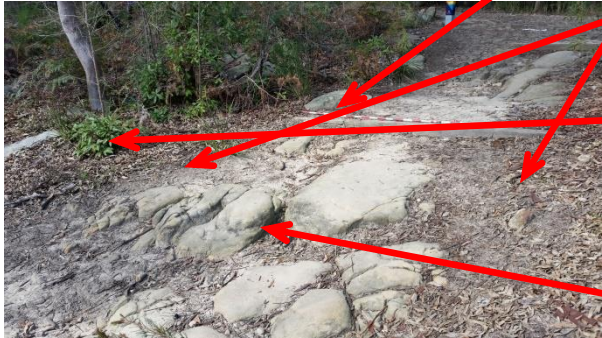
**Site ID: NTL – 1(C)**

*Location:* 338535 6260416 Sleeper waterbar (full of sediment and failed with drainage flows over) above squared/level rock outcrops, some loose rocks/sand, track to 2.4m wide.

Build a gutter paralleling N side of track (beyond rubble barrier) to direct discharge from waterbar, and flows off track, downslope towards outlet from stone-lined invert at next site (Site NTL-1(D)).

Rock armour infill to level uneven/broken areas of in-situ outcrops.

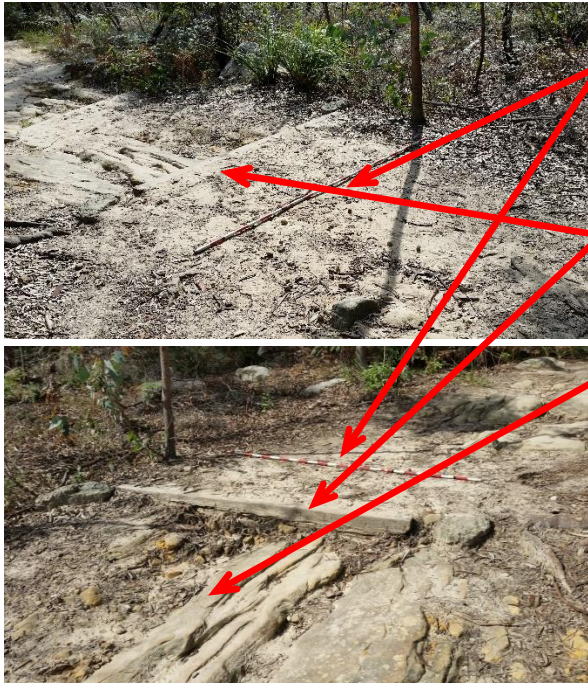
**Site ID: NTL – 1(D)**

**Location:** 338531 6260418 Flat deposition area of loose sand above sleeper waterbar, waterbar is partly rotted and has end rocks/blocks at each end but is full of sediment and failed with drainage over and scour below as well as drainage around S end, then sloping and angled rock outcrops (layered) downslope with compacted/loose and loose rocks/gravel to N, drainage flows down entire site, track to 2.8m wide.

Clean out waterbar and extend to S, to butt into slope and catch/divert drainage off slope and down S side of track. Replace waterbar if too rotted to re-use.

Potential site for a “kissing gate”, with wing fencing extending either side of track (to physical barriers, such as slope to S or gully to N), to prevent/deter mountain bike access and use – site is “defendable location” that is visible from junction with Perimeter Fire Trail (to reinforce no bike access message) and reasonably flat (avoid a sloped or disguised site, as difficult for bikes to stop)

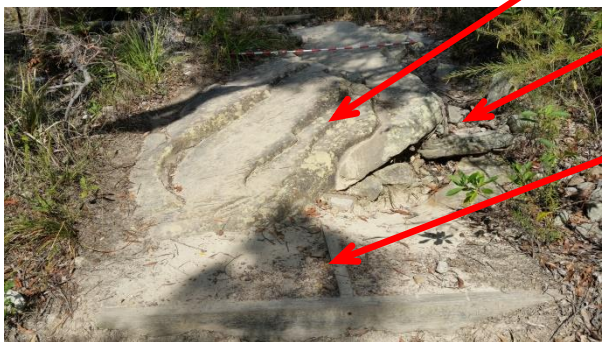
**Site ID: NTL – 1(H)**

*Location:* 338509 6260434 Sleeper step/waterbar, loose sand above, full of sediment and failed with drainage over and some scour, deeply dished track downslope of step/waterbar to 250mm below NSL for 1.8-2m with surface of compacted sand and embedded rock 2.2-2.4 m wide.

Clean out step/waterbar.  
Install a wide boxed step-and-run 1.2-1.5m below step/waterbar and fill/compact above/upslope over embedded rocks  
Pull-in track width along both edges, block access with edge definition and containment/barrier (rock rubble).

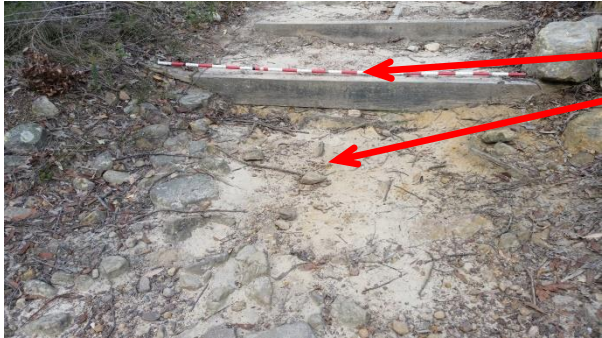
**Site ID: NTL – 1(I)**

*Location:* 338505 6260438 Old rotted pole step/waterbar with placed stone step/flagging below, waterbar full of sediment and failed with drainage flows over, track scour to S to 350mm below NSL, loose sand and gravel plus , embedded rock to S, 2.2-2.4m wide.

Replace rotted pole with 1 or 2 sleeper step/waterbars.  
Pull-in track width along both edges, block access with edge definition and containment/barrier (rock rubble).

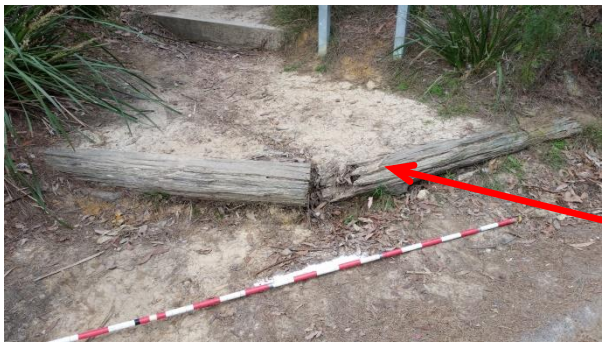
##### **Site ID: NT – 1(A)**

*Location:* 338476 6260524 Eastern entry to Nature Trail, at park access road (Sir Roden Cutler VC Memorial Drive) opposite war memorial, old log/pole step retaining loose sand tread above, but rotting/broken and trip hazard beside road.

Replace steps and pull back from road edge.

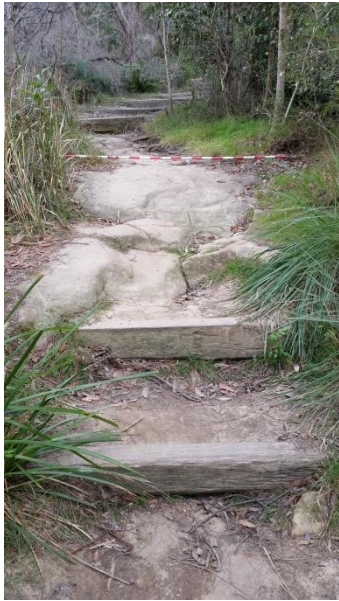
**Site ID: NT – 1(B)**

*Location:* 338480 6260517 Sloped rock outcrop with broken/embedded rock below, uneven outcrop with gravel above, slightly scoured sleeper steps below, 900-1200mm wide, 9° slope.

No works proposed. Leave as is - as a “filter” so track will not be appealing to less capable/mobile walkers or poorly prepared (e.g. wrong footwear)

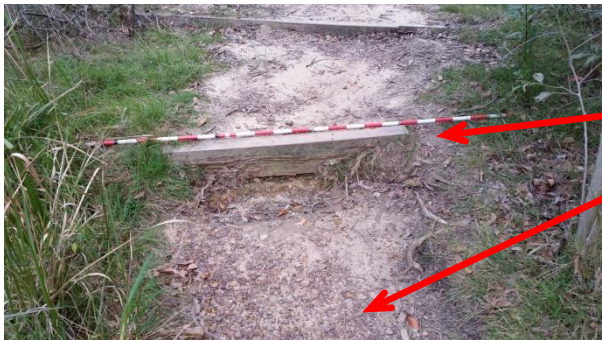
**Site ID: NT – 1(C)**

*Location:* 338484 6260510 Sleeper step (300mm high), scour over and around W end, entrenched 100mm below NSL below.

Extend sleeper step to west (or replace), and clean out.

New sleeper step below existing, fill and compact tread above/behind (fill can be delivered to site from nearby park access road, to S).

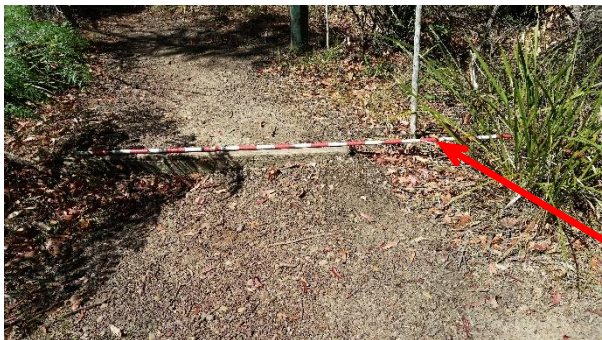
**Site ID: NT – 1(D)**

*Location:* 338481 6260506 Sleeper waterbar with flow/scour and around west end (just downslope of “Dogs Prohibited” sign).

Extend waterbar.

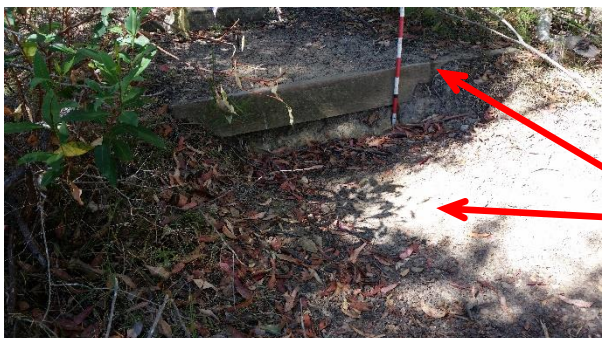
**Site ID: NT – 1(E)**

*Location:* 338481 6260499 Sleeper waterbar, full/failed with scour over and 400mm step off, track dished to 150mm below NSL downslope/below.)

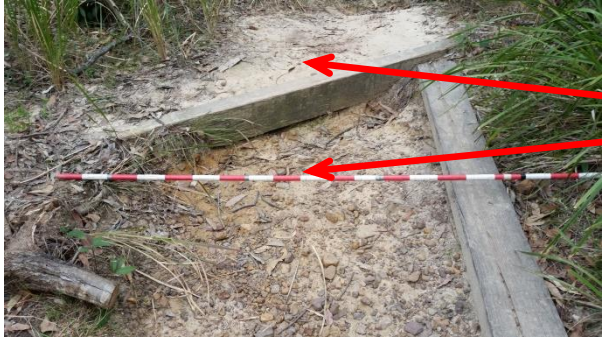
**Site ID: NT – 1(G)**

*Location:* 338488 6260476 Sleeper step (also acting as a waterbar). Wide sleeper step with rotten underside downslope/below. Short sleeper step downslope/below with scour around W end.

Clean out upper step, extend or replace as sleeper waterbar (discharging to W).  
Replace rotting (middle) sleeper step, and clean out.  
Extend (or replace) lower sleeper step, and clean out.

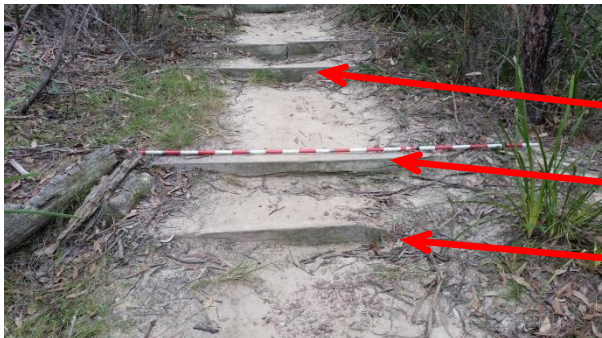
**Site ID: NT – 1(H)**

*Location:* 338486 6260464 Sleeper step, full and failed with scour over and 250mm step off, sleeper step full and failed 1400mm downslope/below.

Rock armour/flagging on step off upper step.  
Replace/reinstall lower step as a waterbar (discharging to W).

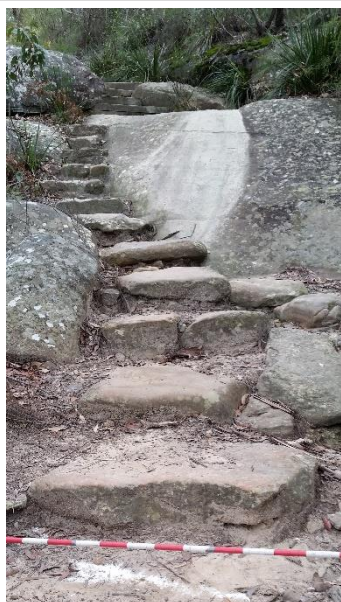
### Site ID: NT – 2(A)

**Location:** 338491 6260456 Run of 12 stone steps, 350-950mm wide (paired rocks towards bottom, narrower to top), down side of steep sloped rock ledge with boulders to east, 2.8m total level difference, 18° slope, drainage down rock face to W of steps flows onto lowest 4 steps (with some scouring around rock steps, but stable) then flows down track (into next segment – NT-1), flatter uneven area at top (with 90° turn to W off top step, at flatter top of ledge).

Infill stonework around scoured steps and inset rocks at bottom, with additional blocks or rubble barrier to define W edge and keep walkers on stone steps.

Monitor 2x largest steps at base of ledge for undercutting or instability (located in run-on zone for drainage flows down rock face).

Cut/level tread on top of rock ledge bedside/W of top step (to provide a safe “landing” and approach for walkers heading down, especially if wet/slippy).

Install low rock wall along top of ledge – from boulder upslope to N/NW (past the *Lomandra*) to catch/divert flows and seepage into existing crevice down face of rock ledge to W (and away from track/steps).

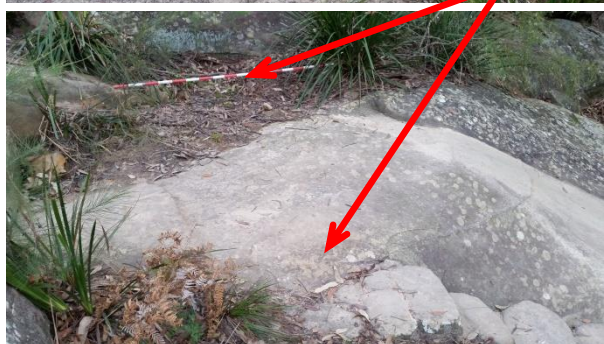
**Site ID: NT – 2(B)**

*Location:* 338495 6260452 4 sleeper steps between outcrops/boulders (at top of site NT – 2A), 550-1500mm wide, drainage flows down/over steps with scouring in loose sand, 400mm high step off bottom step, second step from top is rotting (boxed on E side and loose sand in tread above).

Replace rotting sleeper step.

Install additional boxed step off lower step, built onto top of rock ledge below, fill and rock armour/flagged tread.

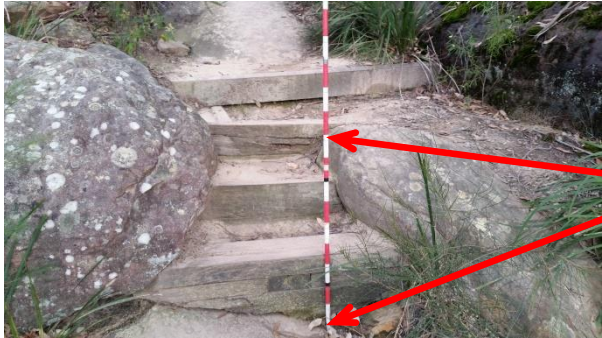
**Site ID: NT –2(C)**

*Location:* 338497 6260448 Long sloped/rounded rock outcrop/pavement, loose slippery sand on rock/track, drainage flows down E side with scour into flanking clay/sand and stones, sleeper step at top, drainage pools in dip and loose sand below on E side (with placed rock) then flows back onto track, 900-1200mm wide, 6.5m at 9° slope, 1.2m total level difference. Sleeper step above.

Waterbar off NE lower corner of rounded outcrop/pavement, and bottom of V- drain, discharging to NE.

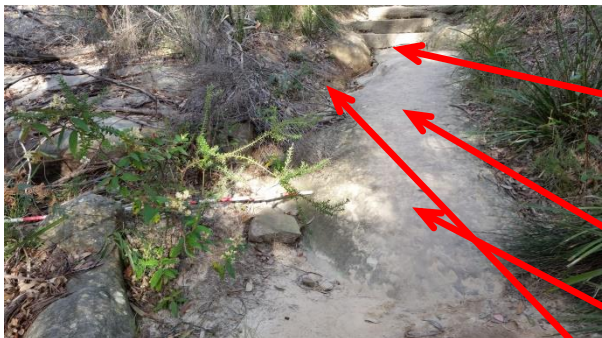
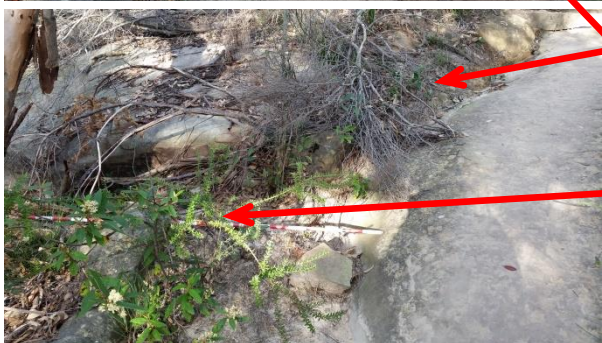
**Site ID: NT – 2(D)**

- sleeper step, full and failed with flows/scour over E end, 300mm step off;
- log step (split pair), full and failed with scour around E end;
- short log step (split/pair), embedded rock to west, flows/scour around both ends;
- 5 rock steps (600-1400mm wide) up/onto a built stone wall above (stone wall extends to NW), third step is narrow only 200mm wide, second step (from top) is an old concrete slab, top step has hump in centre, total step height of 1.2m, drainage flows over/down steps, steps are off-centre from track above (safety issue);
- drop off stone wall to east of steps is over 1m (safety issue);
- log waterbar along top of stone wall (and above steps) (trip hazard, safety issue), waterbar is full of sediment (and grassed on W end), discharges to NW.

Replace split/pair log step with 2 stone steps, fill and level above with rock armour/flagging with fall to E, include stone-lined invert discharging to E (cut outlet channel through mound beside track to E) (rock armour/flagging needed to protect against continued flows down/over).

Replace short log step with boxed stone step, built onto in-situ outcrop, rock armour/flagging on tread to bottom step above/upslope.

Level tread on existing top stone step (cut level or infill flagging) to minimise trip hazard, and level hump at rear of fourth step.

New/additional waterbar at least 1m above top of steps (and wall), with extended discharge to NW to prevent backflow to track.

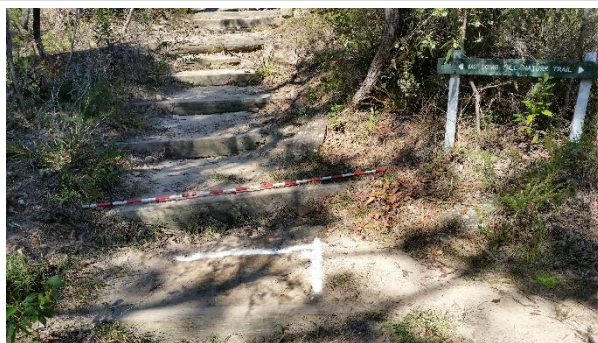
**Site ID:** *Junction with Nature Trail Link Track (from SE upslope), and Nature Trail turns 90° to N/NW downslope as Segment NT-2)*

**Location:** 338501 6260440 Small routed timber sign “McComb Hill” with arrow E/upslope (up sleeper steps) and “Nature Trail” with arrow W along contour. Good condition.

Upgrade signage at junction with Nature Trail Link Track at upper/S as per Manly Dam Sign Location Plan.

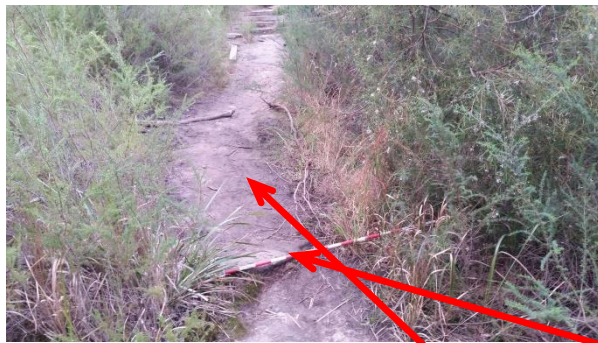
**Site ID: NT – 3(B)**

*Location:* 338457 6260438 14m long seepage/ponding area 1-1.5m wide, compacted moist sand track loose sleeper and laid branches, also receives runoff from rock outcrop to E (site NT-3(A)). Timber plank and laid branches as ad hoc/informal treatments.

Open low side windrows at all ponding sites. Waterbar at E end, built onto bottom edge of rock outcrop to E (site NT-3(A)), with extended outlet to NW to discharge well off track.

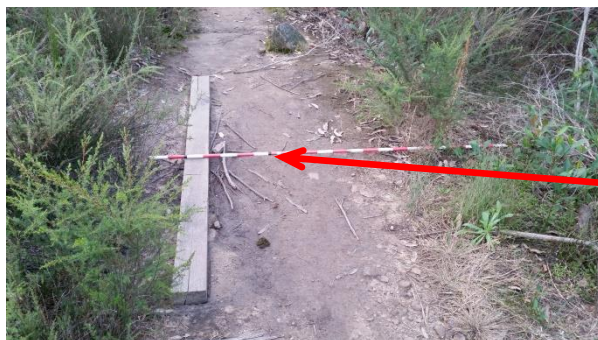
**Site ID: NT –3(C)**

*Location:* 338444 6260433 1-1.2m wide compacted moist sand track, ponding area with seepage and cross flows, 3m long, timber plank as ad hoc/informal treatment.

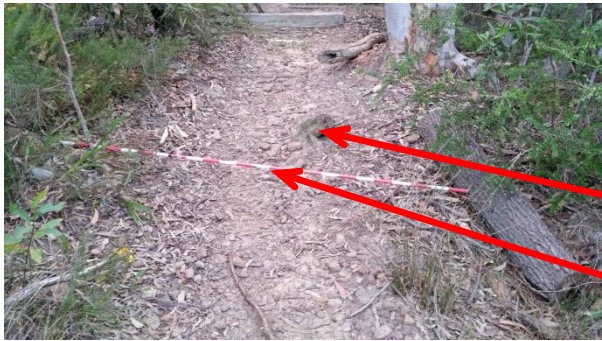
**Site ID: Junction with Picnic Area Link Track (from N/NW downslope)**

**Location:** 338390 6260443 Small routed timber sign for “Nature Trail”, with “McComb Hill” and “Section 3” both with directional arrows. Dislodged (leaning against tree stump) and in poor condition.

Upgrade signage at junction as per Manly Dam Sign Location Plan.

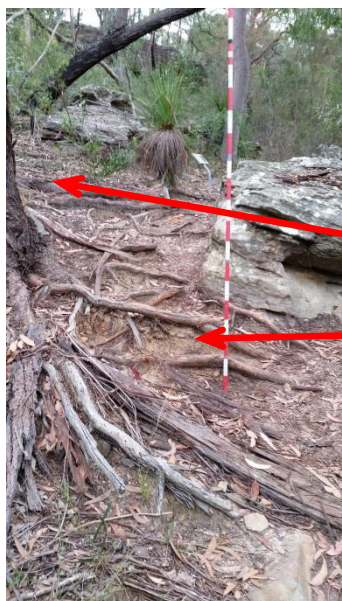
**Site ID:** NT – 4(A)

**Location:** 338364 6260430 Exposed roots protruding to 250mm high on slope around boulder, drains down, 1.1m 8m total level difference over 4.5m, 14° gradient around tree/boulder with drainage flows down track

Install 6 boxed steps over roots on a curved alignment around tree, with filled and compacted treads

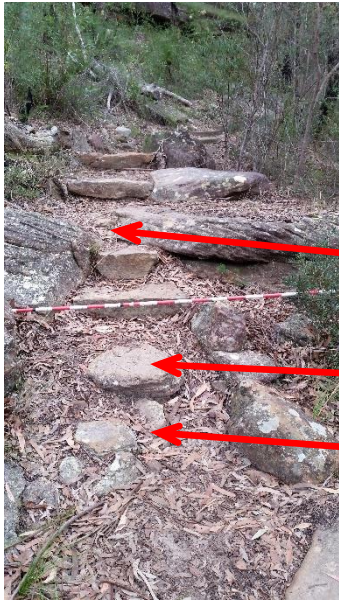
**Site ID: NT – 4(B)**

*Location:* 338356 6260425 Upper - large square rock step and smaller rock step below cleft/funnel between rock ledges/outcrops. Lower - rounded rock step, with embedded rocks and sloped rock outcrop below.

Replace rounded step with wider squared stone step.

Additional flat rock step at low end (relocate/re-use embedded rocks).

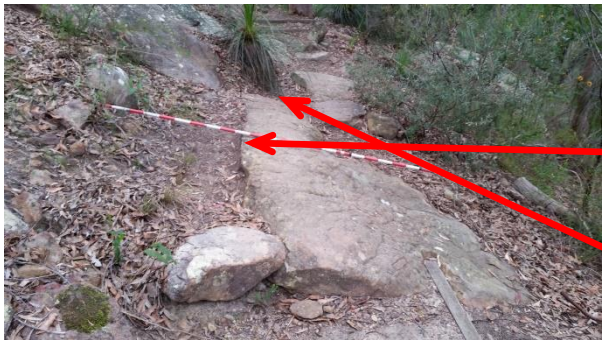
**Site ID: NT –4(C)**

*Location:* 338342 6260416 Stone step to high side of angled and irregular rock outcrop, track worn along high side/lip then off to placed flat rock at NW end beside grass tree (2.5m long).

Cut upslope lip of outcrop to match/level with rock armour/flagging along worn footpad along high side of outcrop.

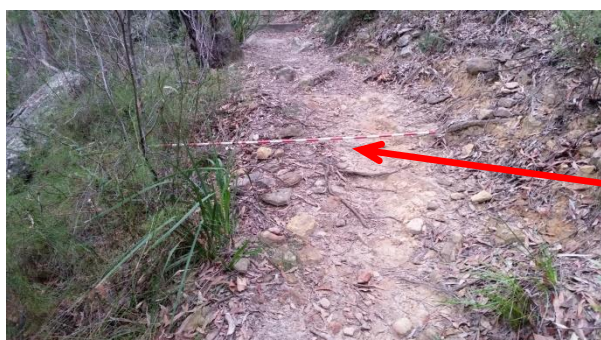
**Site ID:** NT – 5(A)

**Location:** 338314 6260416 Compacted sand/clay benched track, 1,000mm wide, embedded and protruding rocks, 4° gradient.

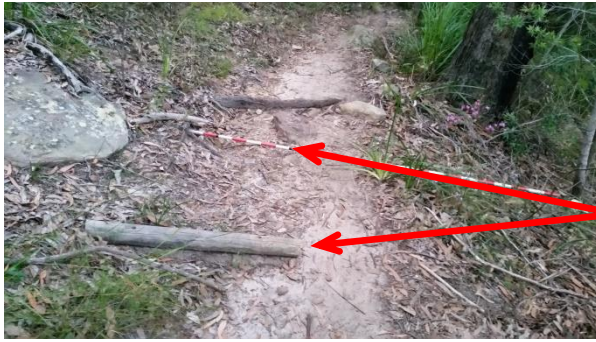
**Site ID: NT – 5(C)**

*Location:* 338288 6260421 Old log waterbar part way across track. Root and embedded rock upslope.

Remove old log. Install new boxed step-and-run, fill upslope/behind to cover embedded rock and root.

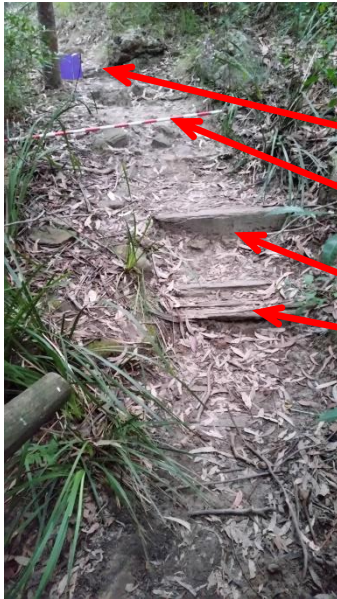
**Site ID: NT – 5(D)**

*Location:* 338282 6260416 Embedded and protruding rocks at top of 9° gradient slope with 2 old/decayed sleeper steps (on SE approach to small timber bridge).

Replace rotten / decayed sleeper steps, angled to also serve as waterbars (to divert flows, and sediment, before end of timber bridge below).

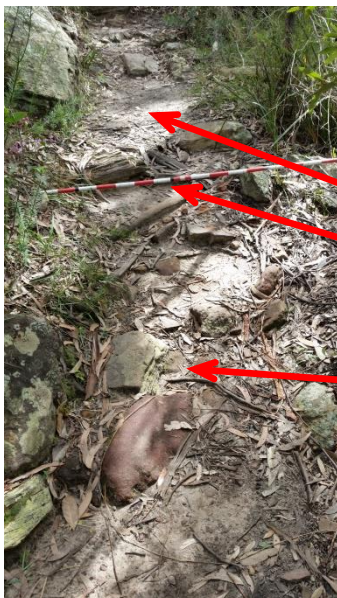
**Site ID: NT – 5(E)**

*Location:* 338269 6260424 Embedded rock and compacted sand, boulders beside track, part of old sleeper, and roots, 4m long, 5° slope (on NW approach to small timber bridge).

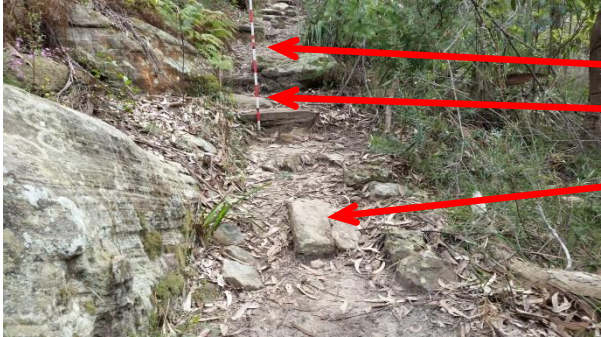
**Site ID: NT – 5(F)**

*Location:* 338266 6260426 5m long section of embedded rocks and compacted sand track, 11° gradient, part of old sleeper, 2 boulders at top act as “natural” step with an old sleeper step (900mm total height)

Install stone-lined invert above rock steps.

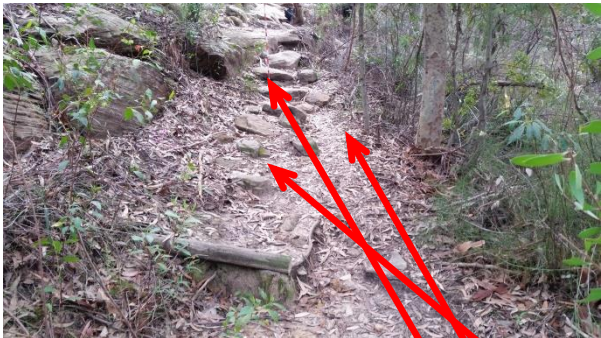
Total 1.7m rise over 9.5m section of track, failed (and detoured) log waterbar at bottom, compacted sand and embedded rocks in middle, then failed rock steps of large placed rocks above (with some track widening/avoidance to lower side, boulders then rock ledge (400mm step off), drain flows down entire section.

Cut step into rock ledge at upper end (at least 700mm wide).

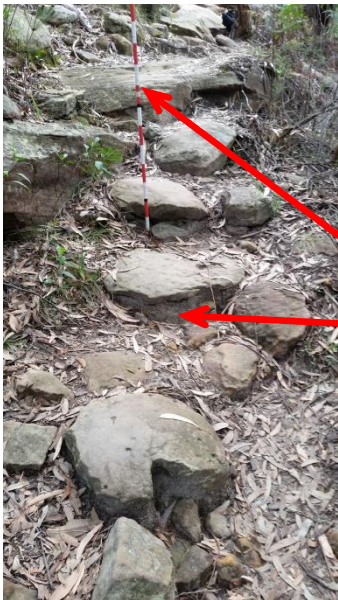
**Site ID: NT – 5(H)**

Bottom to top – rock ledge (top of Site NT – 5(I)); then compacted sand ledge for 6m at 2° gradient with protruding roots and embedded rocks, and drainage across, and displaced retaining logs downslope on low side; boulder at end and failed/displaced log waterbar; then 27m long section of track of rocky, loose and compacted sand and rubble, rising a total of 6m at 18° gradient steeply diagonally up/down slope with considerable flows down; ledge at 10m from top, angled/sloped boulder at bottom of next steeply sloped rocky section with 3 log waterbars in centre of slope (all failed, scour under to 400mm step off) then rock face/ledge along upslope side with minor rock platform below and paced rock steps a up/alongside rock face (some track widening/avoidance on downslope side); failed log waterbar at top then large roots from dead/cut tree retaining track as steps; embedded and loose rocks above to crest/top.

Relocate embedded large rock/boulder to form informal rock step (with rocks upslope), rock armour landing as stone-lined invert to channel flows across track. Remove roots.

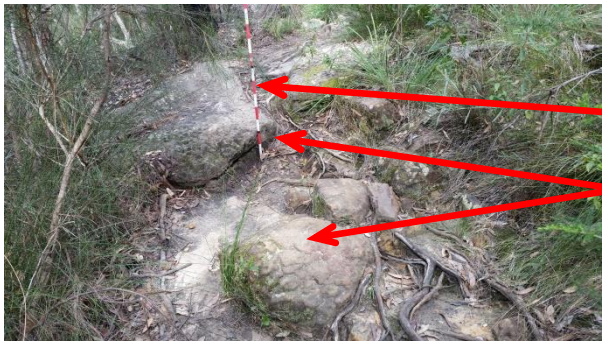
**Site ID: NT – 5(J)**

**Location:** 338226 6260461 Sloped rounded boulder with track widening around both sides, with drainage and sediment off track downslope. Embedded roots then log waterbar/step (full of sediment and failed) with compacted sand retained above, also retaining log along low side of track. 4 placed rock steps in small “chute” between rock ledge and boulders, 400mm drop off lowest step. Another step placed above boulder between ledges. Drainage down/over all rock steps, steps scoured but stable. 12m of track with 14° gradient overall.

Monitor existing rock steps for stability.

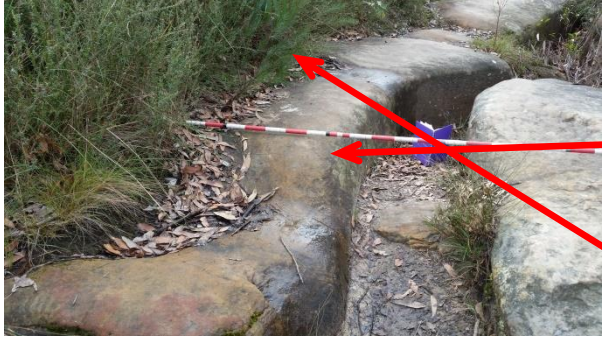
**Site ID: NT – 5(K)**

**Location:** 338225 6260468 Gutter between two rock ledges.

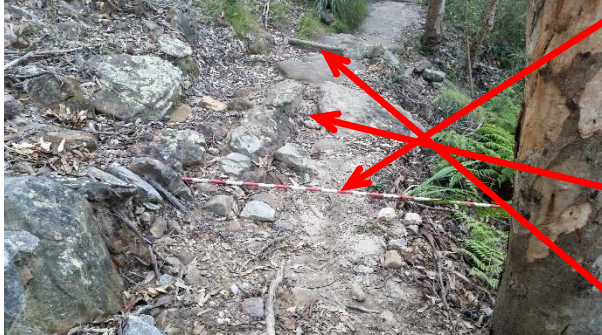
*Location:* 338190 6260512 Low point with stormwater flows across track. Angled rock outcrop and protruding rocks with gap between on W side of dip, then old log waterbar halfway across track on uneven rock outcrops.

Rock armour a wide channel/invert at stormwater crossing point (will also receive redirected flows from works upslope of Site NT - 6(A)). Define/retain low edge of channel, to avoid undercutting.

Level angled outcrop and protruding rock and rock infill gap to match levels, as informal step.

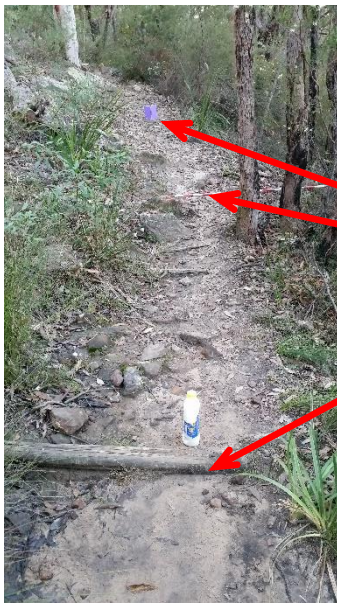
*Location:* 338185 6260518 Failed log waterbar at base of slope of compacted sand with embedded and protruding rocks, 11° gradient.

Replace waterbar.

2 new waterbars spaced up slope, built onto in-situ outcrops and larger embedded rocks. Remove protruding roots.

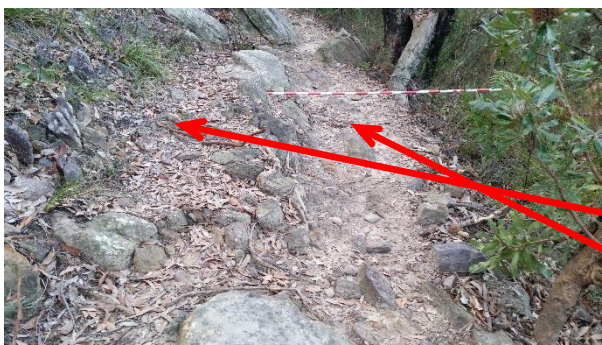
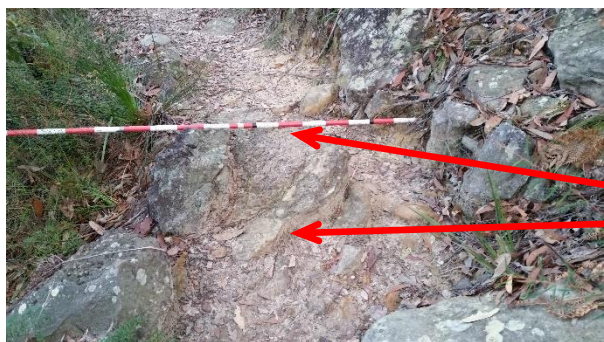
**Site ID: NT - 6(F)**

*Location:* 338167 6260532 Embedded angled rocks on crest, track benched-in to 300mm below NSL on high side and boulder upslope.

Remove/level protruding rocks on crest. Build informal rock step using in-situ outcrops, and rock waterbar or small gutter below.

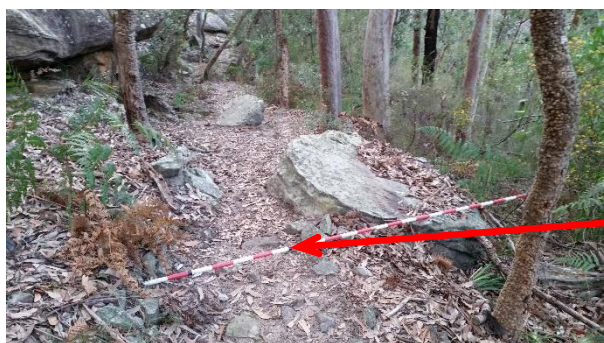
**Site ID: NT - 6(G)**

*Location:* 338163 6260540 Large flat boulder sloping off low side of track, at top of 11.5° gradient slope, embedded and protruding rocks in compacted sand.

Build waterbar off high side of boulder.

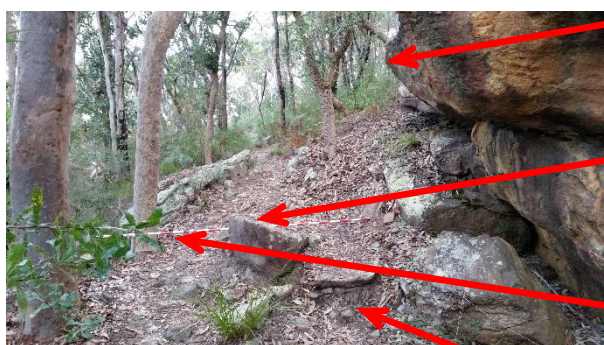
**Site ID: NT - 6(H)**

*Location:* 338163 6260545 11.5° gradient slope of embedded and protruding rocks in compacted sand, some loose rocks, large rock ledge/shelf upslope beside track, large boulder midway with placed rock step on high side but track braids to low side w to 1700mm wide with drainage flows and scour.

Remove point of rock ledge/shelf at head height above track's preferred high alignment (possible hazard) for taller walkers.

Build stone step-and-run below existing rock step, 1.5m long tread filled and compacted, built onto rock outcrop on high side and box/retain along low side, pull in track and barrier/block (rock rubble) low side below large midway boulder.

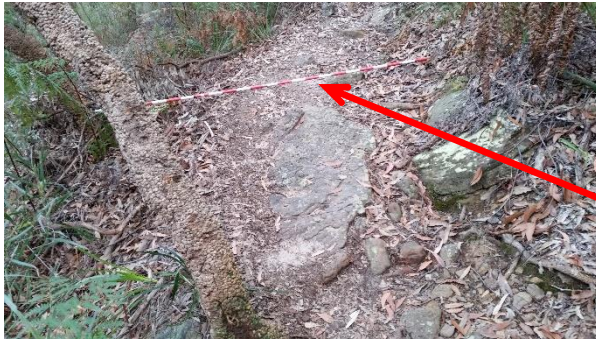
**Site ID: NT - 6(I)**

**Location:** 338155 6260552 Flat angled rock outcrop (attractive boulder and rock overhang upslope off track)

Build waterbar off high side of flat rock outcrop.

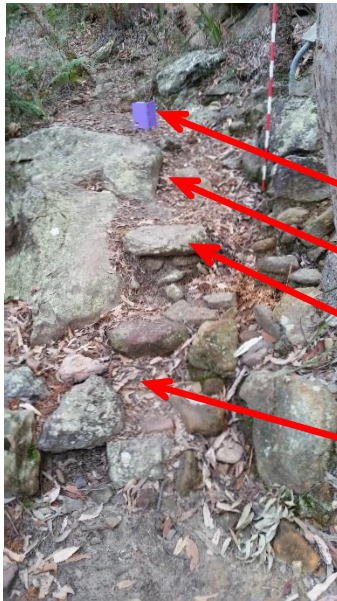
**Site ID: NT - 6(J)**

**Location:** 338153 6260558 Small rocky slope 5m long, 12° gradient, 800mm level change overall, 3 placed stone steps among embedded rocks and boulders high side and large angled outcrops low side, uppermost step is undercut, drainage down track with scour to 150mm below NSL. Old interpretation panel high side of track (poor condition).

Reinforce, or replace, uppermost existing step and build additional stone step below.

Reinforce, or replace, existing 2 lower steps.

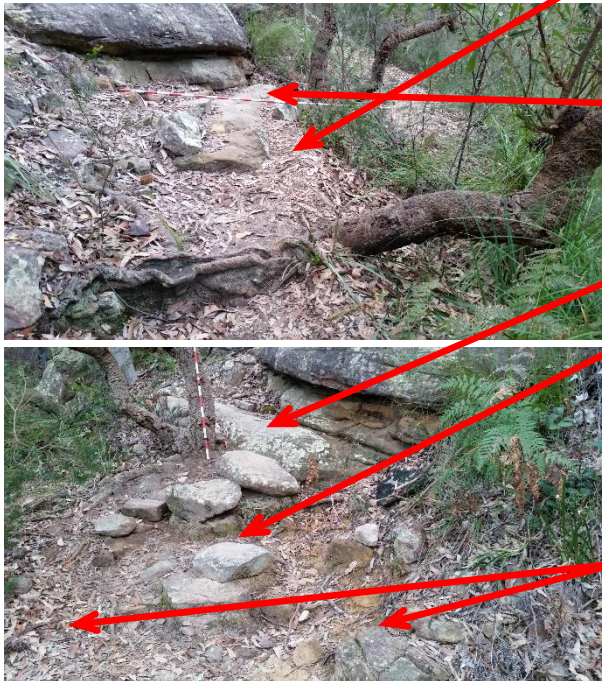
**Site ID: NT - 6(L)**

**Location:** 338146 6260574 9° gradient over 5m, failed log waterbar at bottom, 2 placed stone steps and “natural” step on rock outcrop, loose/placed rocks and embedded rocks at top, flows down track but little scour, 2 large boulders high side.

New stone step at top, with stone-lined invert above, and stabilise loose rock.

Replace waterbar, and extend/upgrade lower rock step to abut adjacent boulders.

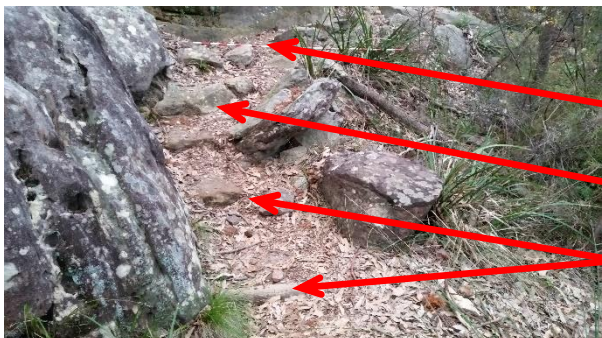
**Site ID: NT - 6(M)**

*Location:* 338142 6260574 Dual track, line of placed rocks offset from base of rock face/ledge as upslope alignment is rockier and less used, compacted sand and embedded rocks plus roots at NW end on undulating downslope alignment (less well used). Alignments re-join at NW end at embedded/protruding rocks and boulder.

Block and disguise upper alignment.

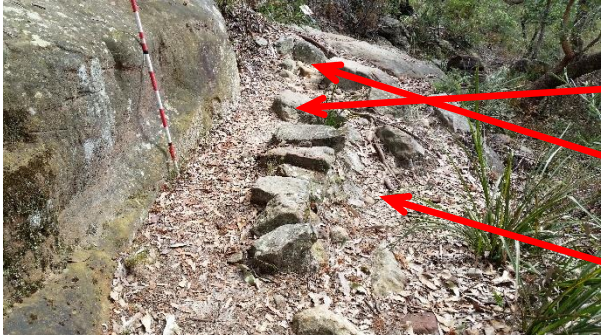
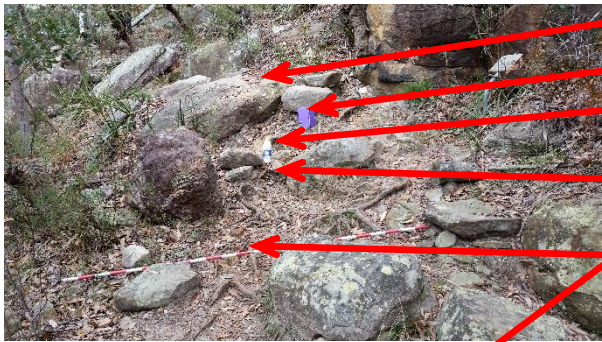
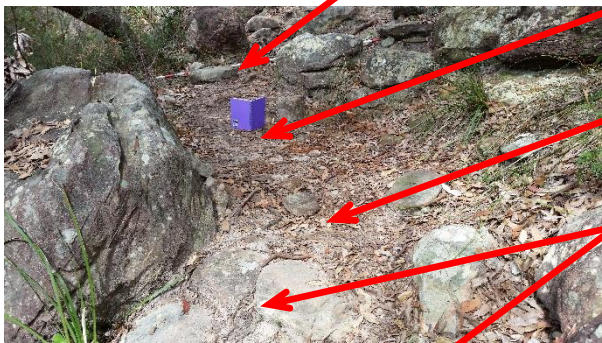
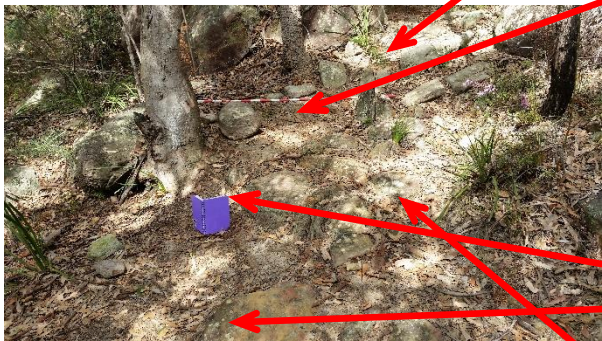
**Site ID: NT - 6(N)**

14m section of rocky slope with boulders and large embedded rocks (including “pedestal” rock) in compacted sand, roots, rockier on upslope section with 500mm steps off larger rocks/boulders and 2 placed stone steps, some loose rock. 16° gradient overall (more gently sloped central section), 3.6m overall elevation change. Drainage flows down track and track braiding or widening at obstacles. Old interpretation panel high side of track (poor condition).

Level/cut tread in top outcrop.

Build 2 stone steps below existing top step.

Stone lined invert below/downslope of new steps (above “pedestal” rock), extend upslope to intercept higher drainage path. Build stone step off low side of invert.

Pull in both sides of track and barrier/block (rock rubble).

2 boxed step-and-runs, with filled/compacted treads, across central flatter area upslope of large boulder.

Rock armour/flag landing off lower step – at top of sloped rock outcrops (to protect against continued drainage from upslope).

Cut step (at least 700mm wide) into sloped rock outcrop and build stone step below - align to N/NE (not higher alignment to NW).

Stone lined invert below/downslope of outcrop/step, extend upslope (as rock wall or stone waterbar) to intercept higher/secondary drainage path and extend outlet to discharge through/past downslope boulders. Build stone step off low side of invert (anchored onto laterite outcrop), and cut/level landing into outcrop as needed.

Rock armour/flagging below laterite outcrop.

Build boxed step onto lowest boulder/outcrop

Pull in track and barrier/block (rock rubble), especially inside of curve/high side.

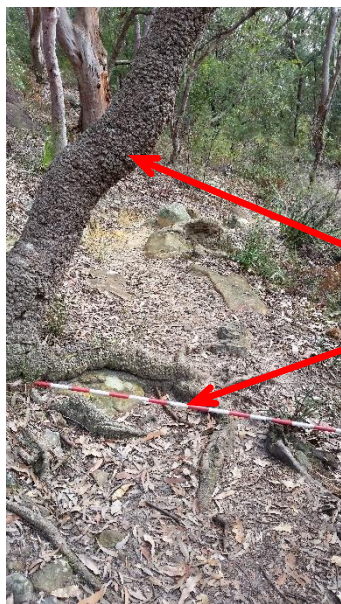
**Site ID: NT - 6(O)**

*Location:* 338144 6260592 Leaning Banksia (head/neck height), exposed/protruding roots and stump, track widening downslope of tree.

Mark tree as "height hazard".

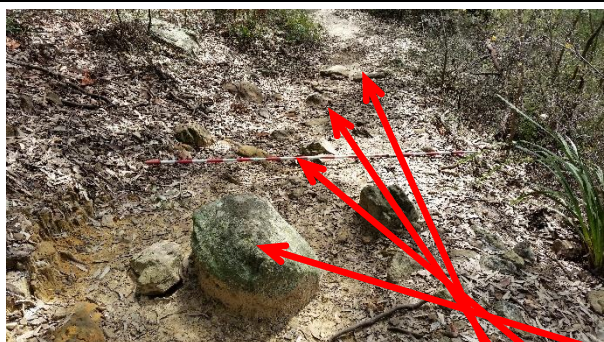
**Site ID: NT - 6(P)**

*Location:* 338142 6260602 9m slope at 9° gradient, up and around boulder at top/crest and benched in to 300mm below NSL, then braids each side of "pedestal" rock, widening track of embedded and loose rocks on sandy/clay slope with drainage flows down entire length.

Pull in track and barrier/block (rock rubble) low side.

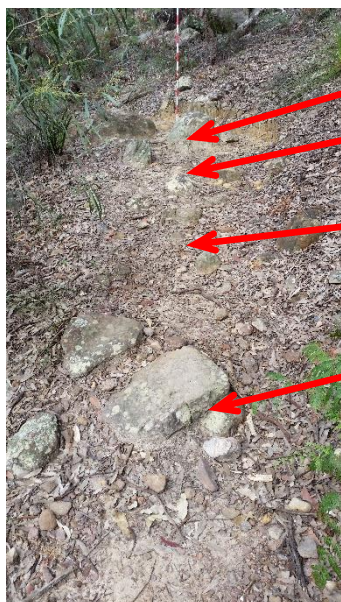
**Site ID: NT - 6(Q)**

*Location:* 338137 6260612 5m slope at 4° gradient, roots and low side boulder at bottom, embedded/vertical outcrops and embedded rocks at top, compacted sand and loose rocks.

Stone-lined invert above top step, discharging low side of Angophora.

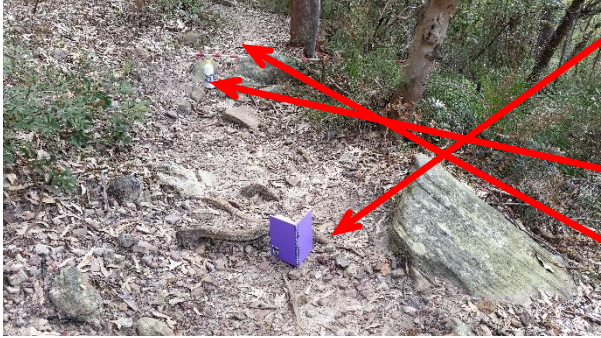
**Site ID: NT - 6(R)**

*Location:* 338130 6260620 Exposed roots in dished track of compacted sand and loose rocks.

Waterbar/step, filled and compacted upslope/above over roots.

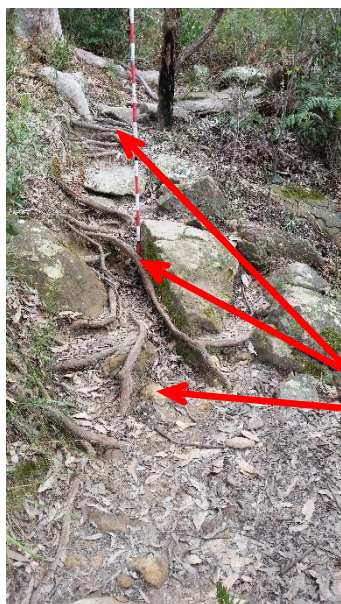
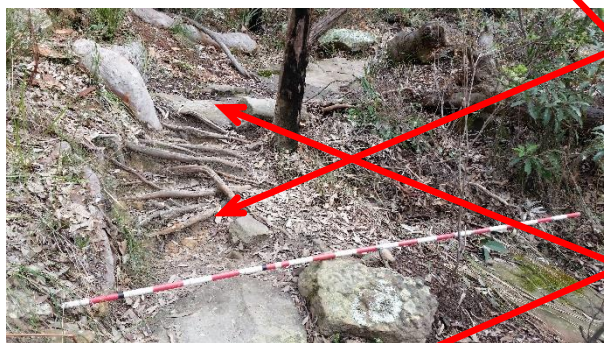
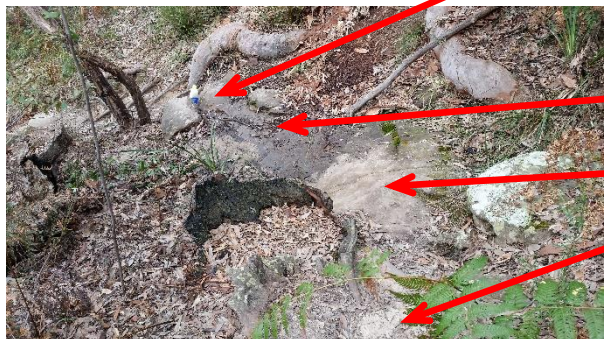
**Site ID: NT - 7(B)**

*Location:* 338113 6260630 Junction with large track to NW. Track closed and blocked with placed branches, signposted "TRACK CLOSED" on dislodged thin wooden post, and "NATURE TRAIL" sign (with directional arrow) on ground nearby and held in place by rock – both temporary laminated paper signs. Nature Trail turns +90° upslope.

Reinforce physical closure, and rehabilitate initial section, of closed track.

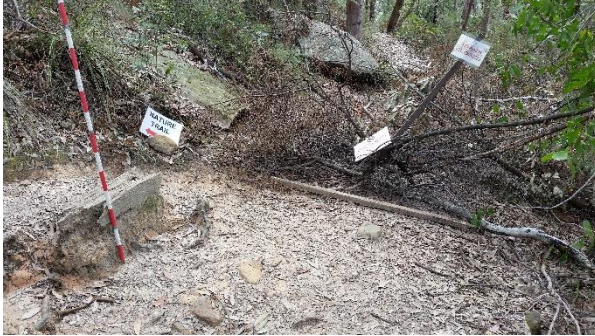
**Site ID: NT - 7(C)**

Remains of old sleeper step at bottom, 350mm step off and avoided with track widening at junction. Then 4 failed log waterbars/steps, some burnt and /or only partially across track, drainage flows over/down and scour, steps of >300mm. Track of eroded compacted sand/clay, protruding roots, benched-in to 250mm on high side, 10m and 11° gradient overall.

Replace 3 upper failed treatments with longer waterbars/steps, extending well off track both sides.

Replace lowest waterbar/step with 2 boxed steps and/or step-and-runs, with filled/compacted treads.

Monitor for avoidance/widening.

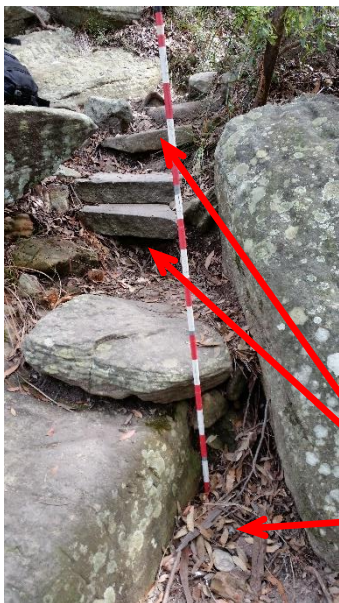
**Site ID: NT - 7(G)**

*Location:* 338092 6260630 Rock ledge with large placed flat rock at end, 550mm step height from compacted sand track below (Site NT – 7(F), 2 small metal directional arrows on ledge. 5 stone steps between boulders (350mm riser on lowest step, and 3<sup>rd</sup> step loose) curving low side of Angophora and boulder at top, large root is additional step (placed rock adjacent), drainage flows over/down steps (hard to redirect due to containing boulders). 8m at 30° gradient. Trample track (loose sand) at 2m above steps, up/down slope to informal track/junction below (Site NT – 7(F)).

Stabilise, or replace, 3<sup>rd</sup> step.

Monitor root step for trip hazard (from scouring of adjacent treads) or rot/decay.

Block/disguise shortcut.

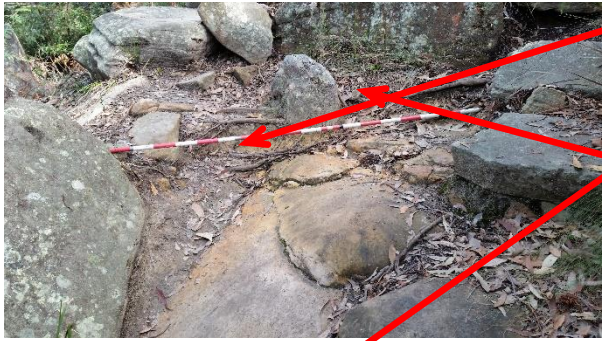
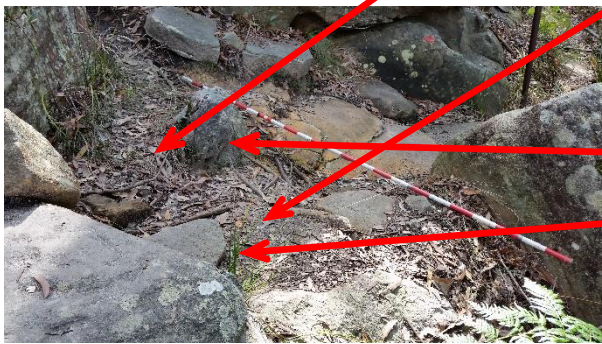
**Site ID: NT - 7(I)**

**Location:** 338089 6260629 Upper edge of rounded/sloped rock outcrop with drainage down from upslope and from old track alignment along base of cliffline to NW. Retaining root/step 250mm high above, with protruding and embedded rock in compacted sandy clay upslope to large boulder (Site NT – 7(J)), 3m at 14° gradient.

Build 2 stone steps at top edge of rounded/sloped rock outcrop, butt onto boulder on low side (match with works at Site NT – 7(H) immediately below).

Build rock along high side of track above/NW of top of rounded/sloped rock outcrop, to catch/divert drainage from upslope (off old alignment and cliffline) and direct to new stone-lined invert.

Stone-lined invert upslope of protruding rock (high side) to channel flows across track and discharge past/above boulder (low side).

Leave protruding rock (high side) to define track edge.

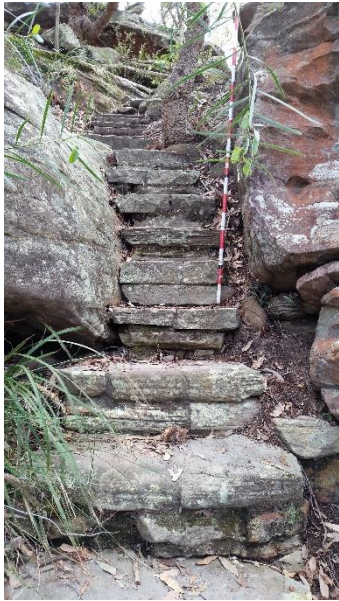
**Site ID: NT - 7(K)**

*Location:* 338083 6260626 10 stone steps in “chute” in cliffline, 400-900mm wide, 250-300mm risers, drainage flows down/over steps but little scour.

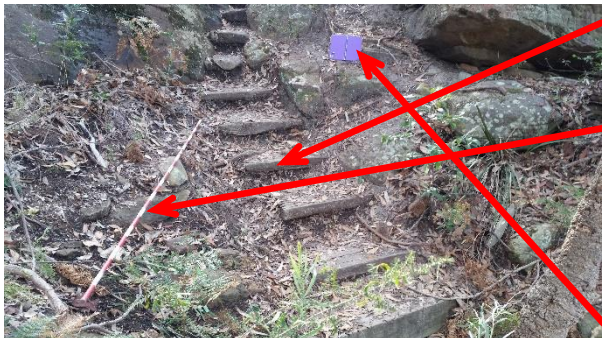
**Site ID: NT - 7(M)**

**Location:** 338079 6260631 5 rock steps in narrow cleft between rock face/ledge and large boulder at top of cliffline, 300-400mm wide, drainage flows down and some scour over/beside lowest step, embedded rocks and protruding roots at top of above steps with scour to 200mm below NSL (trip hazard), 6m at 32° gradient, major drainage path to NE/above steps on high side of boulder also receives some walker use (to avoid steps).

Stone-lined invert above steps (and below end of squared outcrop on downslope side), with extended outlet to discharge well off track (beyond slope back to track, to prevent backflows), excavate outlet gutter if needed.

**(HIGH - for passability/safety issues)**
